T/L No. 224 Strs. No. 53-58, 182-184, 228-232
T/L 224

LANEXA-NORTHERN NECK

INSPECTION FINDINGS

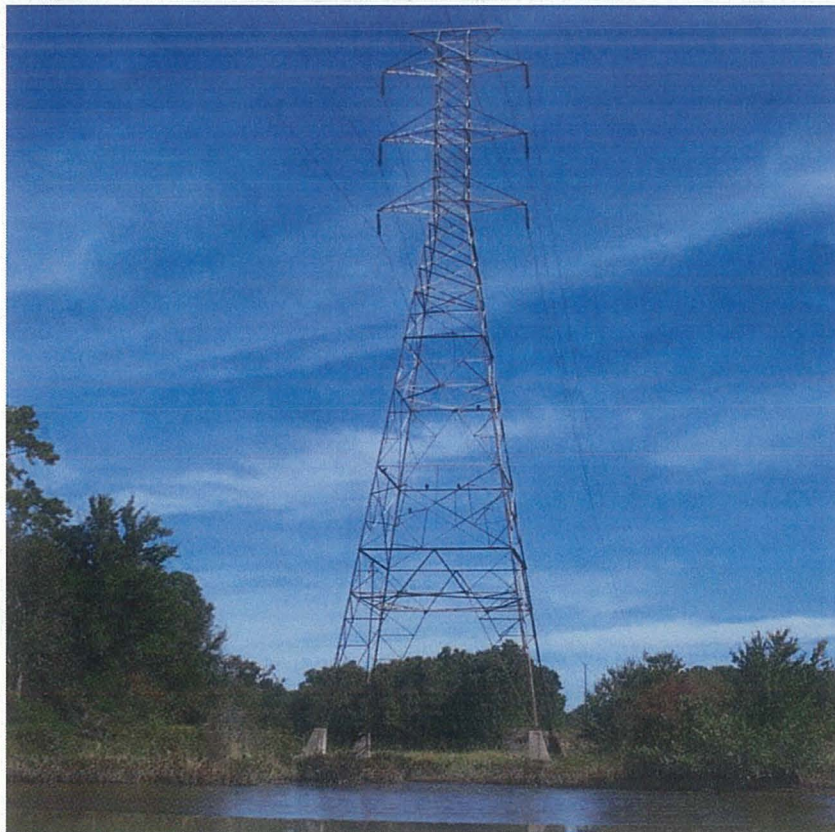
OVERALL CONDITION OF FOUNDATION GOOD ~~FAIR~~ POOR

1/2" CRACK ON UNDERSIDE OF FOUNDATION 4 CAP

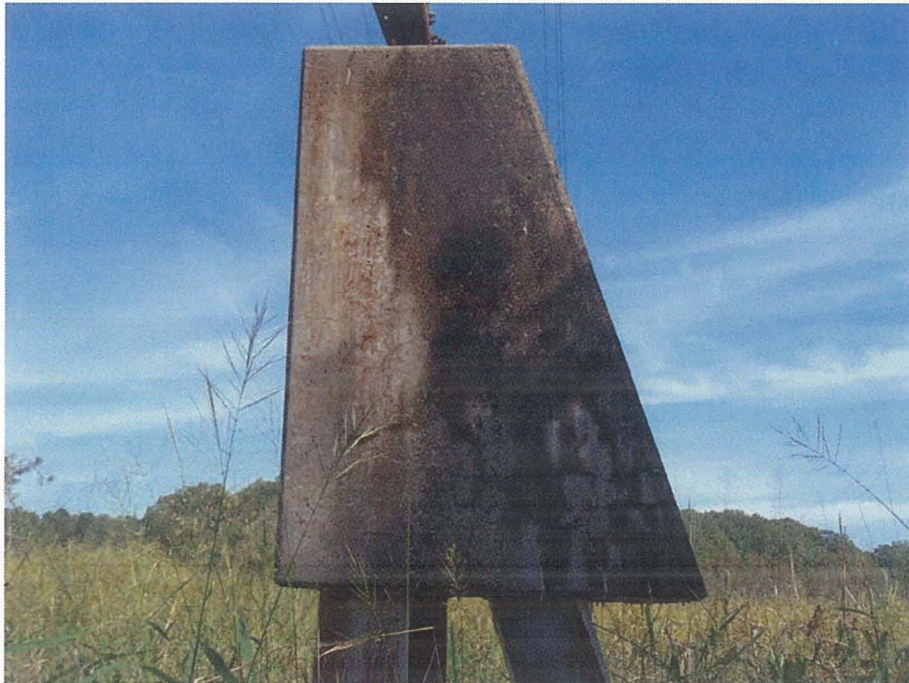
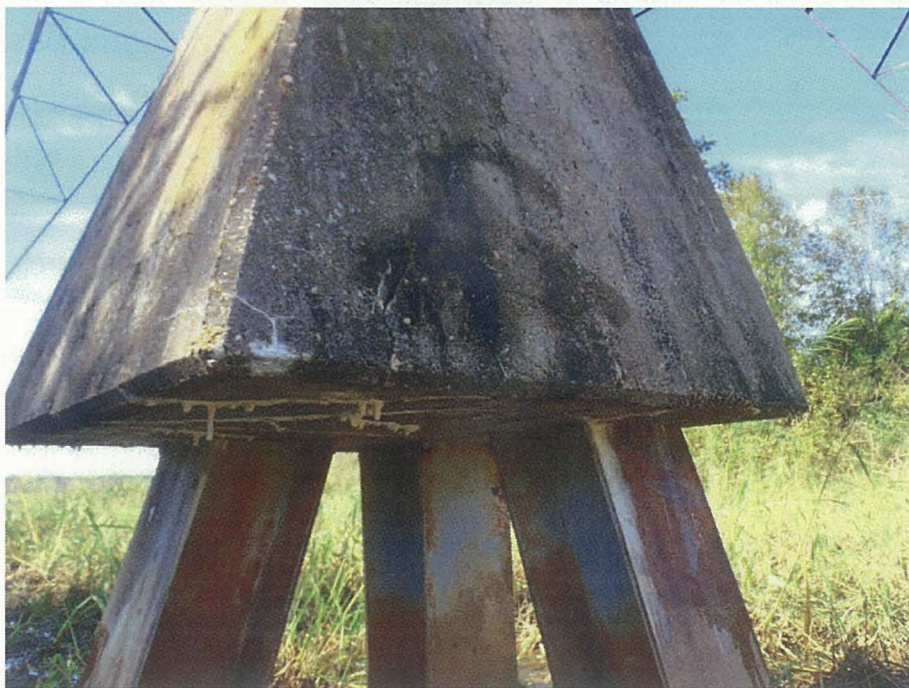
FOUNDATION 1

1/16" TO 1/8" MAP CRACKING WITH EFFLORESCENCE

EAST SIDE 1/4" CRACK AT BASE TO 1/8" CRACK AT TOP OF CAP

1/4" CRACK ON BOTTOM OF CAP FROM NORTH WEST TO SOUTH EAST SIDES OF
CAP. STOPS AT PILE B.

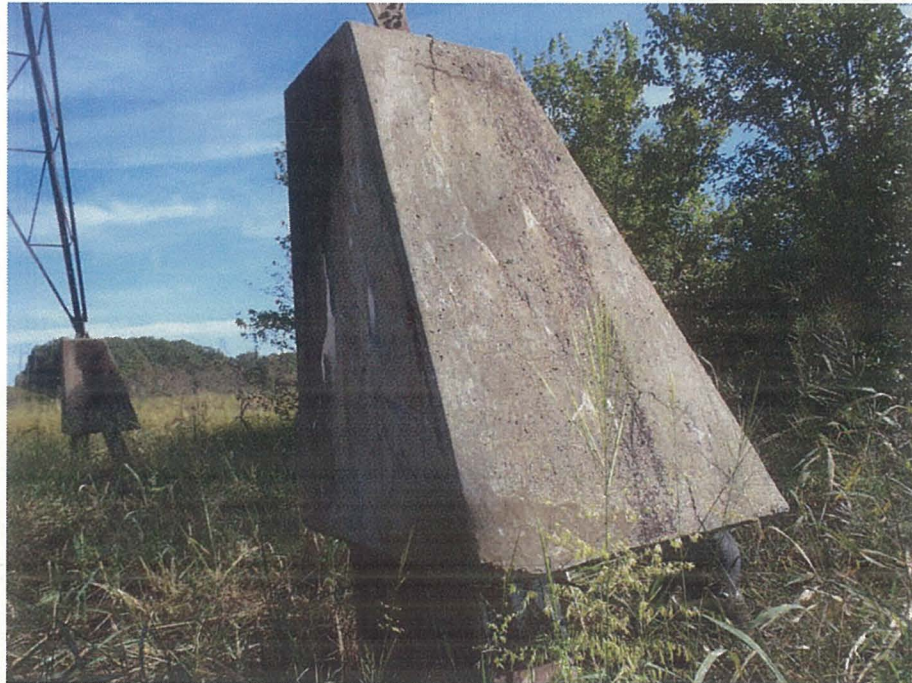
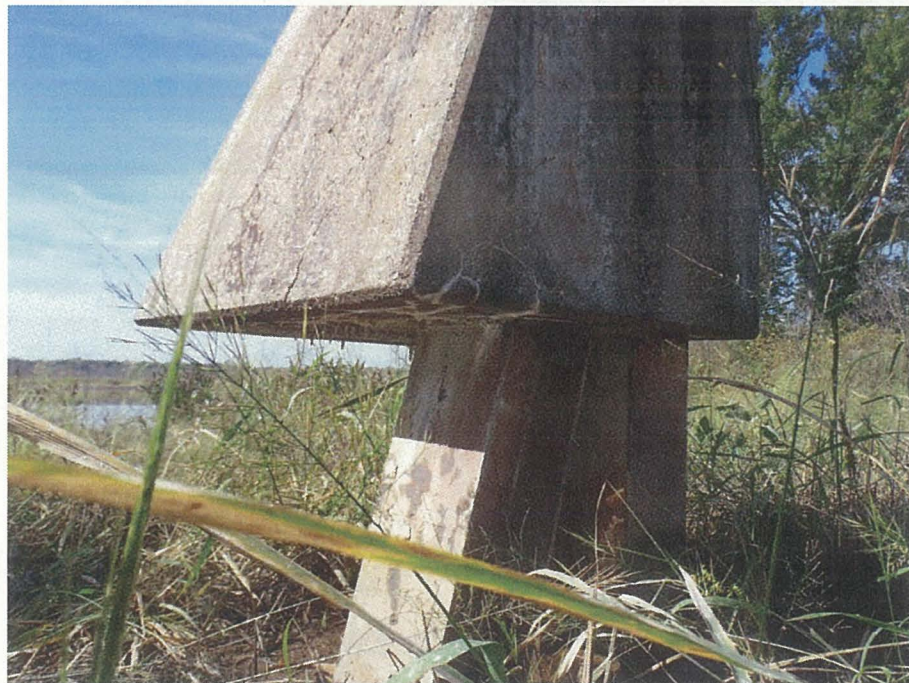
FOUNDATION 2

1/16" TO 1/8" MAP CRACKING WITH EFFLORESCENCE

EAST FACE TWO 1/2" CRACKS AT BASE UP TO 1/8" CRACK AT TOP OF CAP

SOUTH WEST CORNER SPALL 7"W x 4"H x 1/2"D

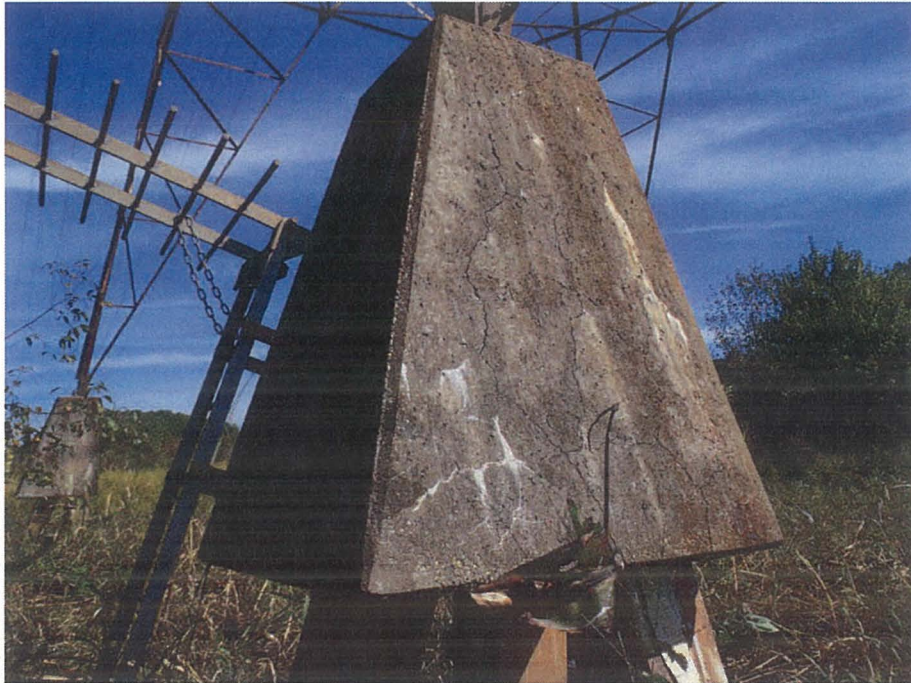
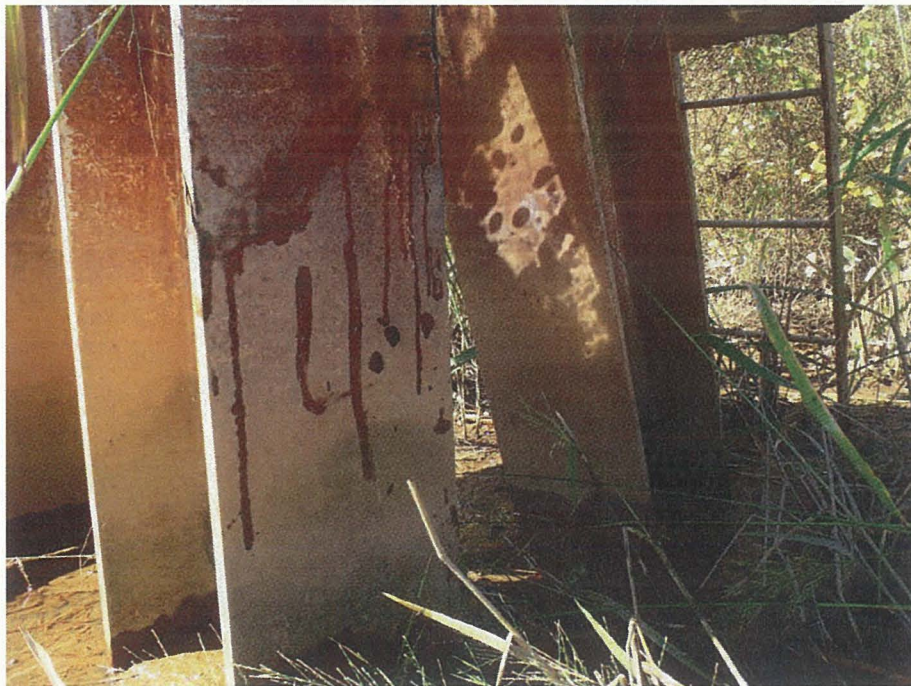
FOUNDATION 3

1/16" TO 1/8" MAP CRACKING WITH HEAVY EFFLORESCENCE

1/4" CRACK ON BOTTOM OF CAP ON SOUTH SIDE TO PILE B WITH EFFLORESCENCE

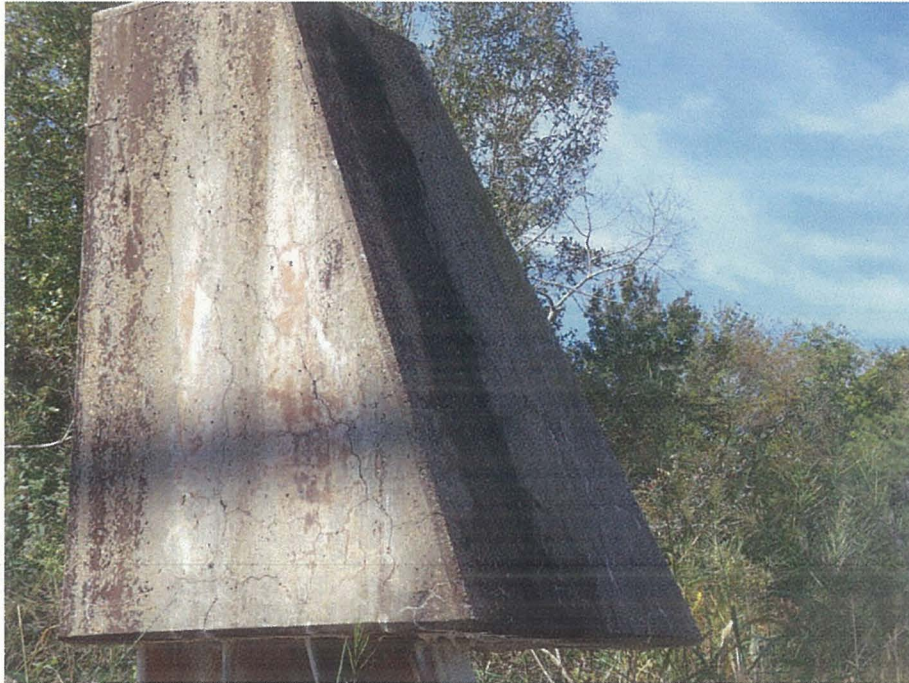
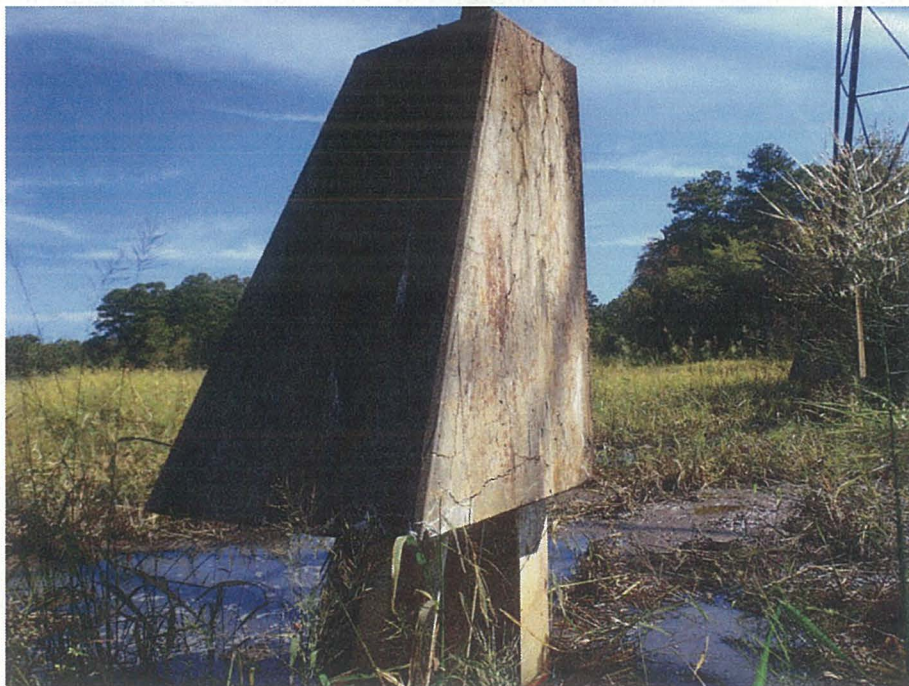
FOUNDATION 4

1/16" TO 1/2" CRACKS AND 1/16" TO 1/8" MAP CRACKING WITH EFFLORESCENCE

SOUTH FACE 1/4" CRACK AT BASE TO 1/8" CRACK AT TOP OF CAP.

1/2" CRACK ON BOTTOM OF CAP ON NORTH SIDE OF PILE B WITH RUST STAINS

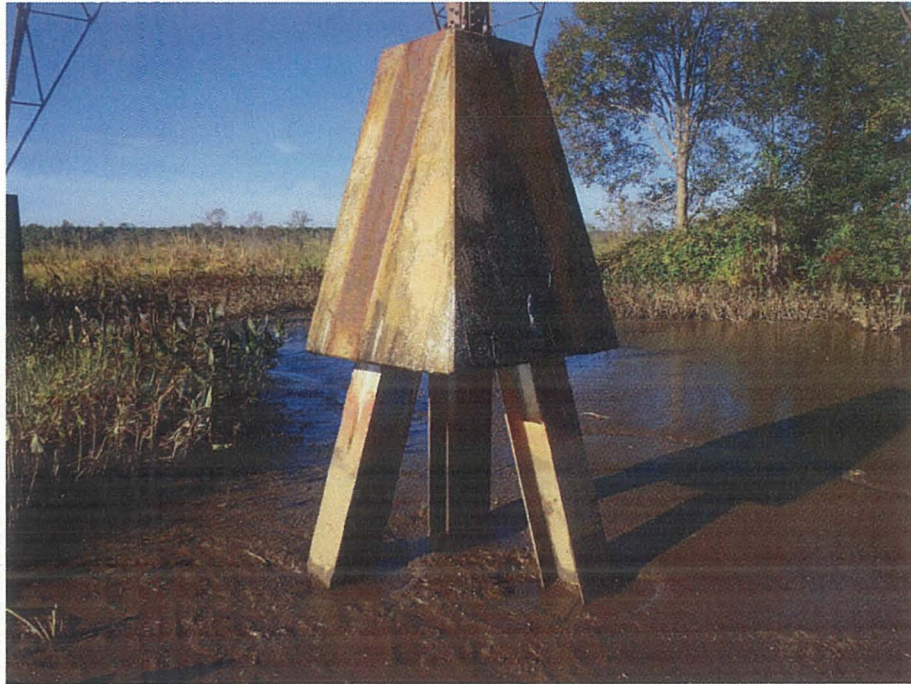
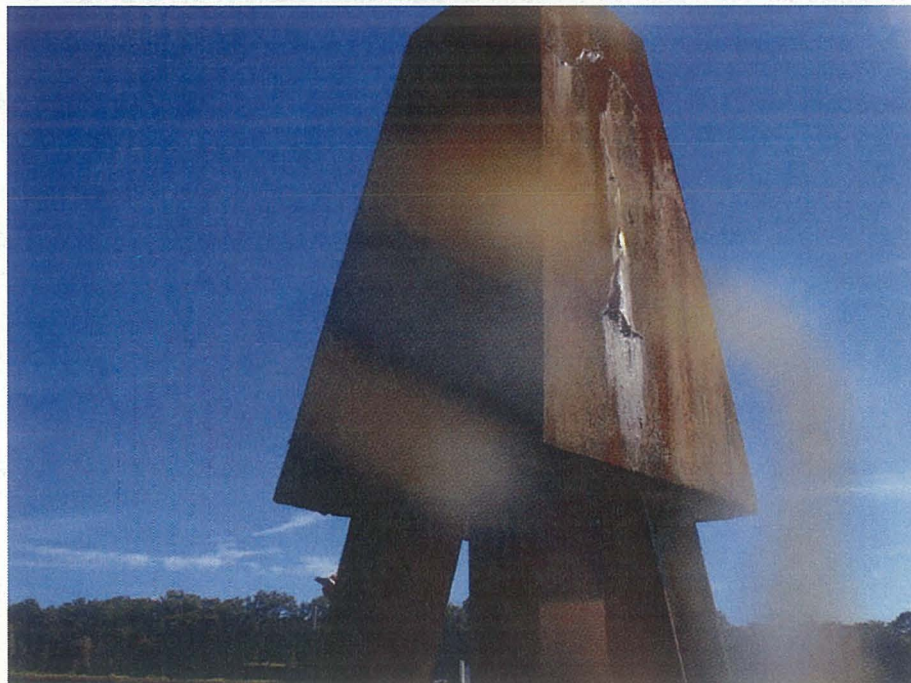
FOUNDATION 1

1/16" TO 1/8" MAP CRACKING WITH EFFLORESCENCE

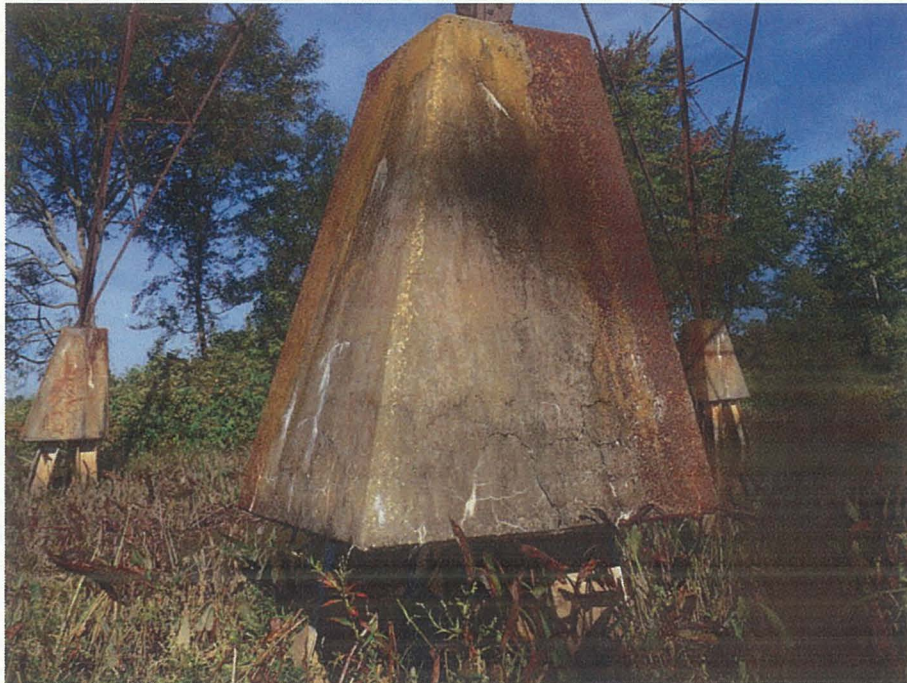
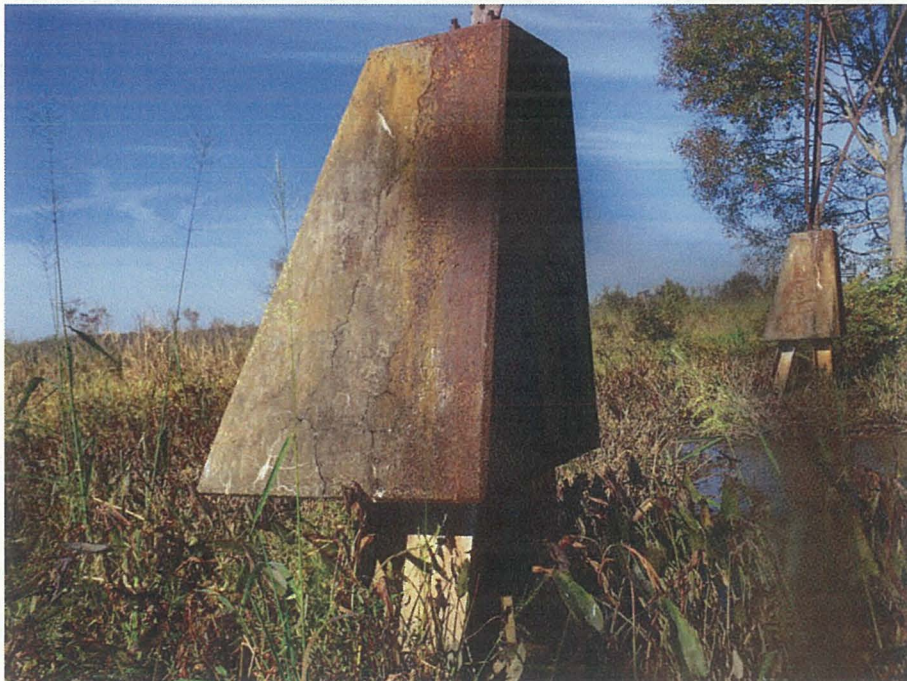
FOUNDATION 2

1/16" TO 1/8" MAP CRACKING WITH EFFLORESCENCE

EAST FACE 1/4" CRACK AT BASE UP TO 1/16" MAP CRACKING WITH
EFFLORESCENCE

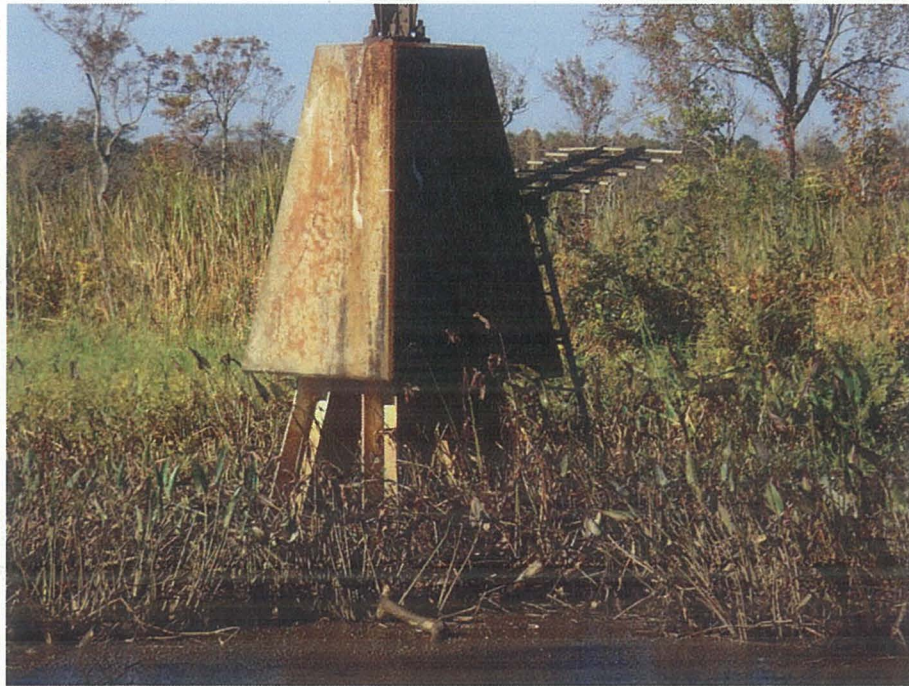
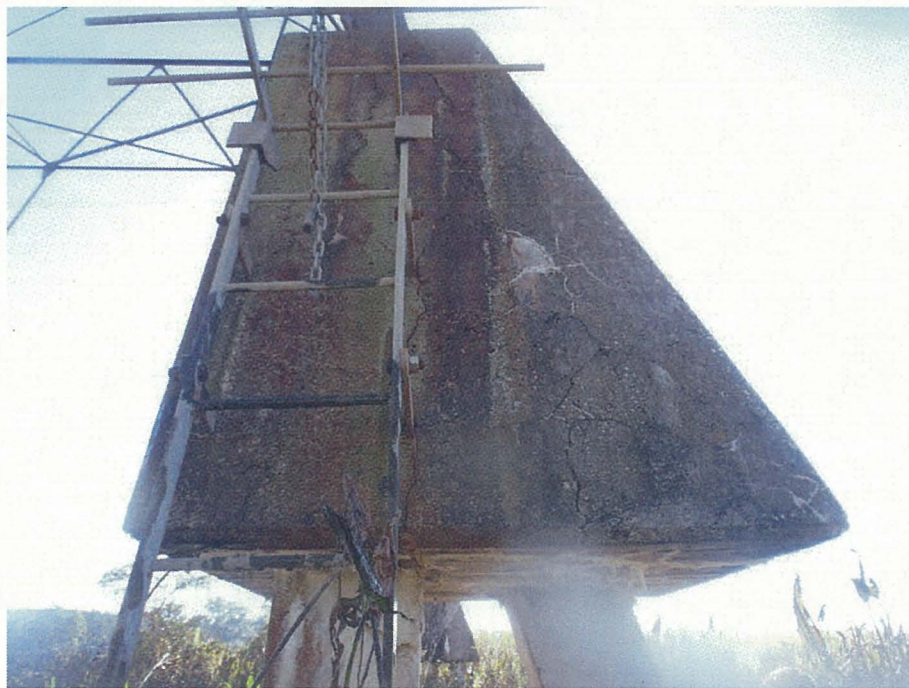
FOUNDATION 3

1/16" TO 1/8" MAP CRACKING WITH EFFLORESCENCE

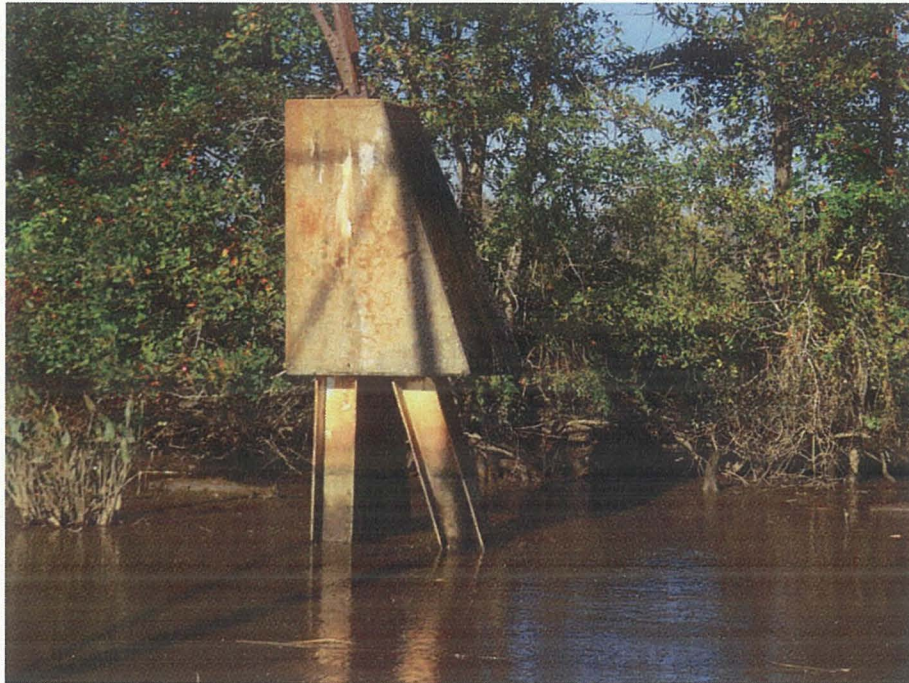
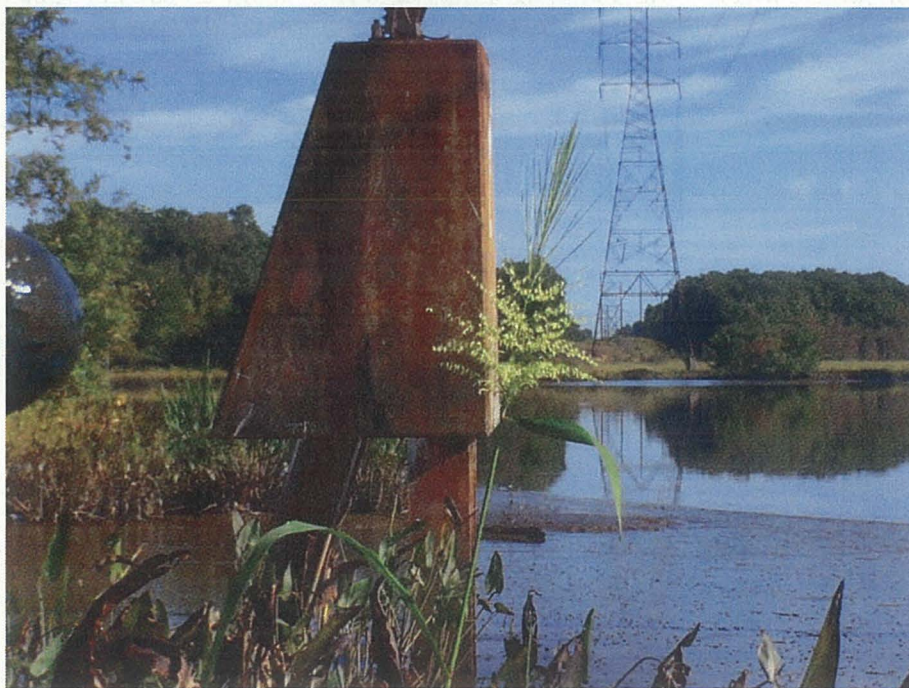
FOUNDATION 4

HAIR LINE TO 1/16" MAP CRACKING WITH EFFLORESCENCE
