## Wetland Determination Data Form - Atlantic and Gulf Coastal Plain Region

Project: CHESTERFIELD - HOPEWELL 230KV REBUILD  
 Applicant: DOMINION ENERGY VIRGINIA  
 City/County: CHESTERFIELD AND PRINCE GEORGE COUNTIES; CITY OF HOPEWELL  
 State: VIRGINIA  
 Investigator(s): B. YOUNG, C. NICE  
 Date: 12/19/2017

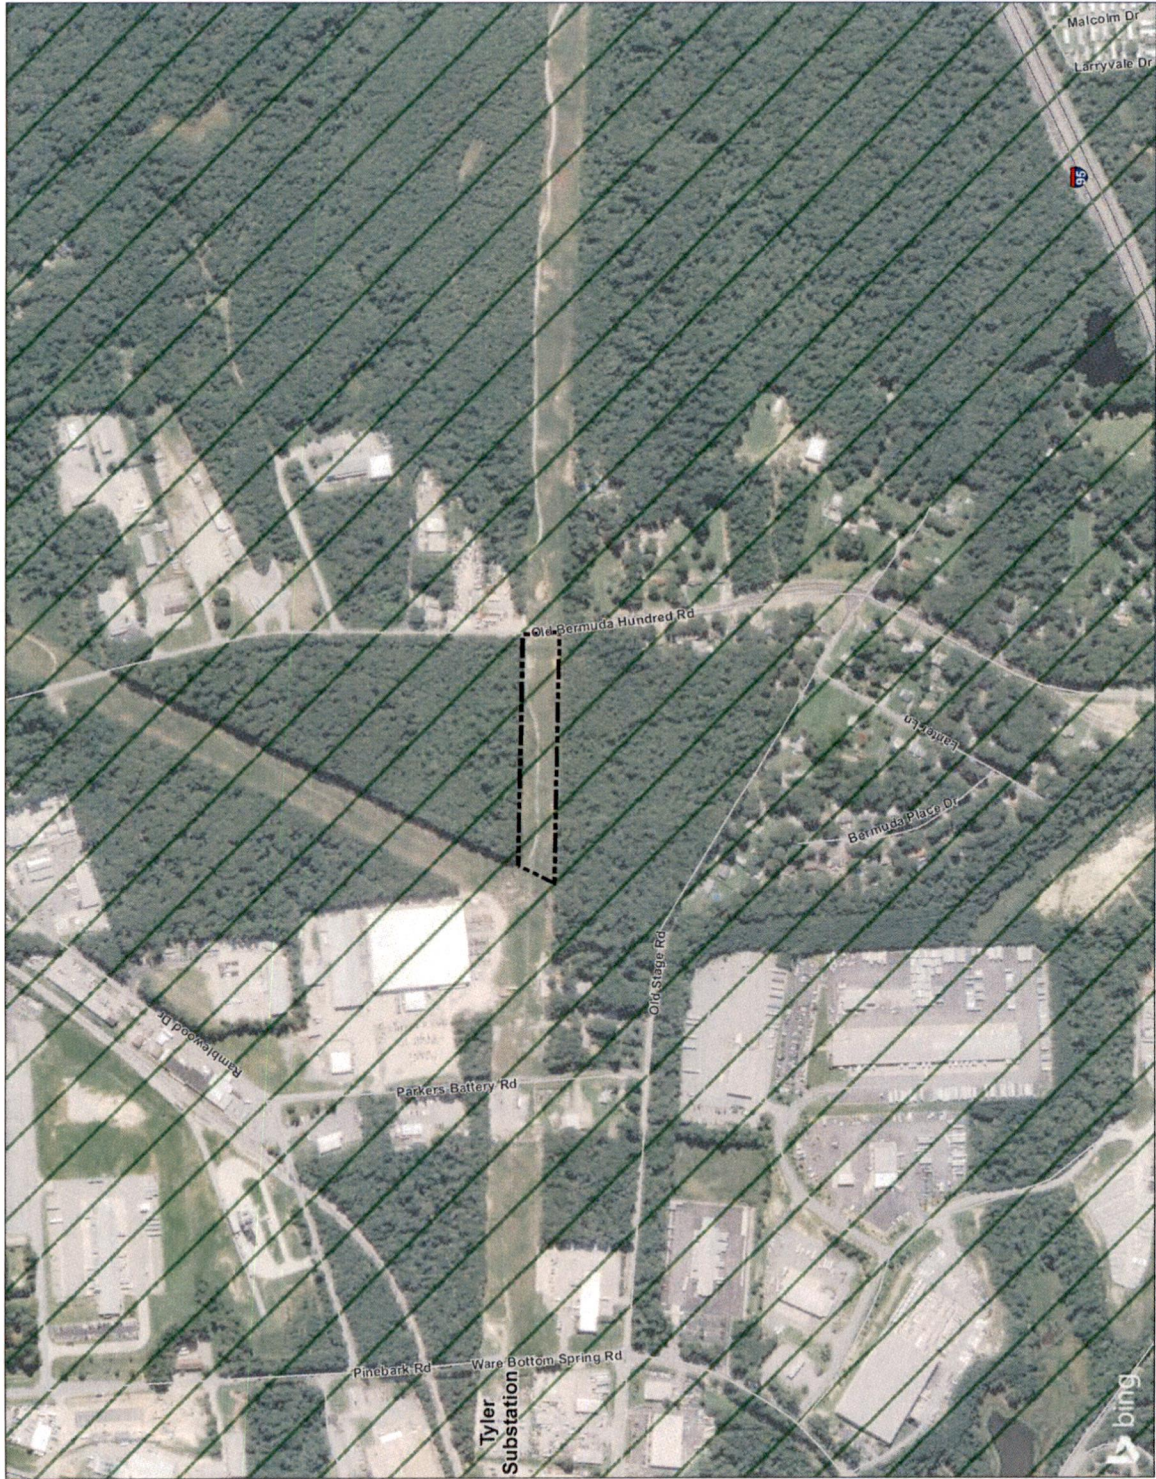
Figure No.  
6

Title  
**Delineation Map**
