Application, Appendix,
DEQ Supplement, Routing
Study, Direct Testimony
and Exhibits of Virginia
Electric and Power
Company

Meadowville 230 kV Electric Transmission Project

**Case No. PUR-2024-00**179

Environmental Routing Study Meadowville 230 kV Electric Transmission Project September 2024 Project No. 64094

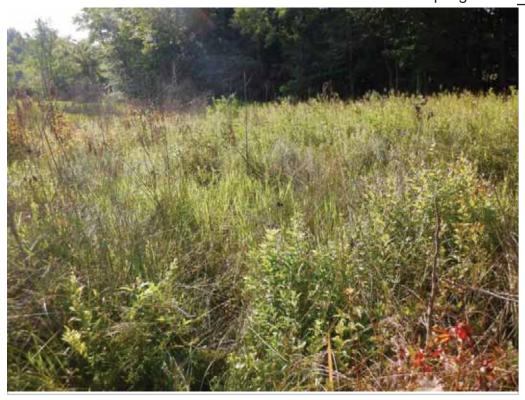
FDS-56A1-1; Representative Vegetation (06/24/2024, K. Winklepleck)

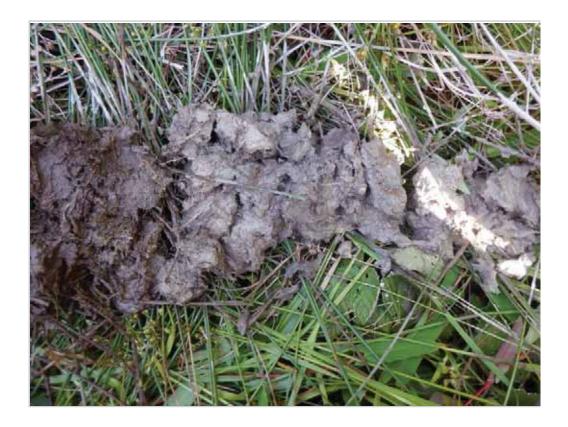
FDS-56A1-1; Representative Soils (06/24/2024, K. Winklepleck)

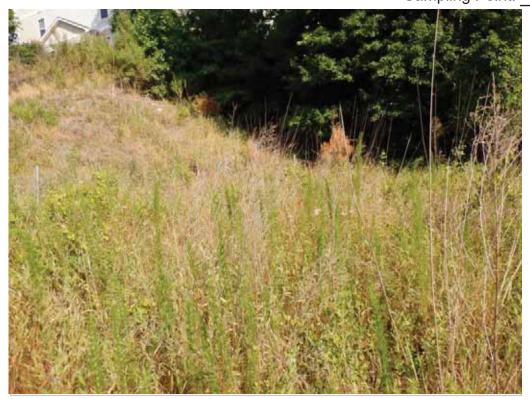
FDS-56A1-2; Representative Vegetation (06/24/2024, K. Winklepleck)

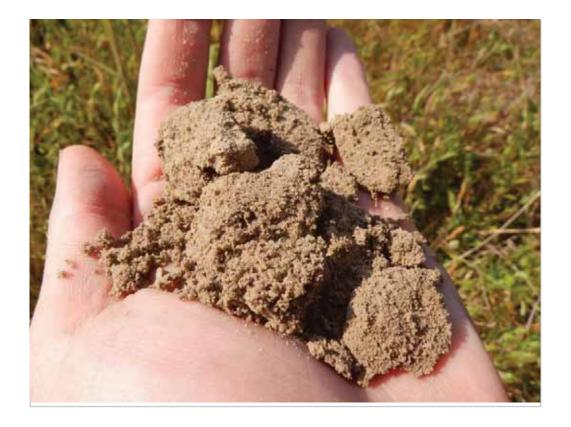
FDS-56A1-2; Representative Soils (06/24/2024, K. Winklepleck)

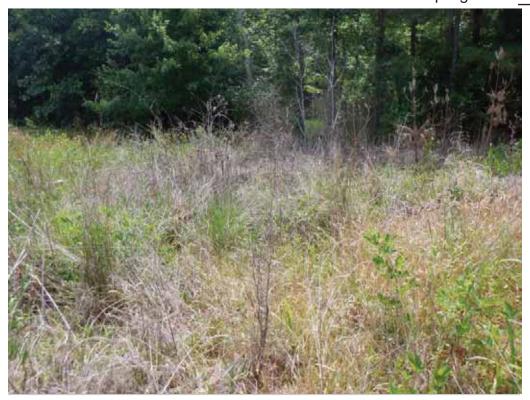
FDS-56M1-1; Representative Vegetation (06/24/2024, K. Winklepleck)

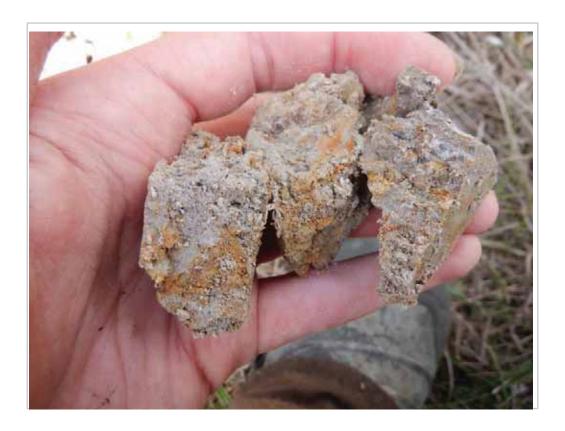
FDS-56M1-1; Representative Soils (06/24/2024, K. Winklepleck)

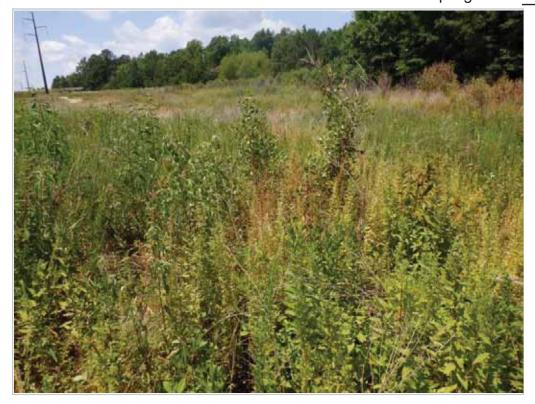
FDS-56M1-2; Representative Vegetation (06/24/2024, K. Winklepleck)

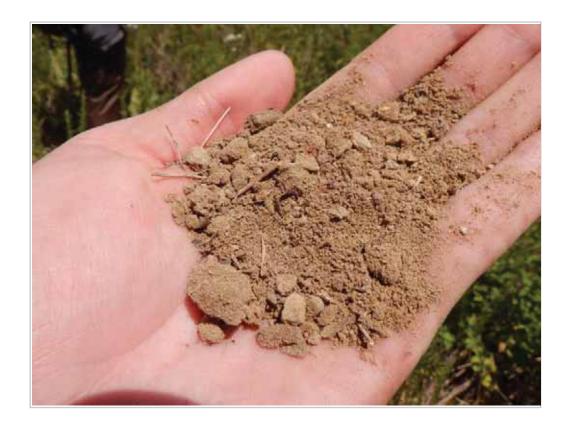
FDS-56M1-2; Representative Soils (06/24/2024, K. Winklepleck)

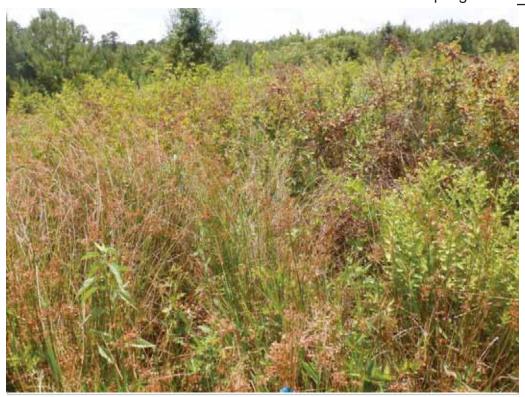
FDS-56U1-1; Representative Vegetation (06/24/2024, K. Winklepleck)

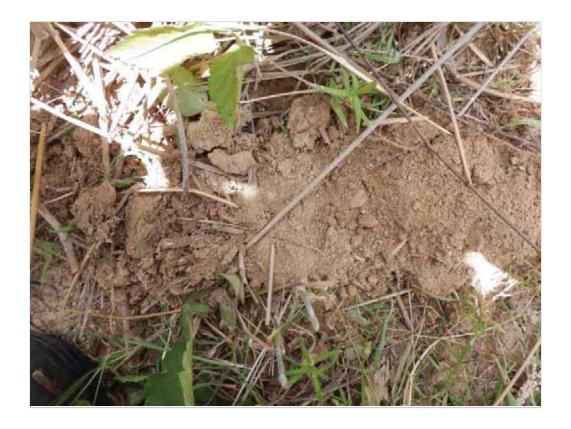
FDS-56U1-1; Representative Soils (06/24/2024, K. Winklepleck)

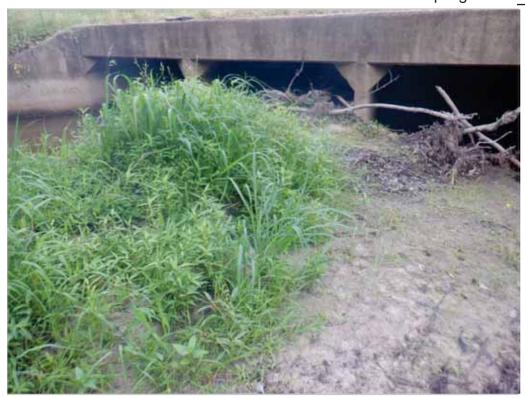
FDS-58C1-1; Representative Vegetation (06/24/2024, A. Leonard)

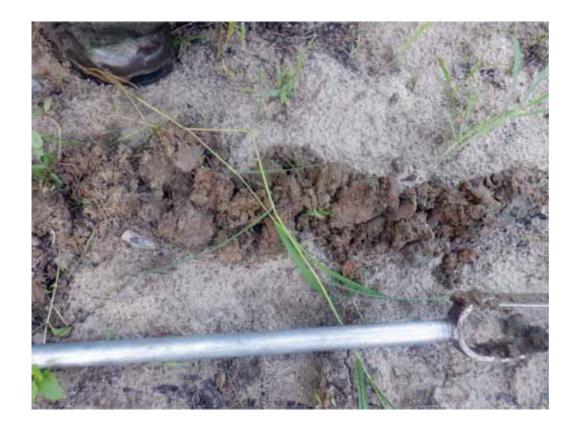
FDS-58C1-1; Representative Soils (06/24/2024, A. Leonard)

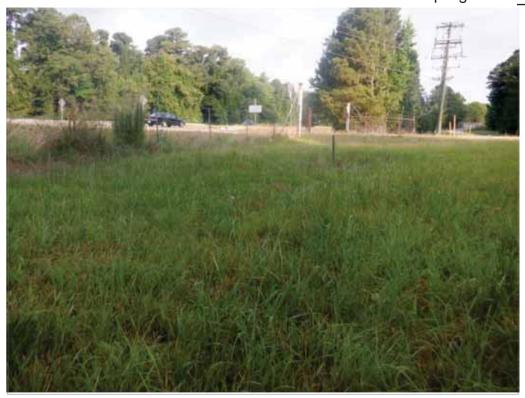
FDS-58C1-2; Representative Vegetation (06/24/2024, A. Leonard)

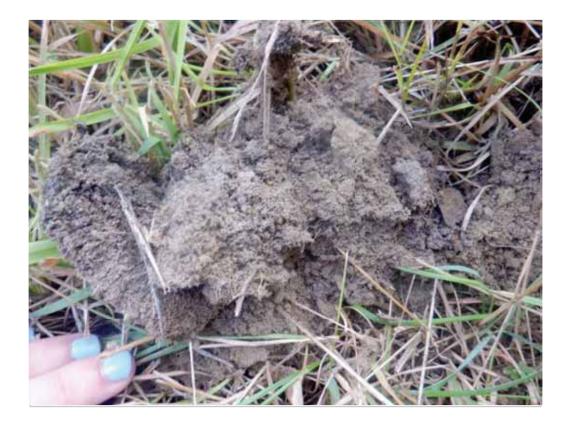
Depth (inches): Hydric Soil Present? Yes	No <u>*</u>
Remarks:	
Auger refusal at 5 inches due to gravel.

FDS-58C1-2; Representative Soils (06/24/2024, A. Leonard)

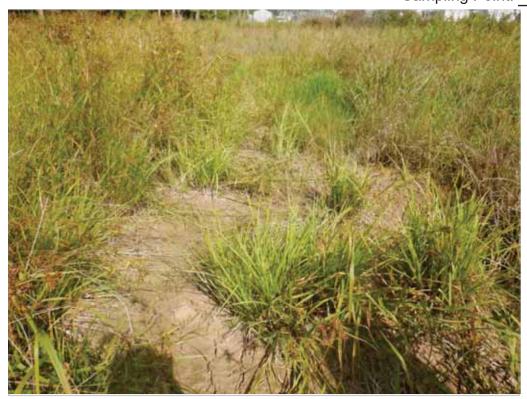
FDS-58D1-1; Representative Vegetation (06/24/2024, A. Leonard)

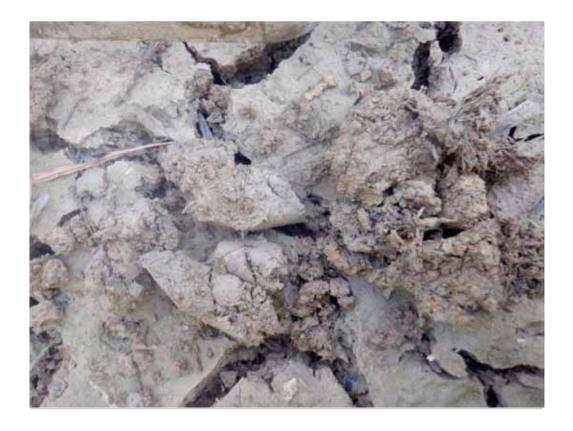
FDS-58D1-1; Representative Soils (06/24/2024, A. Leonard)

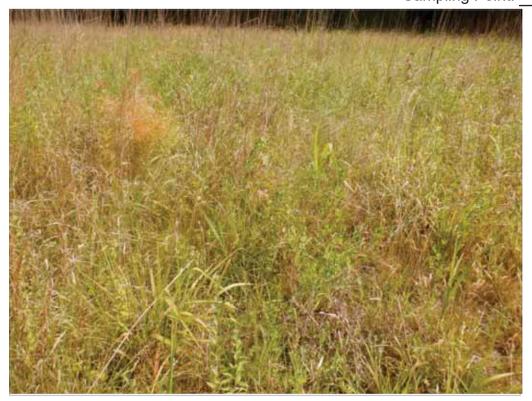
FDS-58D1-2; Representative Vegetation (06/24/2024, A. Leonard)

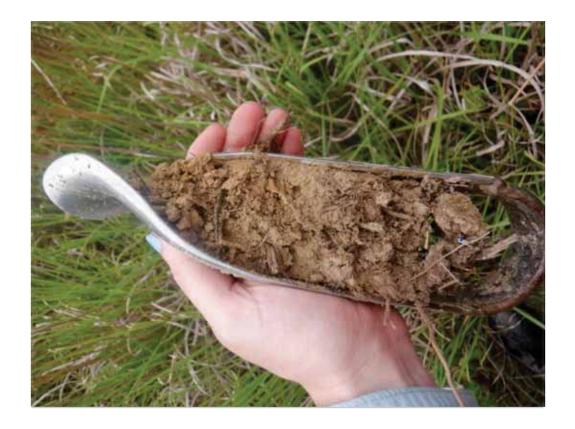
FDS-58D1-2; Representative Soils (06/24/2024, A. Leonard)

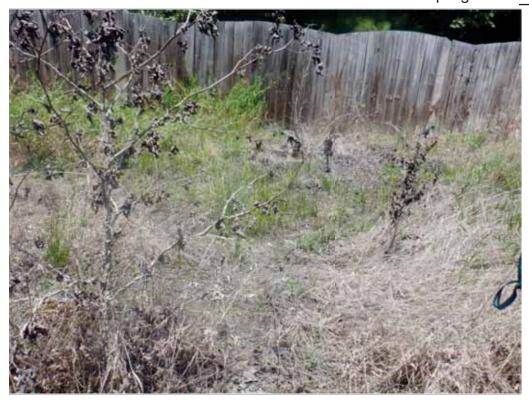
FDS-58N1-1; Representative Vegetation (06/24/2024, A. Leonard)

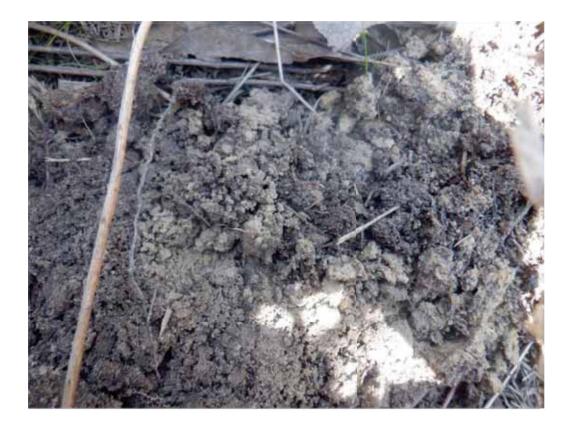
FDS-58N1-1; Representative Soils (06/24/2024, A. Leonard)

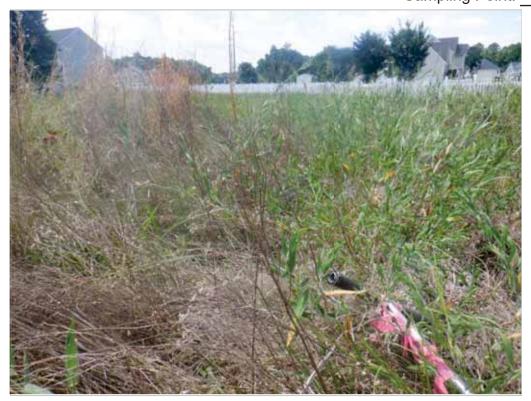
FDS-58N1-2; Representative Vegetation (06/24/2024, A. Leonard)

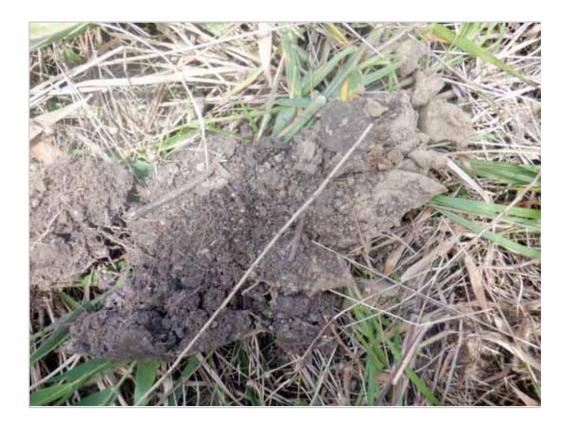
FDS-58N1-2; Representative Soils (06/24/2024, A. Leonard)

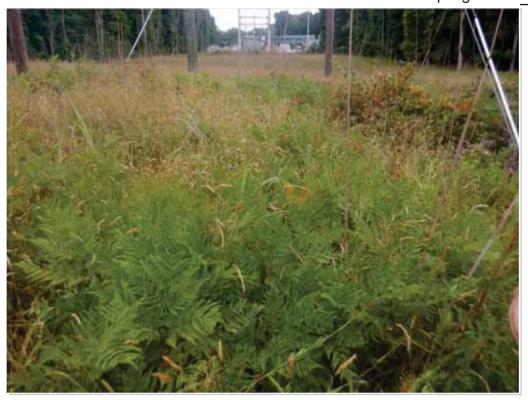
FDS-58U1-1; Representative Vegetation (06/24/2024, A. Leonard)

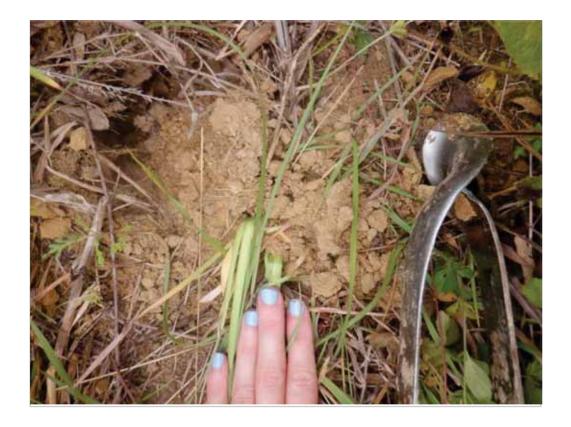
FDS-58U1-1; Representative Soils (06/24/2024, A. Leonard)

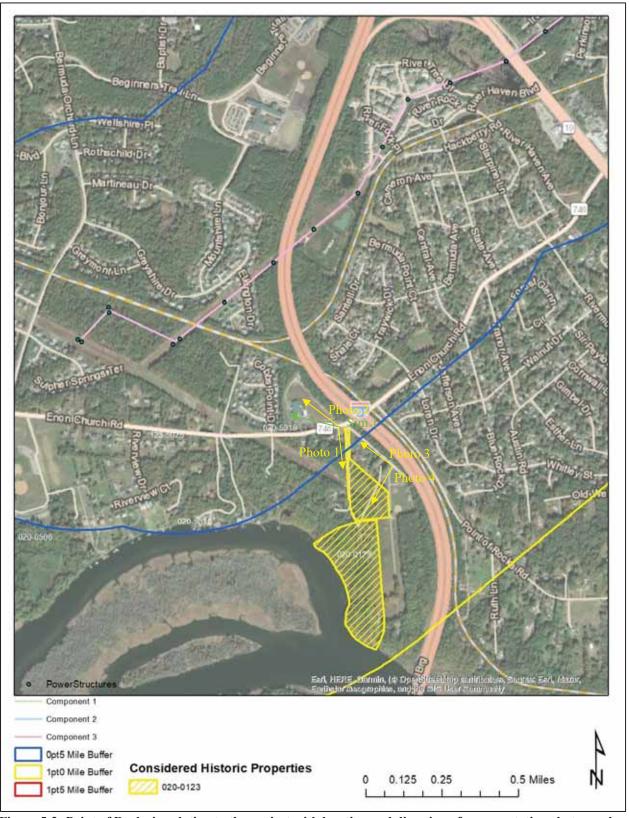
Figure 5-2: Point of Rocks in relation to the project with location and direction of representative photographs shown in yellow and photo simulation shown in green.

Figure 5-2 illustrates the location of the Point of Rocks property in relation to the project and study buffers, with the location and direction of representative photographs and photo simulation. Representative photographs of and from the property are provided in Figure 5-3 through Figure 5-6 and a photo simulation is provided in **Error! Reference source not found.**7 and **Error! Reference source not found.**8.

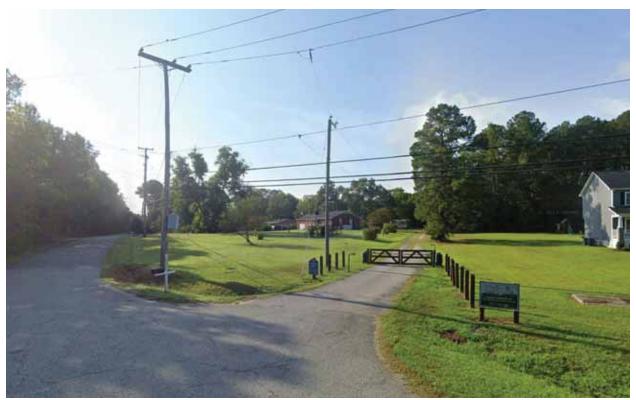
Figure 5-3: View 1- View of Point of Rocks driveway from Enon Church Road, facing south.

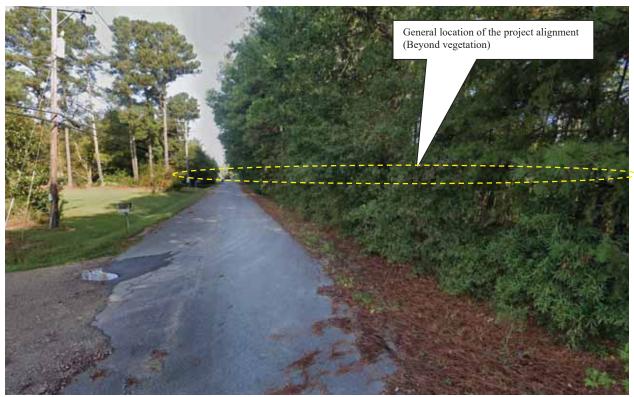
Figure 5-5: View 3- View from Point of Rocks Road towards the project, facing northwest. (No visibility of existing transmission line and no anticipated visibility of the project)

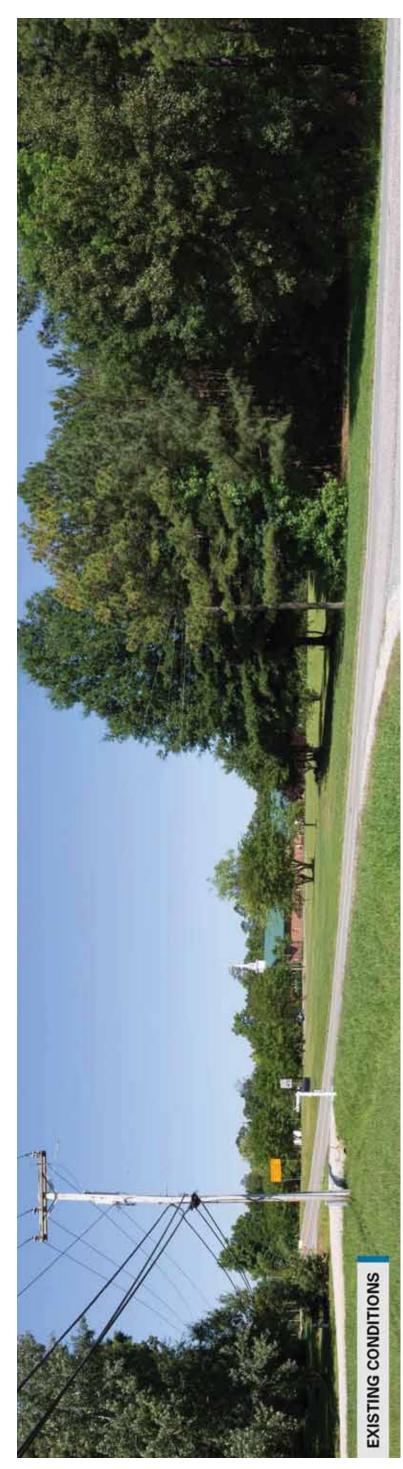
Figure 5-7: Simulation location 1 for Point of Rocks - Existing view from Enon Church Road at Point of Rocks Road (Existing transmission line is not visible). Source: Dominion

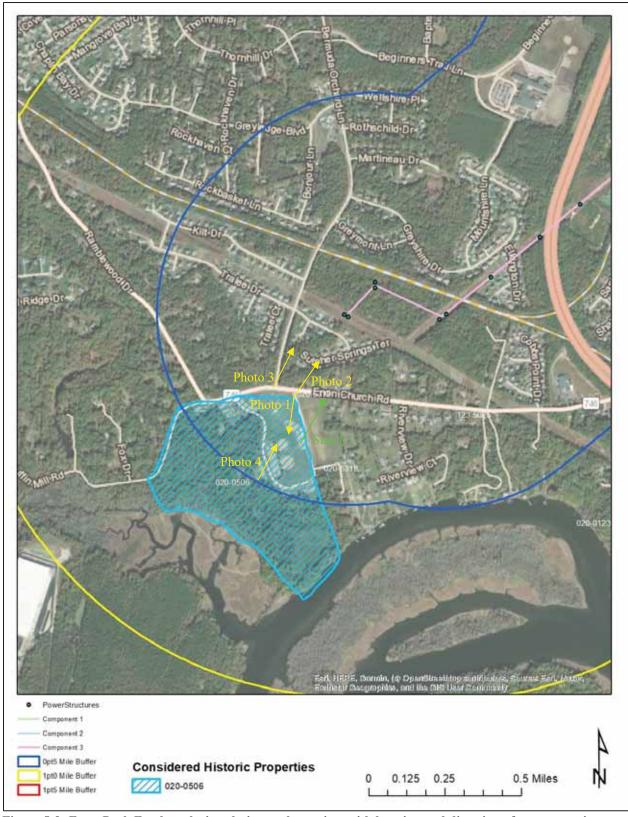
Figure 5-9: Enon Park Earthworks in relation to the project with location and direction of representative photographs shown in yellow and photo simulation shown in green.

**Error! Reference source not found.9** illustrates the location of the Enon Park Earthworks property in relation to the project and study buffers, with the location and direction of representative photographs and photo simulation. Representative photographs of and from the property are provided in Figure 5-10 through Figure 5-13 and a photo simulation is provided in Figure 5-14 and Figure 5-15.

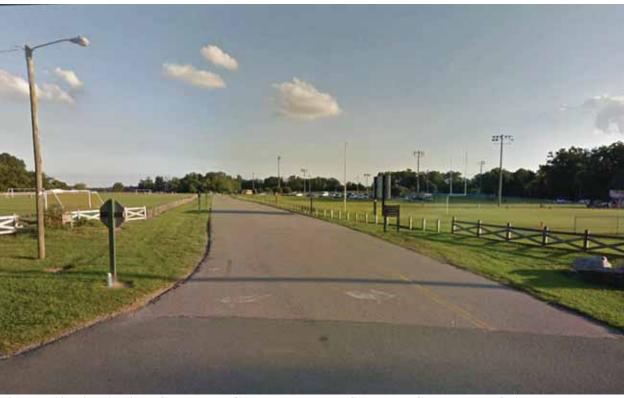
Figure 5-10: View 1- View of entry to R. Garland Dodd Park from Enon Church Road, facing south.

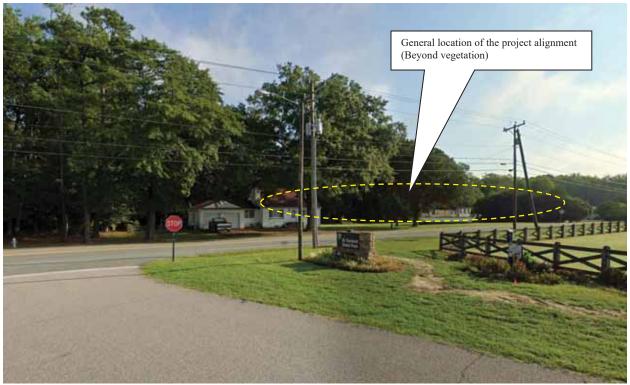
Figure 5-11: View 2- View from park entry along Enon Church Road towards the project, facing northeast. (No visibility of existing transmission line and no anticipated visibility of the project)

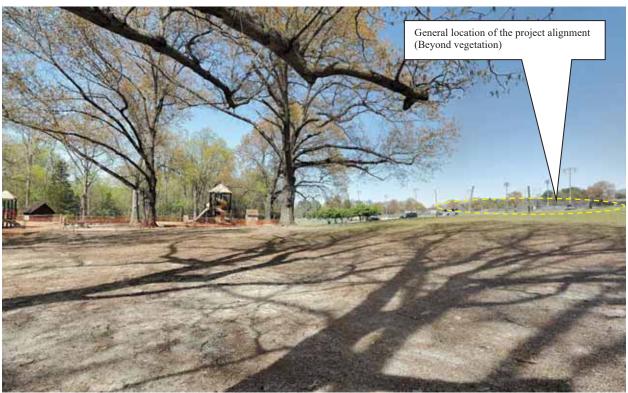
Figure 5-13: View 4- View from playground area towards the project, facing northeast. (No visibility of existing transmission line and no anticipated visibility of the project)

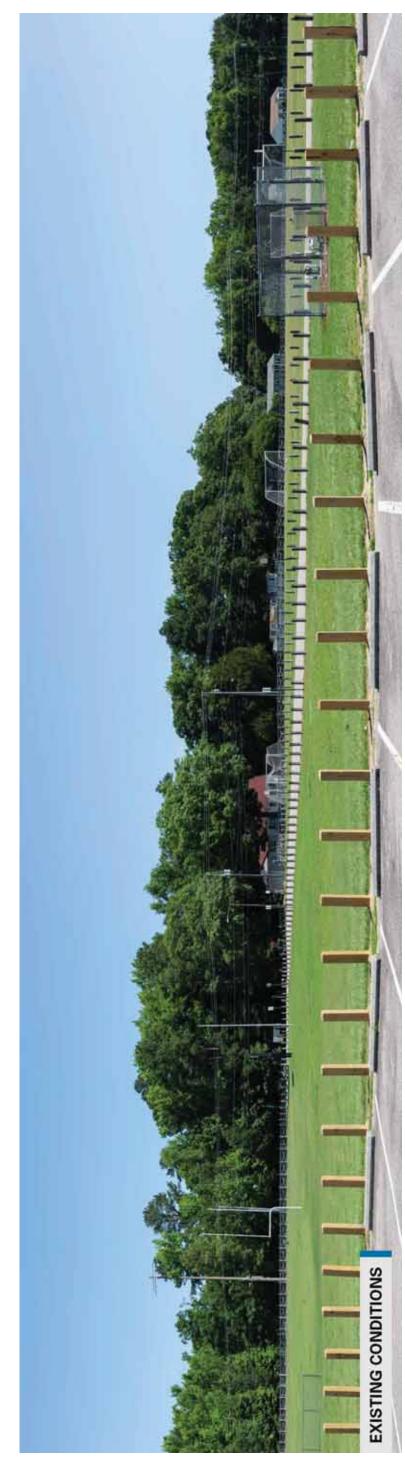
Figure 5-14: Simulation location 1 for Enon Park Earthworks – Existing view from parking lot (Existing transmission line is not visible). Source: Dominion

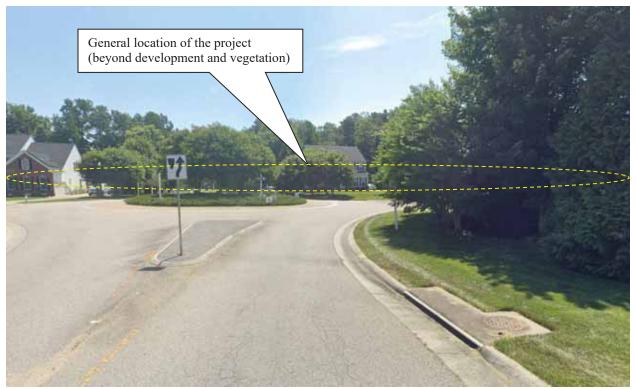
Figure 5-17: Photo location 1- View from Greyledge Boulevard towards the project, facing east. (No visibility of existing transmission line and no anticipated visibility of the project).

Figure 5-16 illustrates the location of the Swift Creek Battlefield in relation to the project and study buffers, with the location and direction of representative photographs and photo simulation. Representative photographs of and from the battlefield are provided in Figure 5-17 through Figure 5-20 and photo simulations are provided in Figure 5-21 through Figure 5-26.

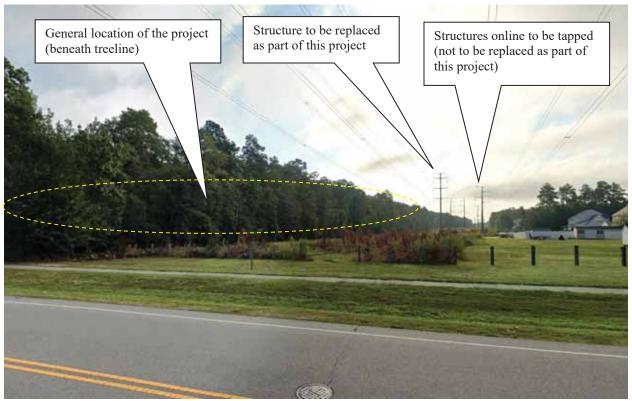
Figure 5-18: Photo location 2- View from Bermuda Orchard Lane towards the project, facing east. (Line #211 to be tapped as part of this project is visible but structures to be replaced are not visible)

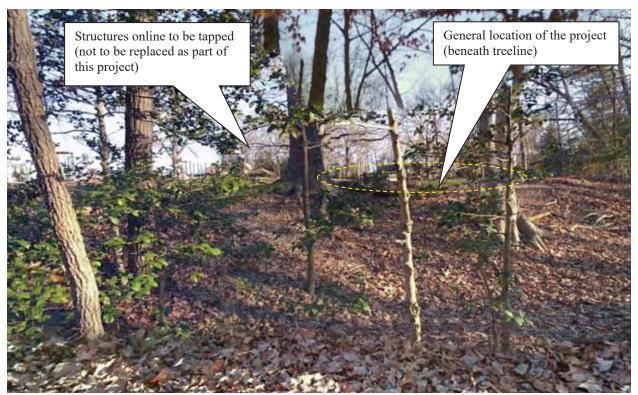
Figure 5-19: Photo location 3- View from Old Bermuda Hundred Road (No project structures visible), facing northwest.

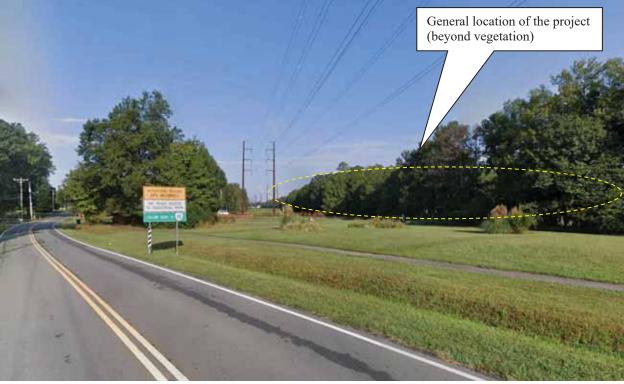
Figure 5-20: Photo location 4- View from Enon Church Road towards the project, facing west. (Line #211 to be tapped as part of this project is visible but structures to be replaced are not visible)

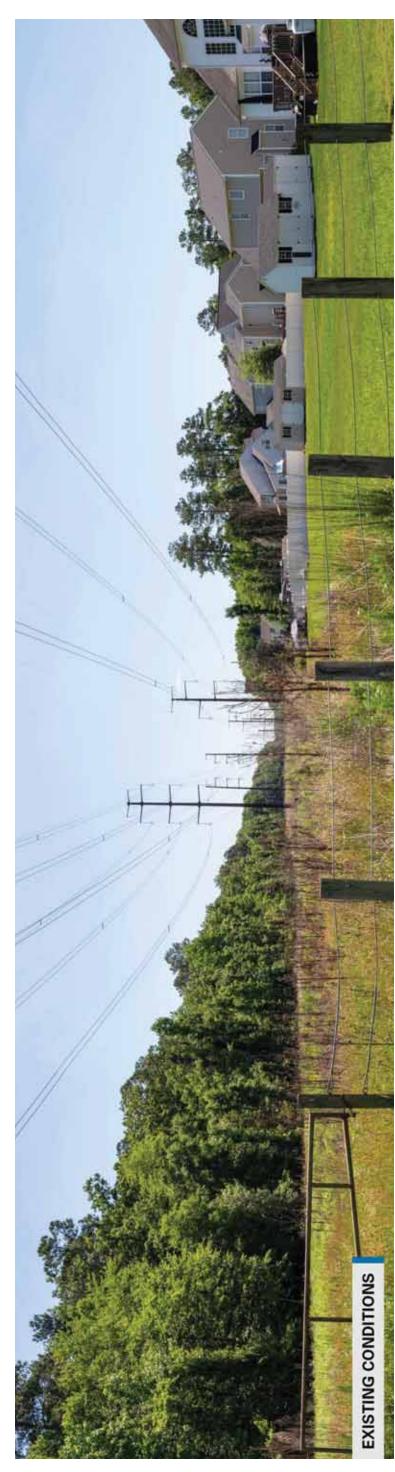
Figure 5-21: Simulation location 1 for Swift Creek Battlefield – Existing view from Bermuda Orchard Lane (One existing transmission structure to be replaced is visible). Source: Dominion

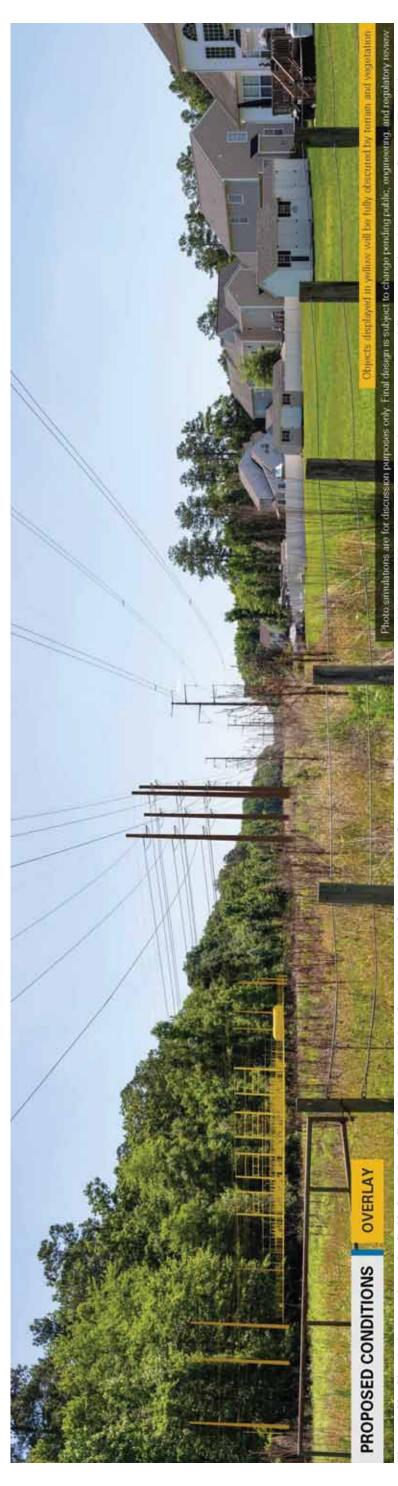
Figure 5-22: Simulation location 1 for Swift Creek Battlefield – Proposed view from Bermuda Orchard Lane (One group of proposed structures is visible; additional structure locations that are not visible are depicted in yellow). Source: Dominion

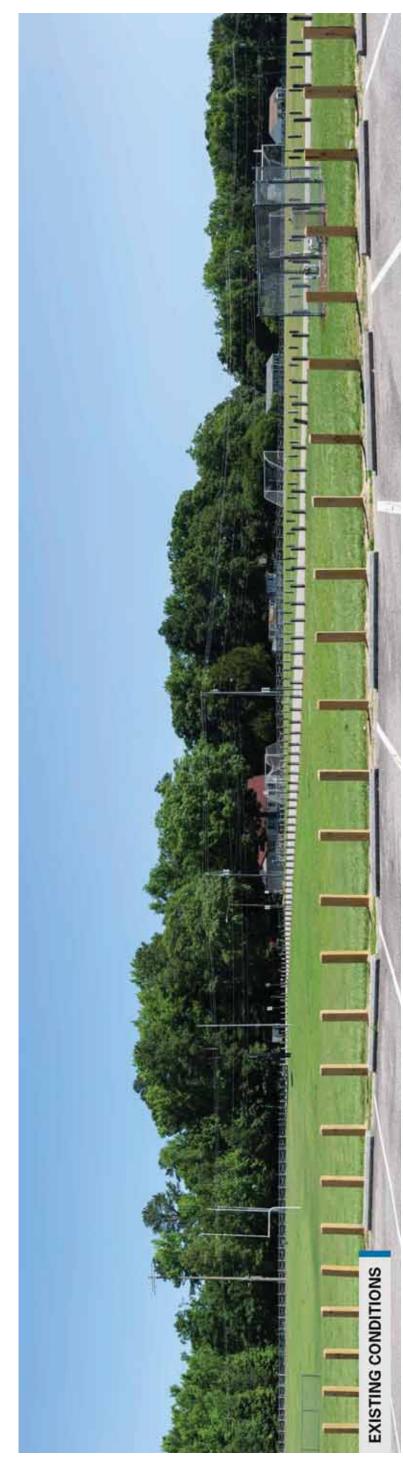
Figure 5-23: Simulation location 2 for Swift Creek Battlefield - Existing view from R Garland Dodd parking lot (Existing transmission line is not visible). Source: Dominion

Photo simulation of the project from multiple vantage points confirmed that visibility of the project would be limited to the tap point on the Line #211 corridor and consist of just one structure location, while all other associated replacement structures would remain screened by the intervening landscape.

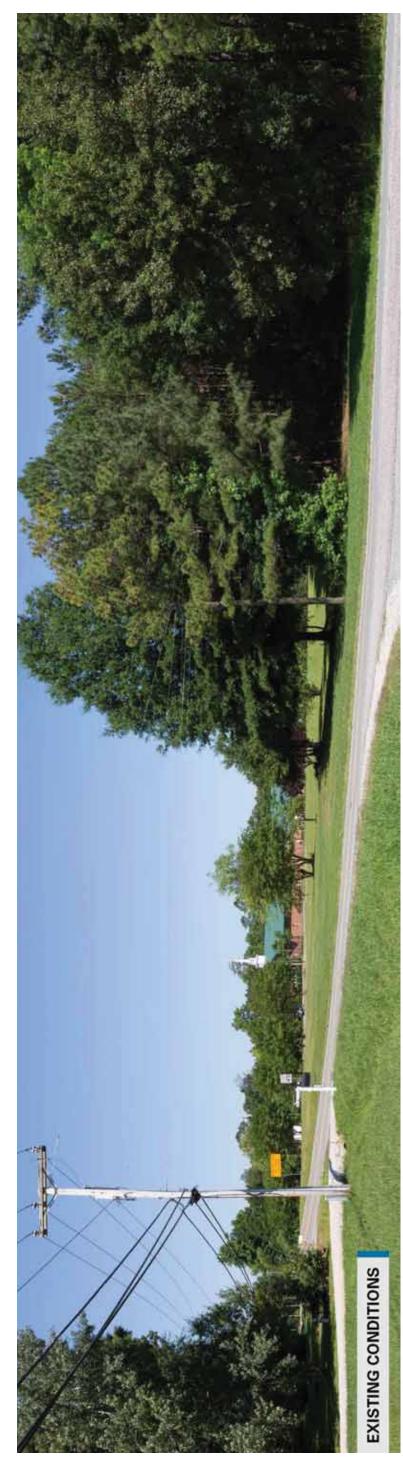
Figure 5-25: Simulation location 3 for Swift Creek Battlefield - Existing view from Enon Church Road near Point of Rocks (Existing transmission line is not visible). Source: Dominion

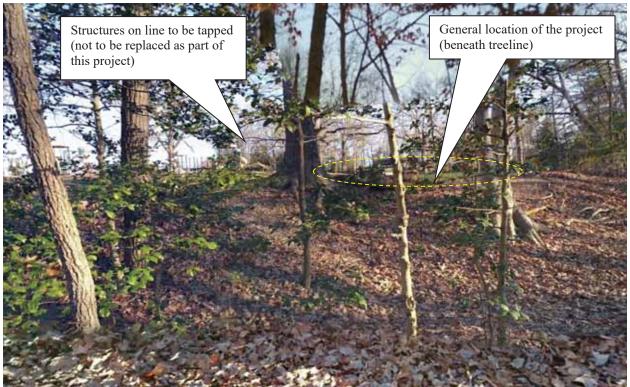
Figure 5-30: Photo location 3- View from Old Bermuda Hundred Road (No project structures visible), facing northwest.

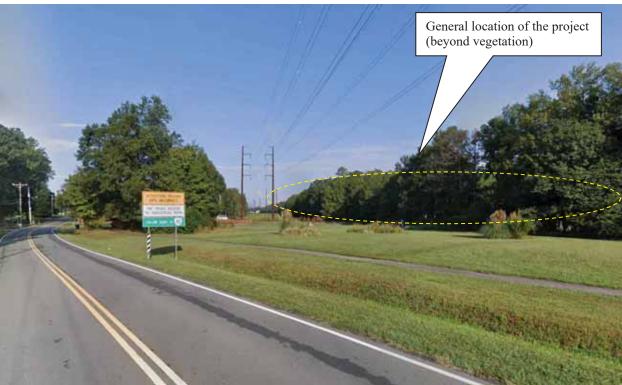
Figure 5-31: Photo location 4- View from Enon Church Road towards the project, facing west. (Line #211 to be tapped as part of this project is visible but structures to be replaced are not visible)

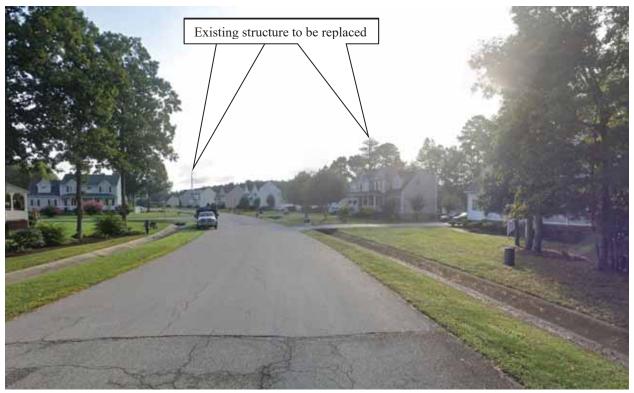
Figure 5-33: Photo location 6- View from Greyshire Drive towards the project, facing northeast. (Several existing transmission structures to be replaced are already visible)

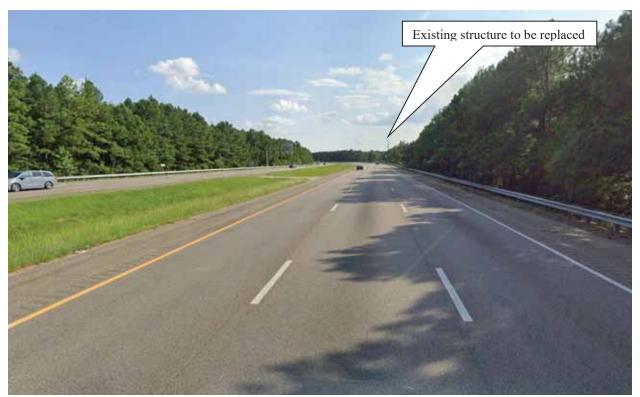
Figure 5-34: Photo location 7- View from I-295 towards the project, facing south. (One existing transmission structures to be replaced is visible and potential for one more to become visible above treeline)

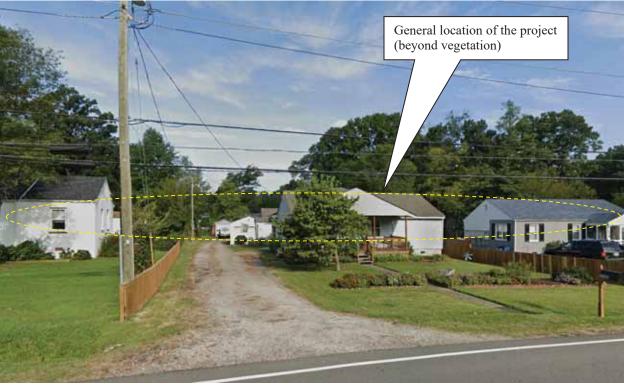
Figure 5-35: Photo location 8- View from Enon Church Road towards the project, facing west. (No visibility of existing transmission line and no anticipated visibility of the project)

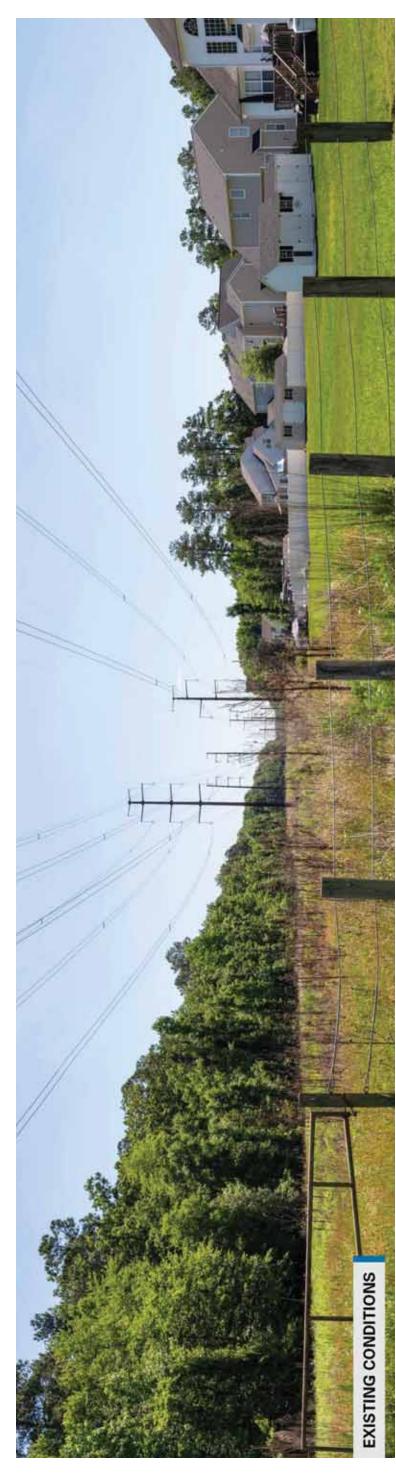
Figure 5-36: Simulation location 1 for Ware Bottom Church Battleffeld – Existing view from Bermuda Orchard Lane (One existing transmission structure to be replaced is visible). Source: Dominion

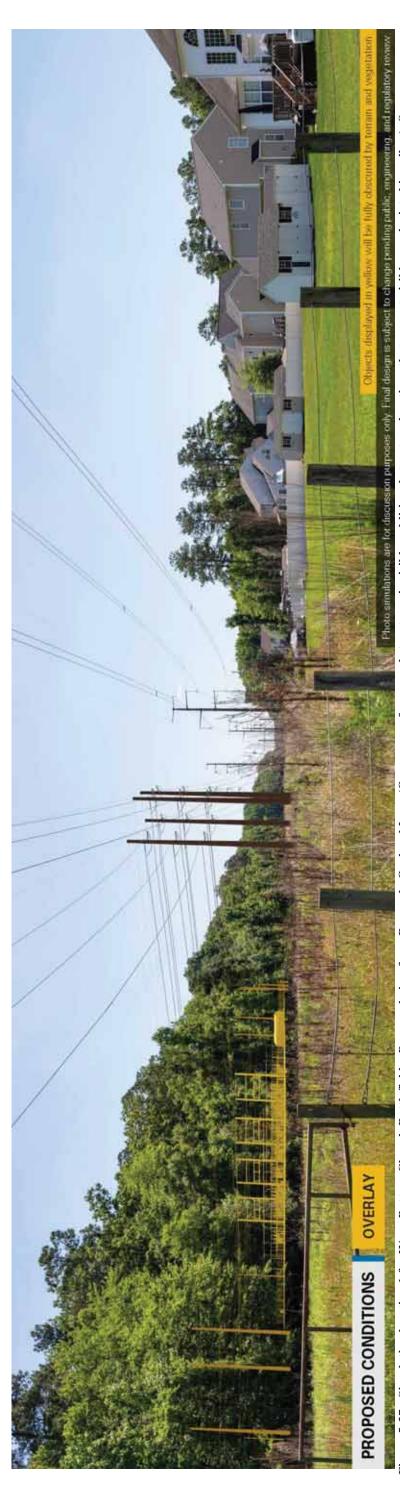
Figure 5-37: Simulation location 1 for Ware Bottom Church Battlefield – Proposed view from Bermuda Orchard Lane (One group of proposed structures is visible; additional structure locations that are not visible are depicted in yellow). Source: Dominion

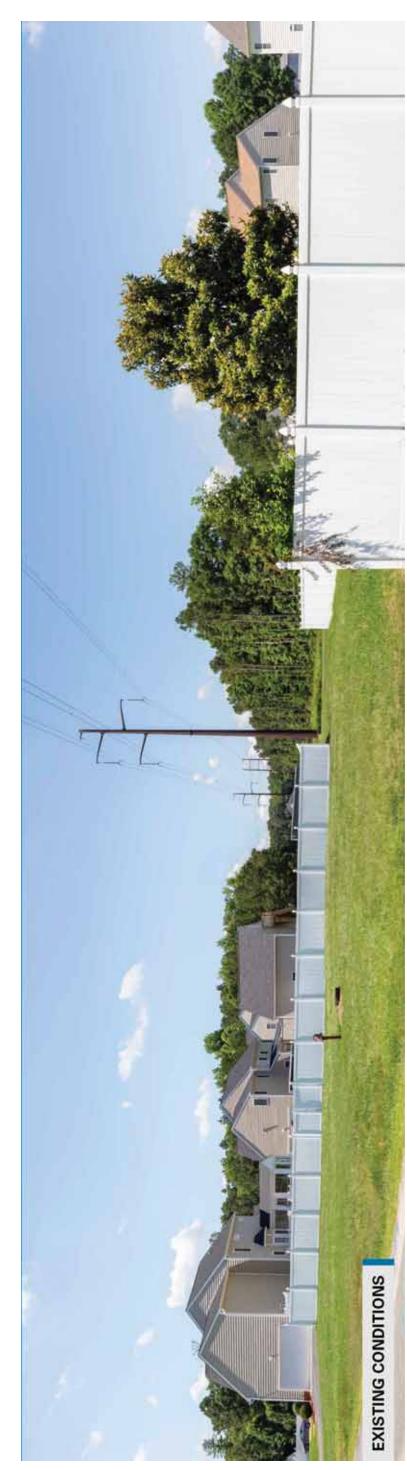
Figure 5-40: Simulation location 3 for Ware Bottom Church Battlefield - Existing view from Elkington Drive (Two existing transmission structures to be replaced are visible). Source: Dominion

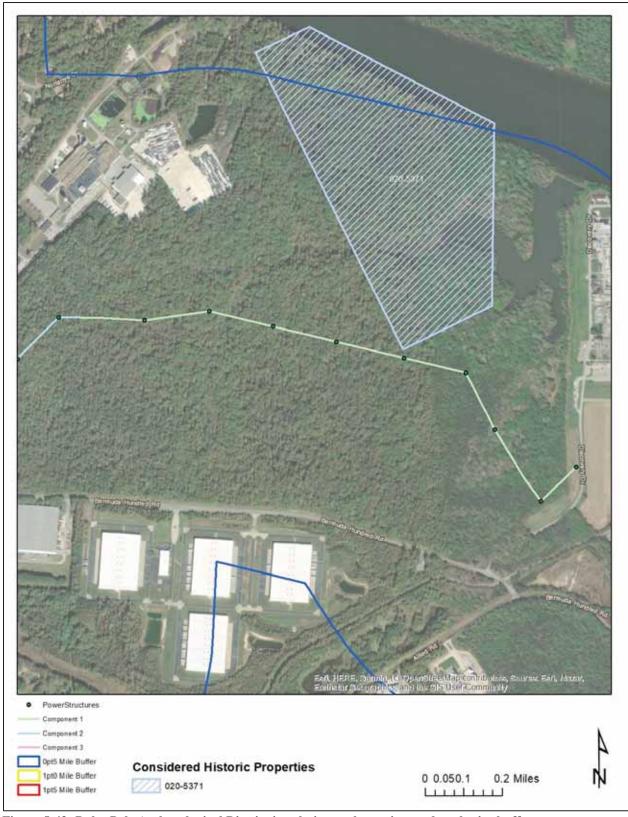
Figure 5-42: Dales Pale Archaeological District in relation to the project and study tier buffers.

Figure 5-42 illustrates the location of the Dales Pale Archaeological District in relation to the project and study buffers and Figure 5-43 illustrates the locations of associated archaeological sites in relation to the project. Because the district is not publicly accessible, no photography or photo simulation was conducted.

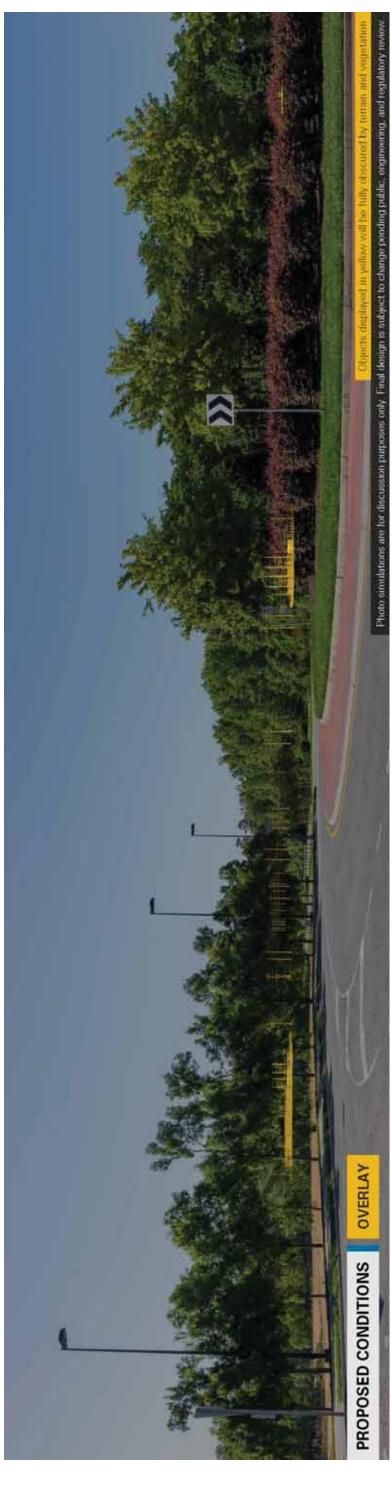
Figure 5-49: Simulation location 2 for New Market Heights Battlefield – Existing view from Meadowville Road (No expected visibility of any structures – structure locations depicted in yellow). Source: Dominion

Figure 5-44 illustrates the location of the New Market Heights/Chaffins Farm Battlefield in relation to the project and study buffers, with the location and direction of representative photographs and photo simulation. Representative photographs of and from the battlefield are provided in Figure 5-45 and photo simulations are provided in Figure 5-46 through Figure 5-49.

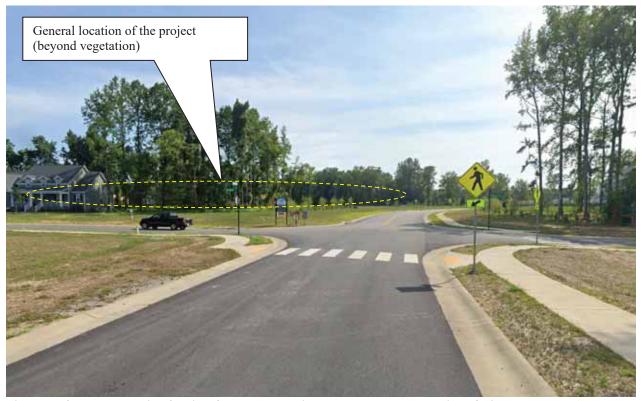
Figure 5-52: Photo location 2- View from Meadowville Road towards the project, facing southwest. (No anticipated visibility of the project).

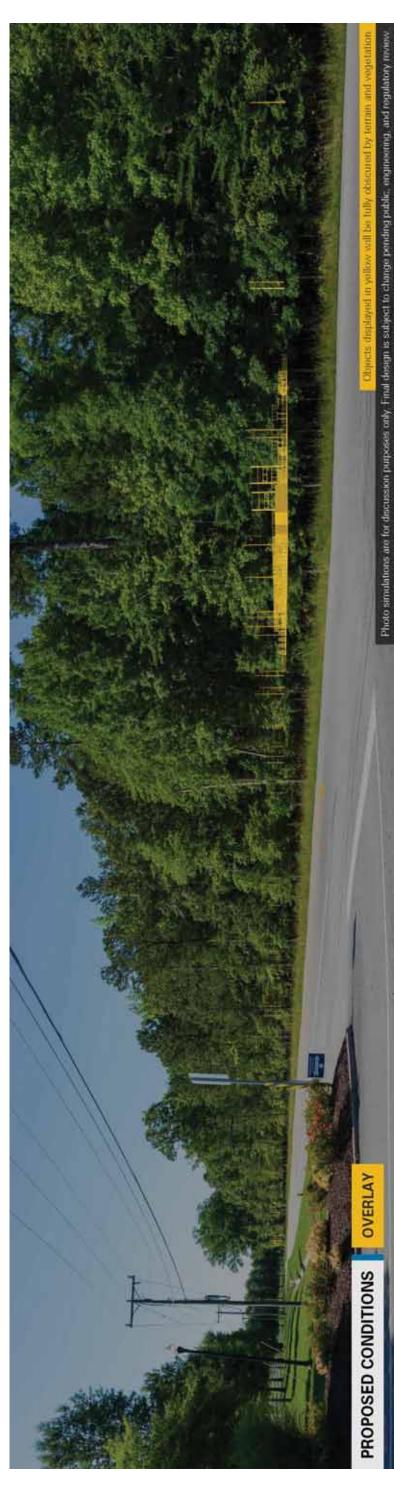
Figure 5-54: Simulation location 1 for First Deep Bottom Battlefield (No expected visibility of any structures - structure locations depicted in yellow). Source: Dominion

Figure 5-50 illustrates the location of the First Deep Bottom Battlefield in relation to the project and study buffers, with the location and direction of representative photographs and photo simulation. Representative photographs of and from the battlefield are provided in Figure 5-5151 and Figure 5-52 and photo simulations are provided in Figure 5-53 through Figure 5-54.

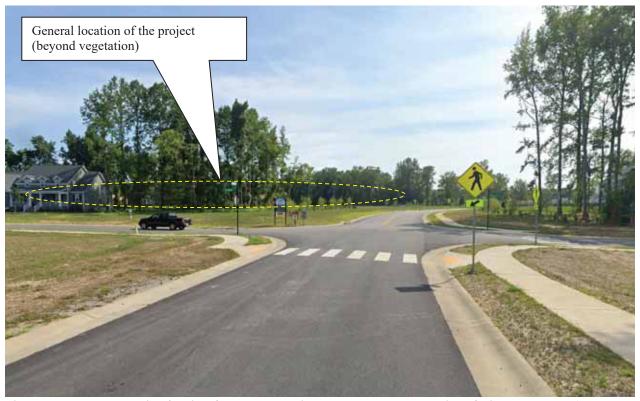
Figure 5-57: Photo location 2- View from Meadowville Road towards the project, facing southwest. (No anticipated visibility of the project).

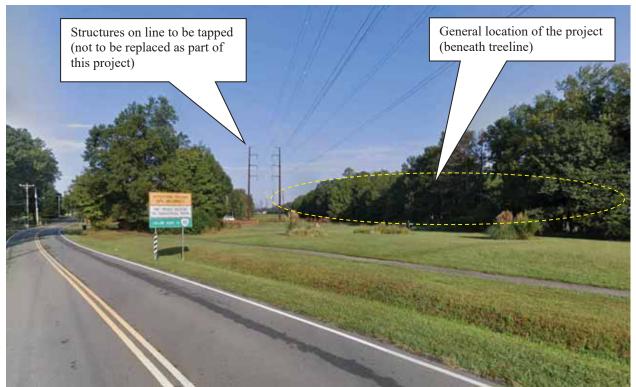
Figure 5-61: Photo location 1- View from Enon Church Road towards the project, facing west. (Line #211 to be tapped as part of this project is visible but structures to be replaced are not visible)

Figure 5-60 illustrates the location of the Second Petersburg Battlefield in relation to the project and study buffers, with the location and direction of representative photographs. Representative photographs of and from the battlefield are provided in Figure 5-61 through Figure 5-67.

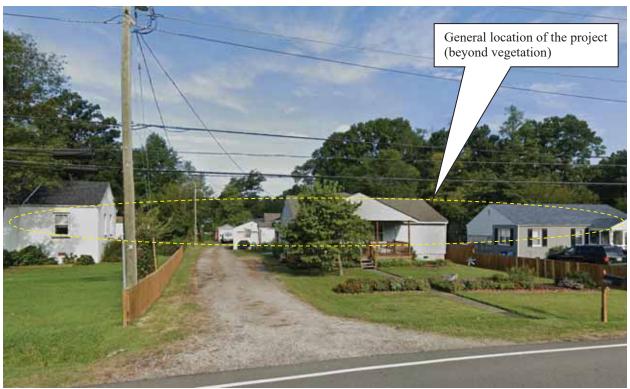
Figure 5-63: Photo location 3- View from Enon Church Road towards the project, facing west. (No visibility of existing transmission line and no anticipated visibility of the project)

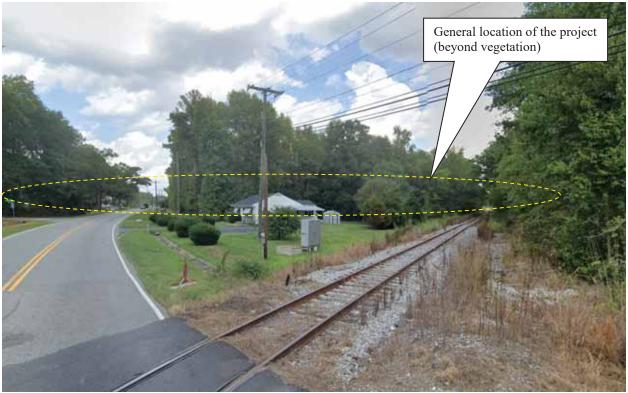
Figure 5-64: Photo location 4- View from Enon Church Road towards the project, facing northeast. (No visibility of existing transmission line and no anticipated visibility of the project)

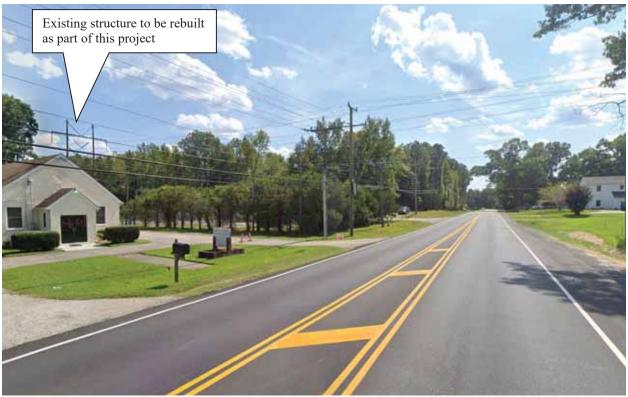
Figure 5-65: Photo location 5- View from Enon Church Road towards the project, facing south. (One existing structure to be rebuilt is visible)

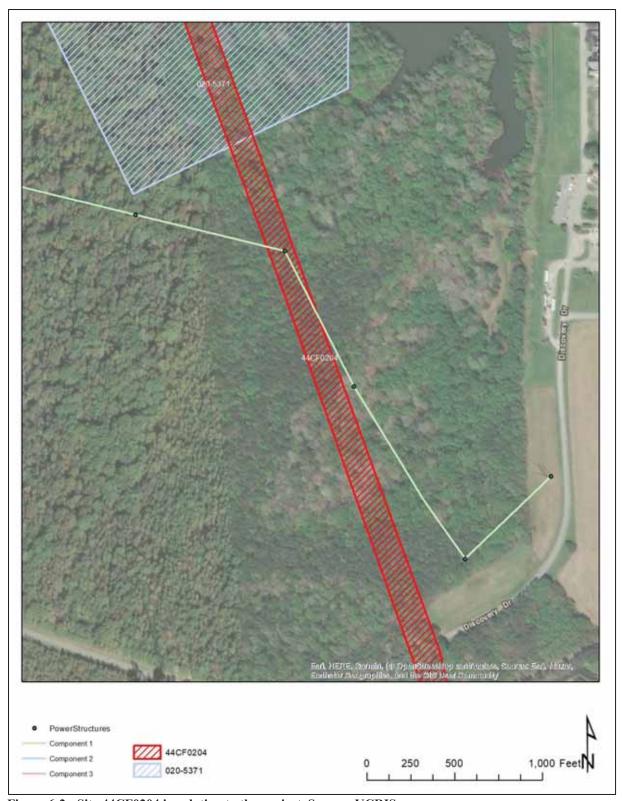
Based upon the boundaries of the site as mapped in VCRIS, which were not reinvestigated or confirmed as part of this effort, a portion of site 44CF0204 is crossed by the proposed alignment of Component 1 of the project, which entails construction of new transmission line with one proposed structure location directly within the site boundary (Figure 6-2). Based upon recent aerial photography, this portion of the site remains in an undeveloped wooded area. Because the site has not been formally evaluated and the portion crossed by the project has not been subject to formal survey and could be impacted by clearing and construction associated with the project, it is D+A's opinion that the limits of the site within the project ROW be subject to further investigation as project details become finalized.

Figure 6-2: Site 44CF0204 in relation to the project. Source: VCRIS.
