T/L No. 224 Strs. No. 53-58, 182-184, 228-232
T/L 224

LANEXA-NORTHERN NECK

INSPECTION FINDINGS

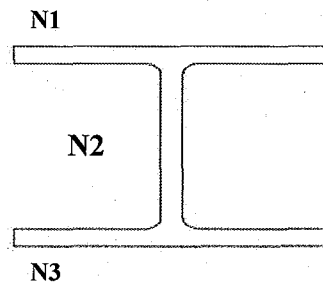
CONCRETE FOUNDATION INSPECTION
CHECKLIST
STR. # 224/182 LEG # 1

RUNNING RUST.

1/16" TO 1/8" MAP CRACKING WITH EFFLORESCENCE

EAST SIDE 1/4" CRACK AT BASE TO 1/8" CRACK AT TOP OF CAP

1/4" CRACK ON BOTTOM OF CAP FROM NORTH WEST TO SOUTH EAST SIDES OF
CAP. STOPS AT PILE B.

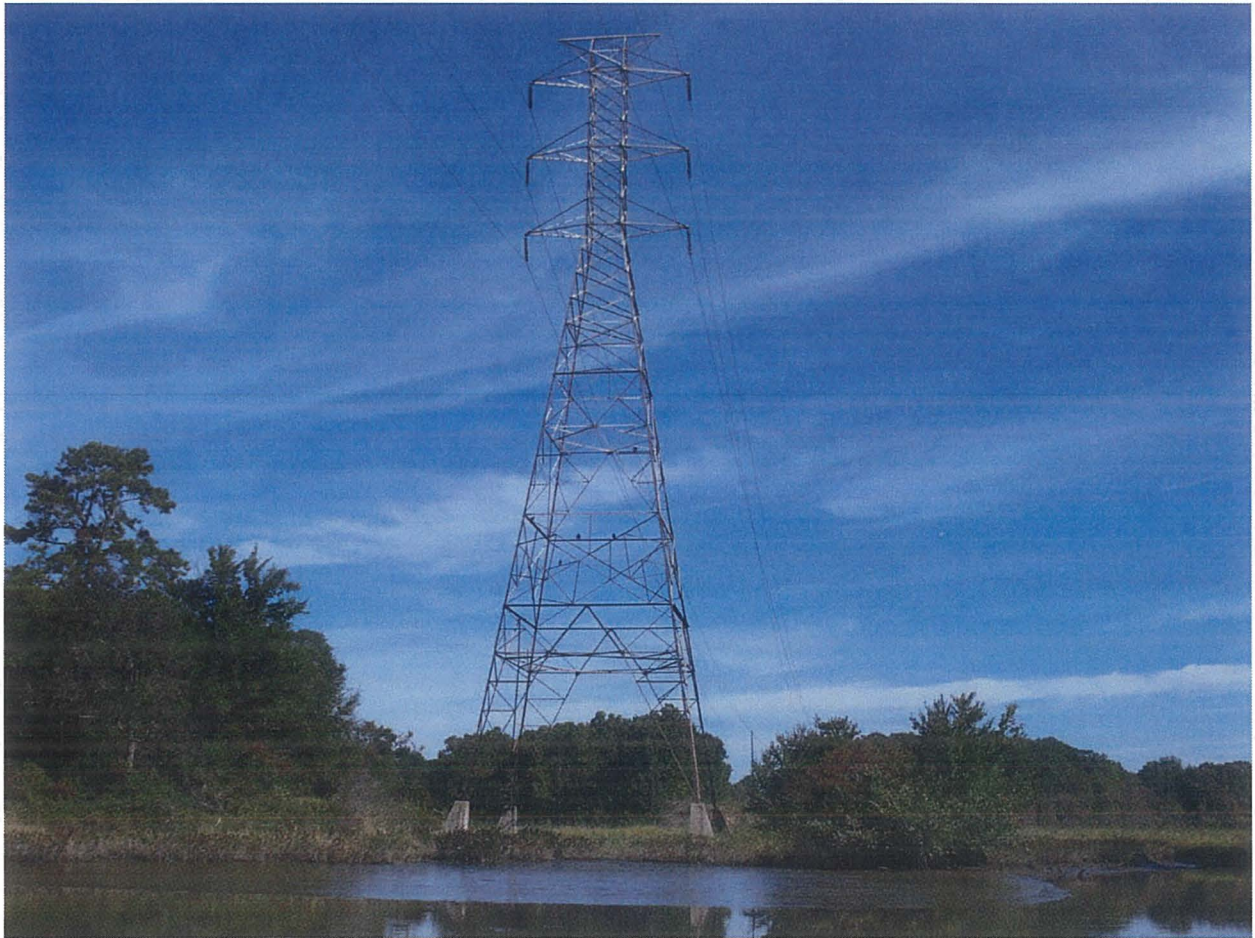
STRUCTURE INVESTIGATION PHOTOGRAPHIC LOG
T/L No. 224 Structure No. 182

These structures exhibit minor loss of steel section but heavy cracking and efflorescence at the concrete caps.

Further investigation is recommended for structures 182-184 that exhibit extensive cracking to the concrete foundation caps.

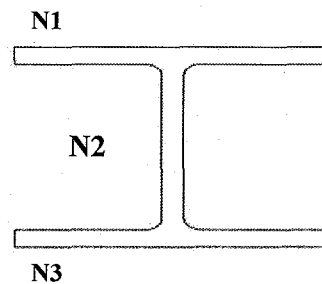
CONCRETE FOUNDATION INSPECTION
CHECKLIST
STR. # 224/183 LEG # 1

RUNNING RUST.

1/16" TO 1/8" MAP CRACKING WITH EFFLORESCENCE
