Re: Application of Virginia Electric and Power Company for Approval and Certification of Electric Transmission Facilities: Fredericksburg-Aquia Harbour Lines #29, #2104, and #2157 Partial Rebuild – Case No. PUR-2024-00035.

Application, Appendix,
DEQ Supplement, Direct
Testimony and Exhibits of
Virginia Electric and Power
Company

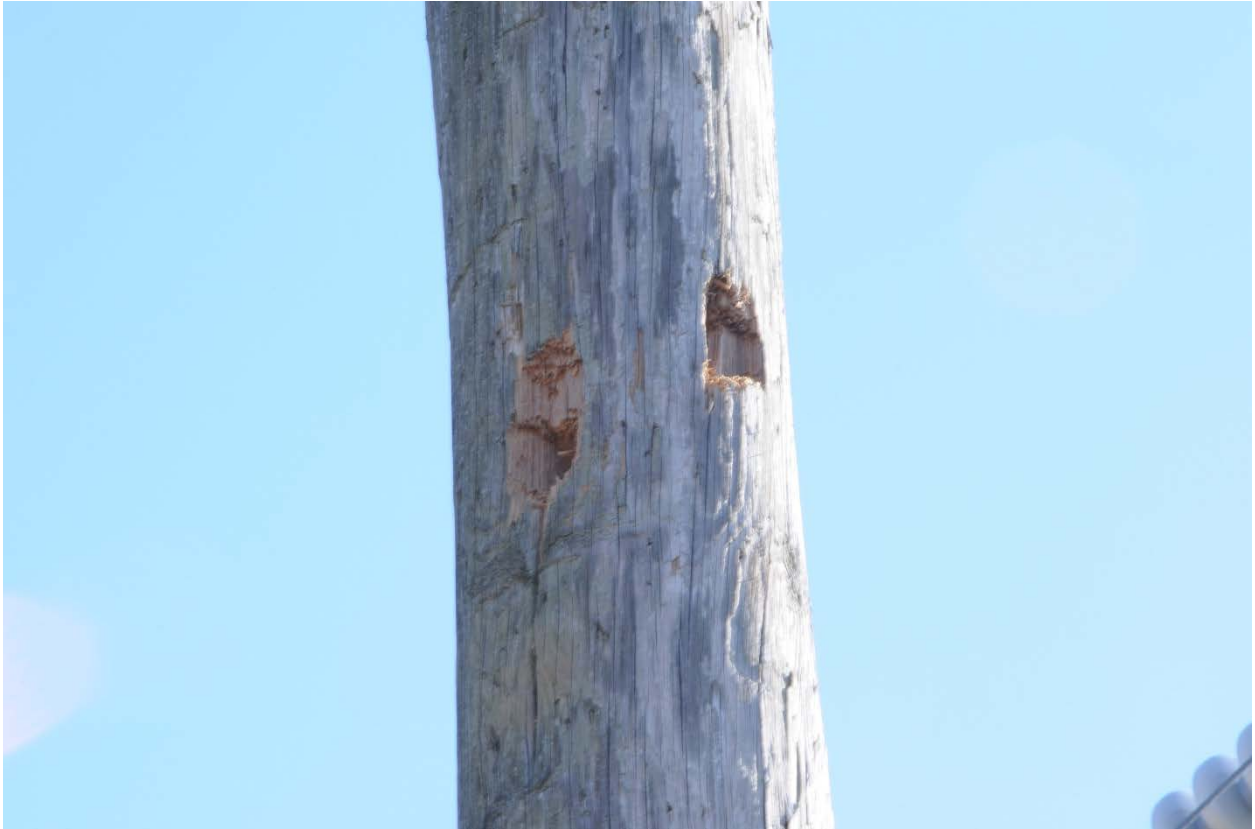
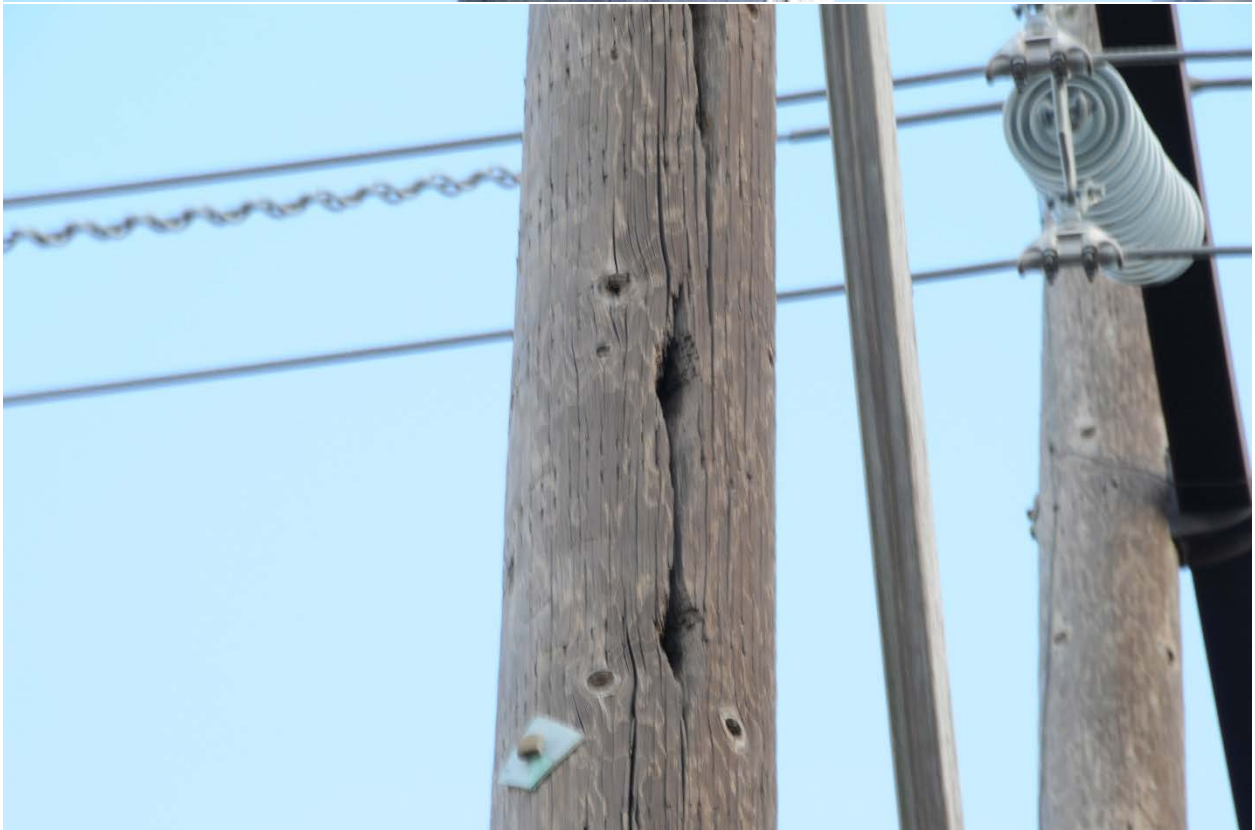
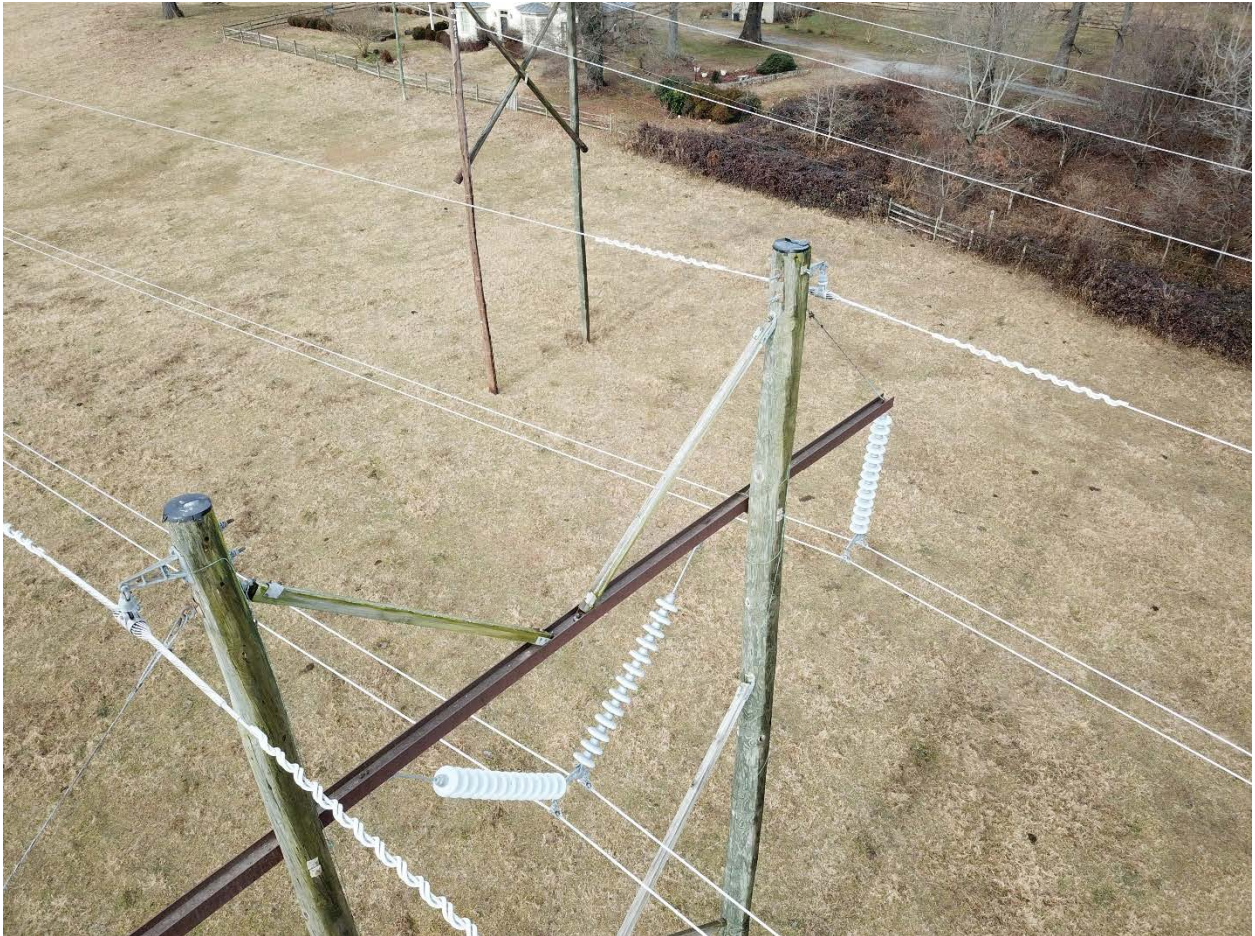
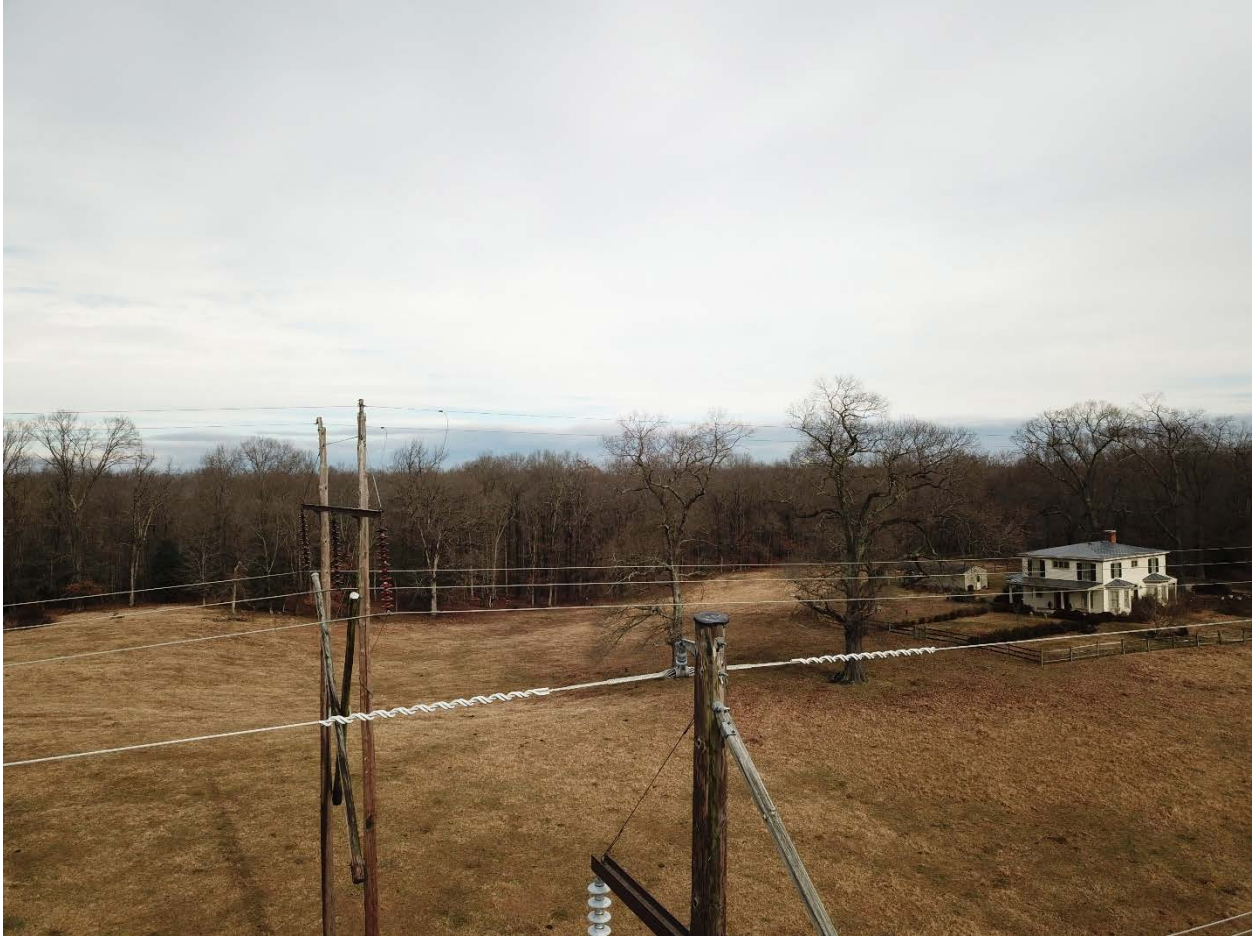
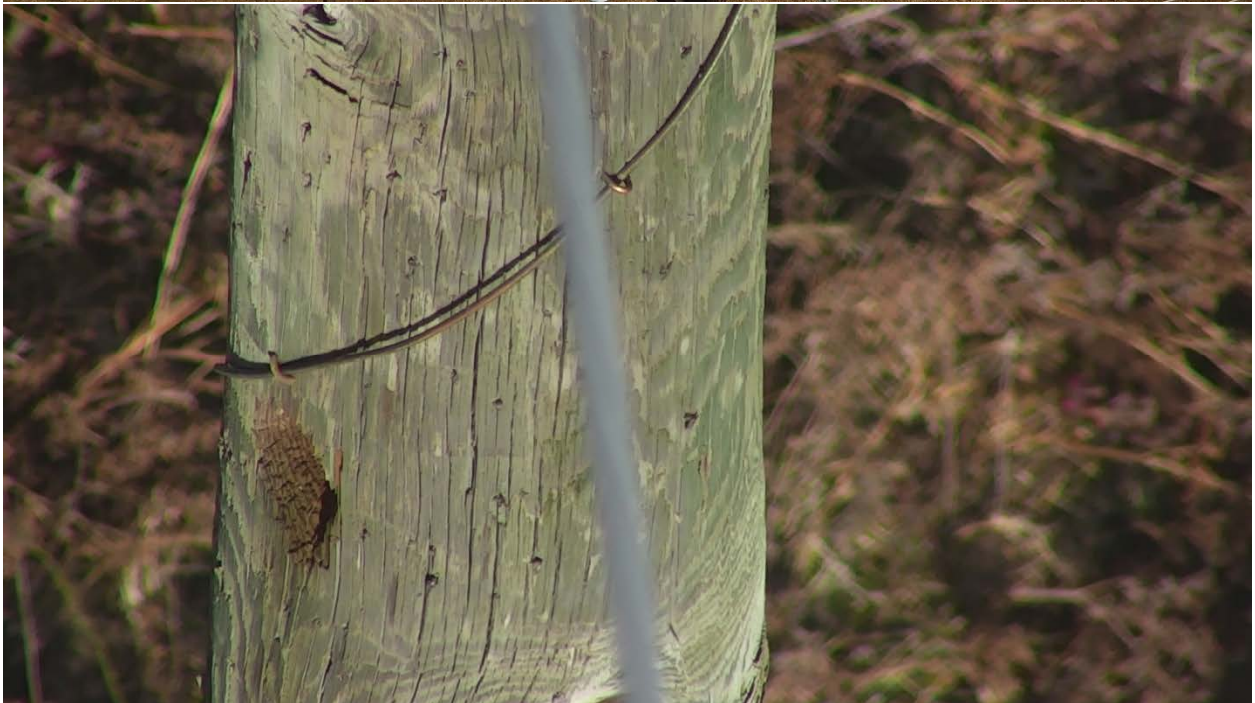
Line 2157

Response: See Attachment I.L.1 for photographs of the deterioration of structures on Lines #29 and #2157. Section I.A provides further detail on the condition of these deteriorating structures. See Attachment I.L.2 for sample inspection records of Lines #29 and #2157.

Response: Between Fredericksburg Substation and Aquia Harbour Station, a total of 108 structures consisting of 87 wood H-frame structures, 10 steel H-frame structures, nine three-pole wood structures, and two three-pole steel structures will be removed from Line #29. The Company will replace these structures with 116 230 kV tubular structures consisting of 79 double circuit V-String suspension structures, 27 double circuit double deadend (DDE) structures, six double circuit two-pole DDE structures, one single circuit DDE structure, one single circuit DDE three-pole structure, and two double circuit DDE backbones, the majority¹⁶ being constructed of weathering steel, to maximize the number of lines that can fit in the right-of-way to serve the significant load growth anticipated in the area. Although Line #29 will be designed to current 230 kV standards, it will continue to operate at 115 kV until a conversion date in the near future. An additional structure is necessary for reasons discussed in Section I.A.

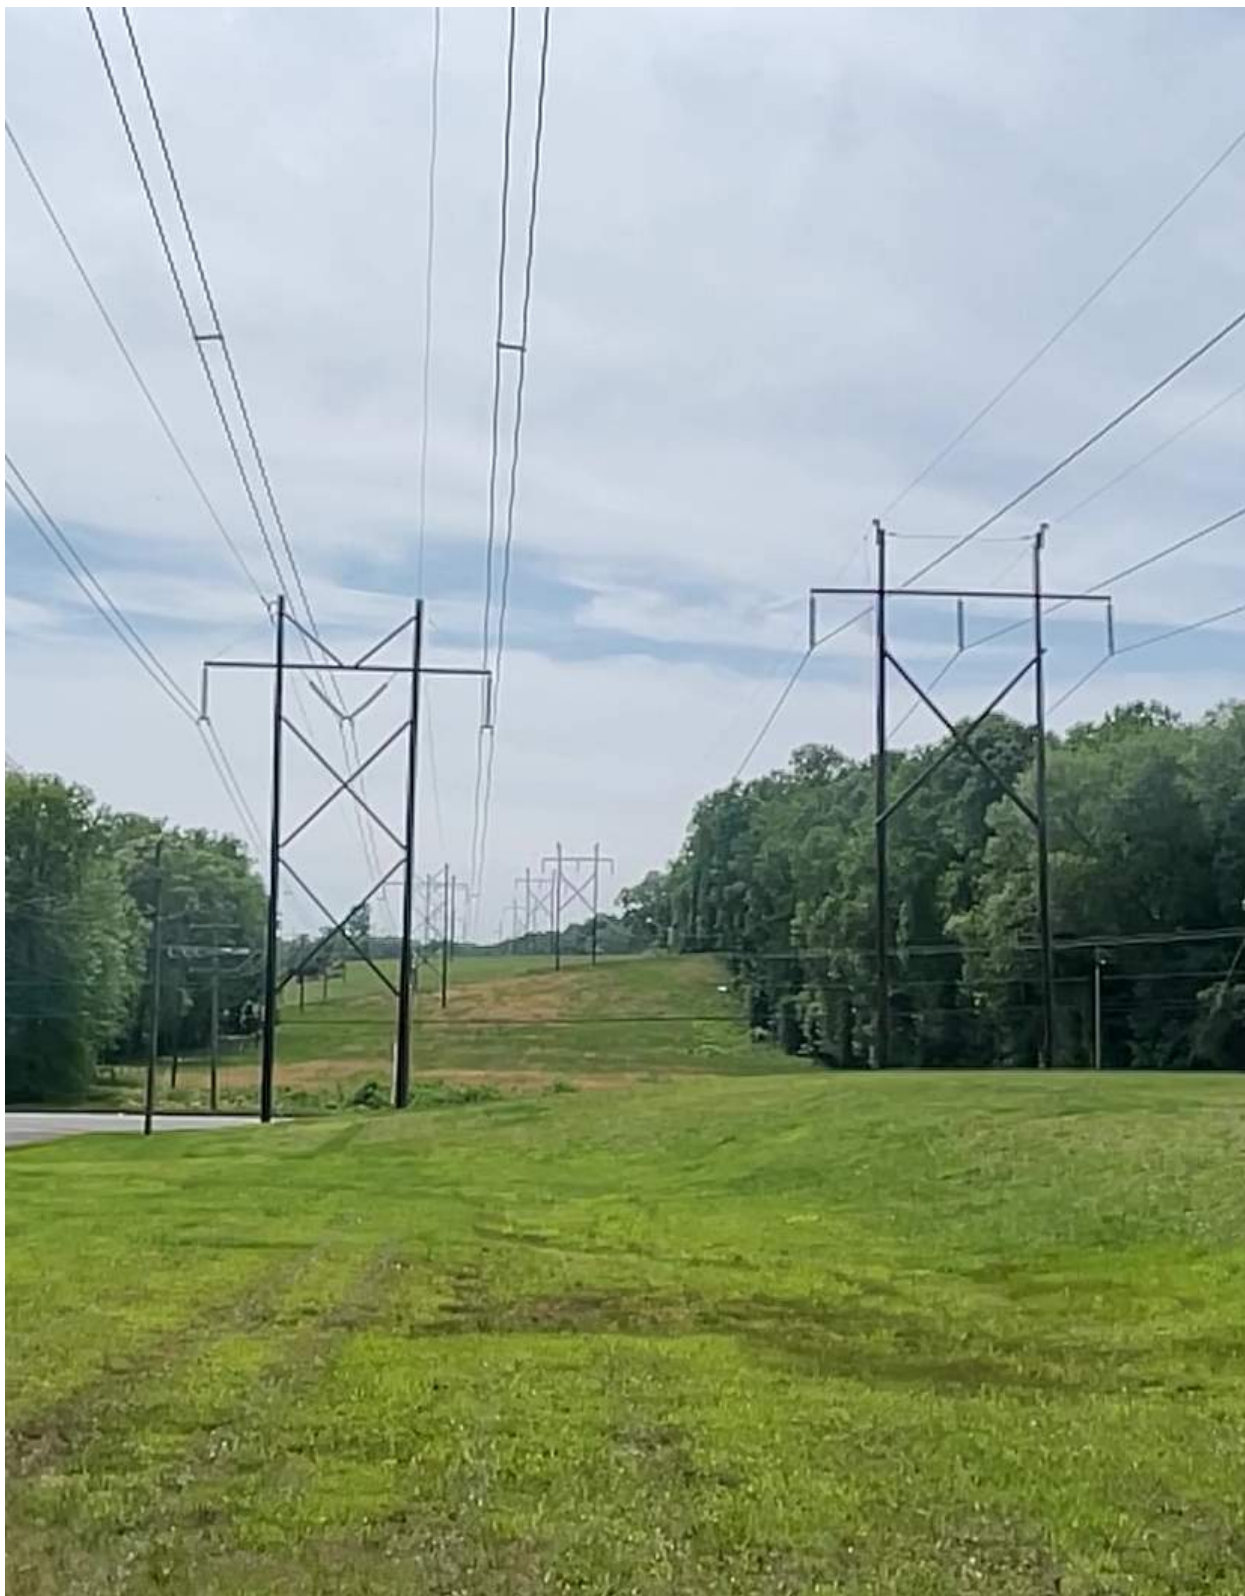
Attachment II.B.6.a.i

Existing Structure Type:
230kV (Left) And 115kV (Right) Single Circuit
Wood H-Frame (Tangent)

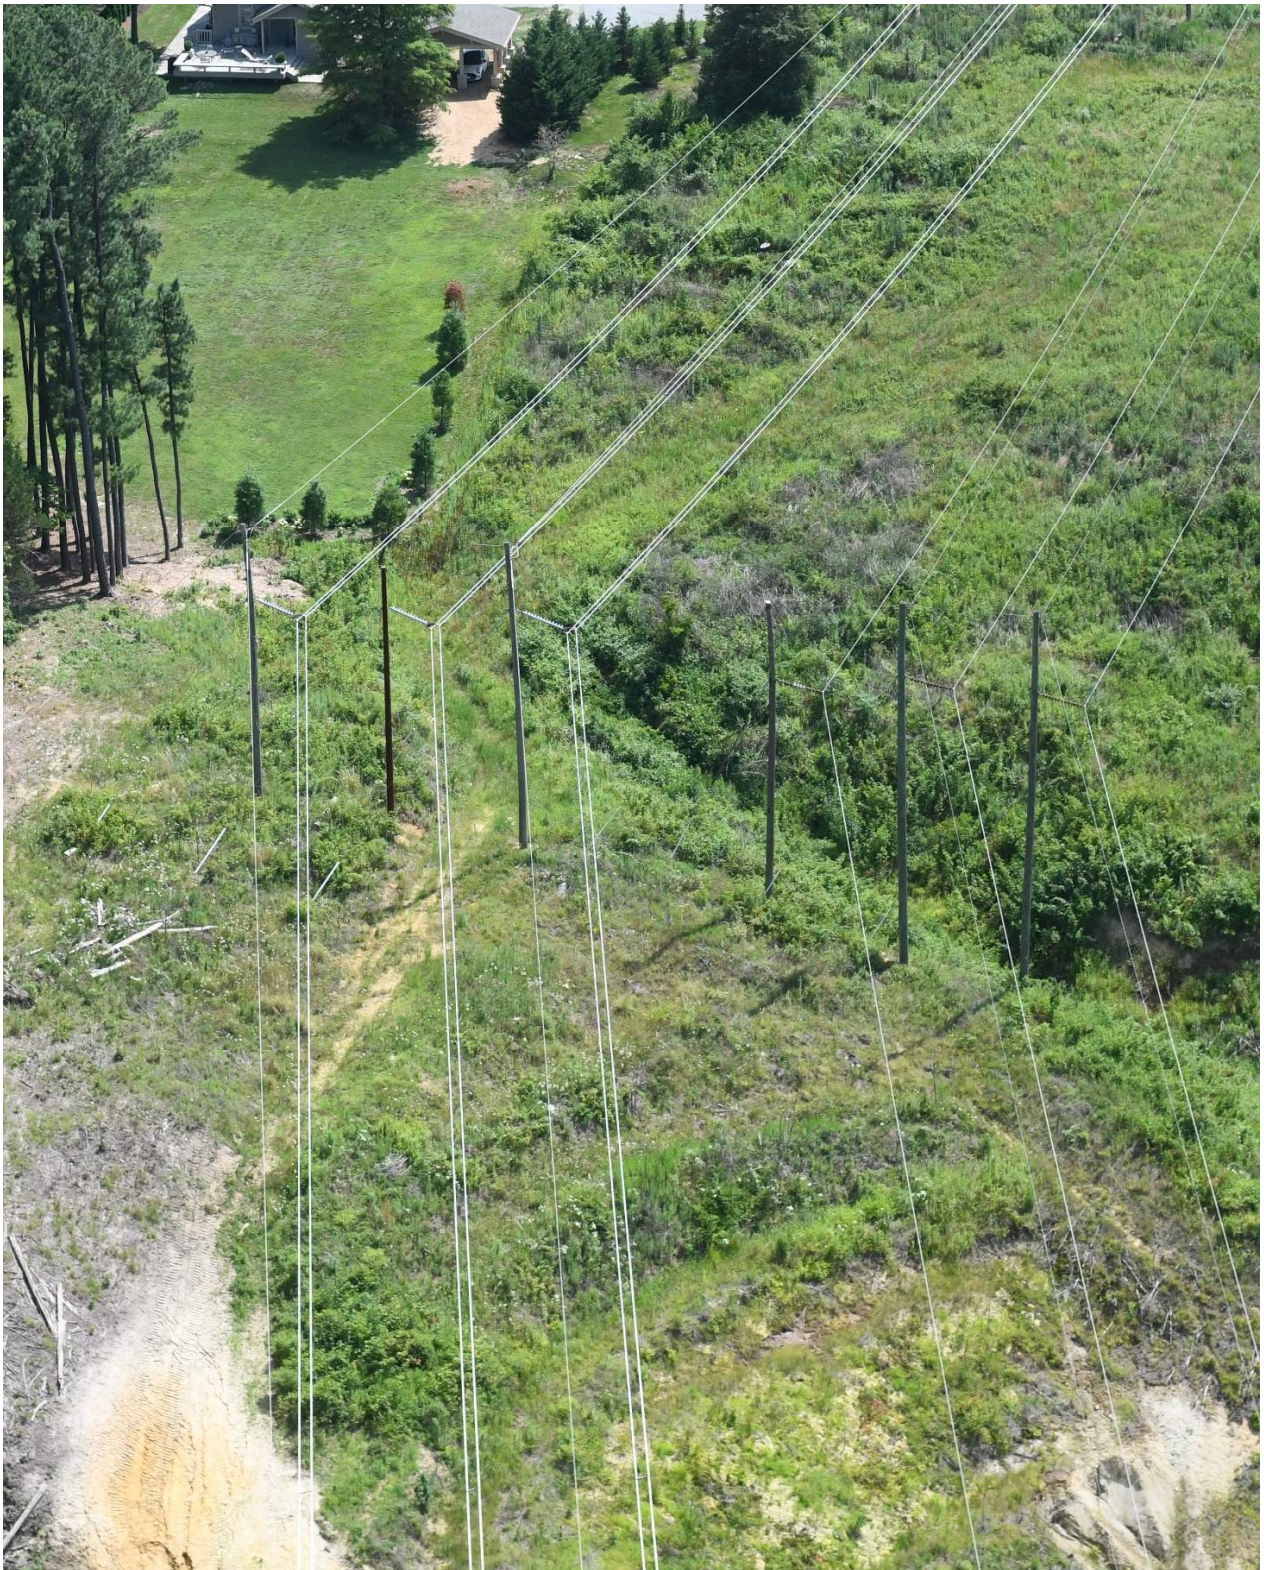
Attachment II.B.6.a.ii

Existing Structure Type:
230kV (Left) And 115kV (Right) Single Circuit
Wood 3-Pole (Running Angle)

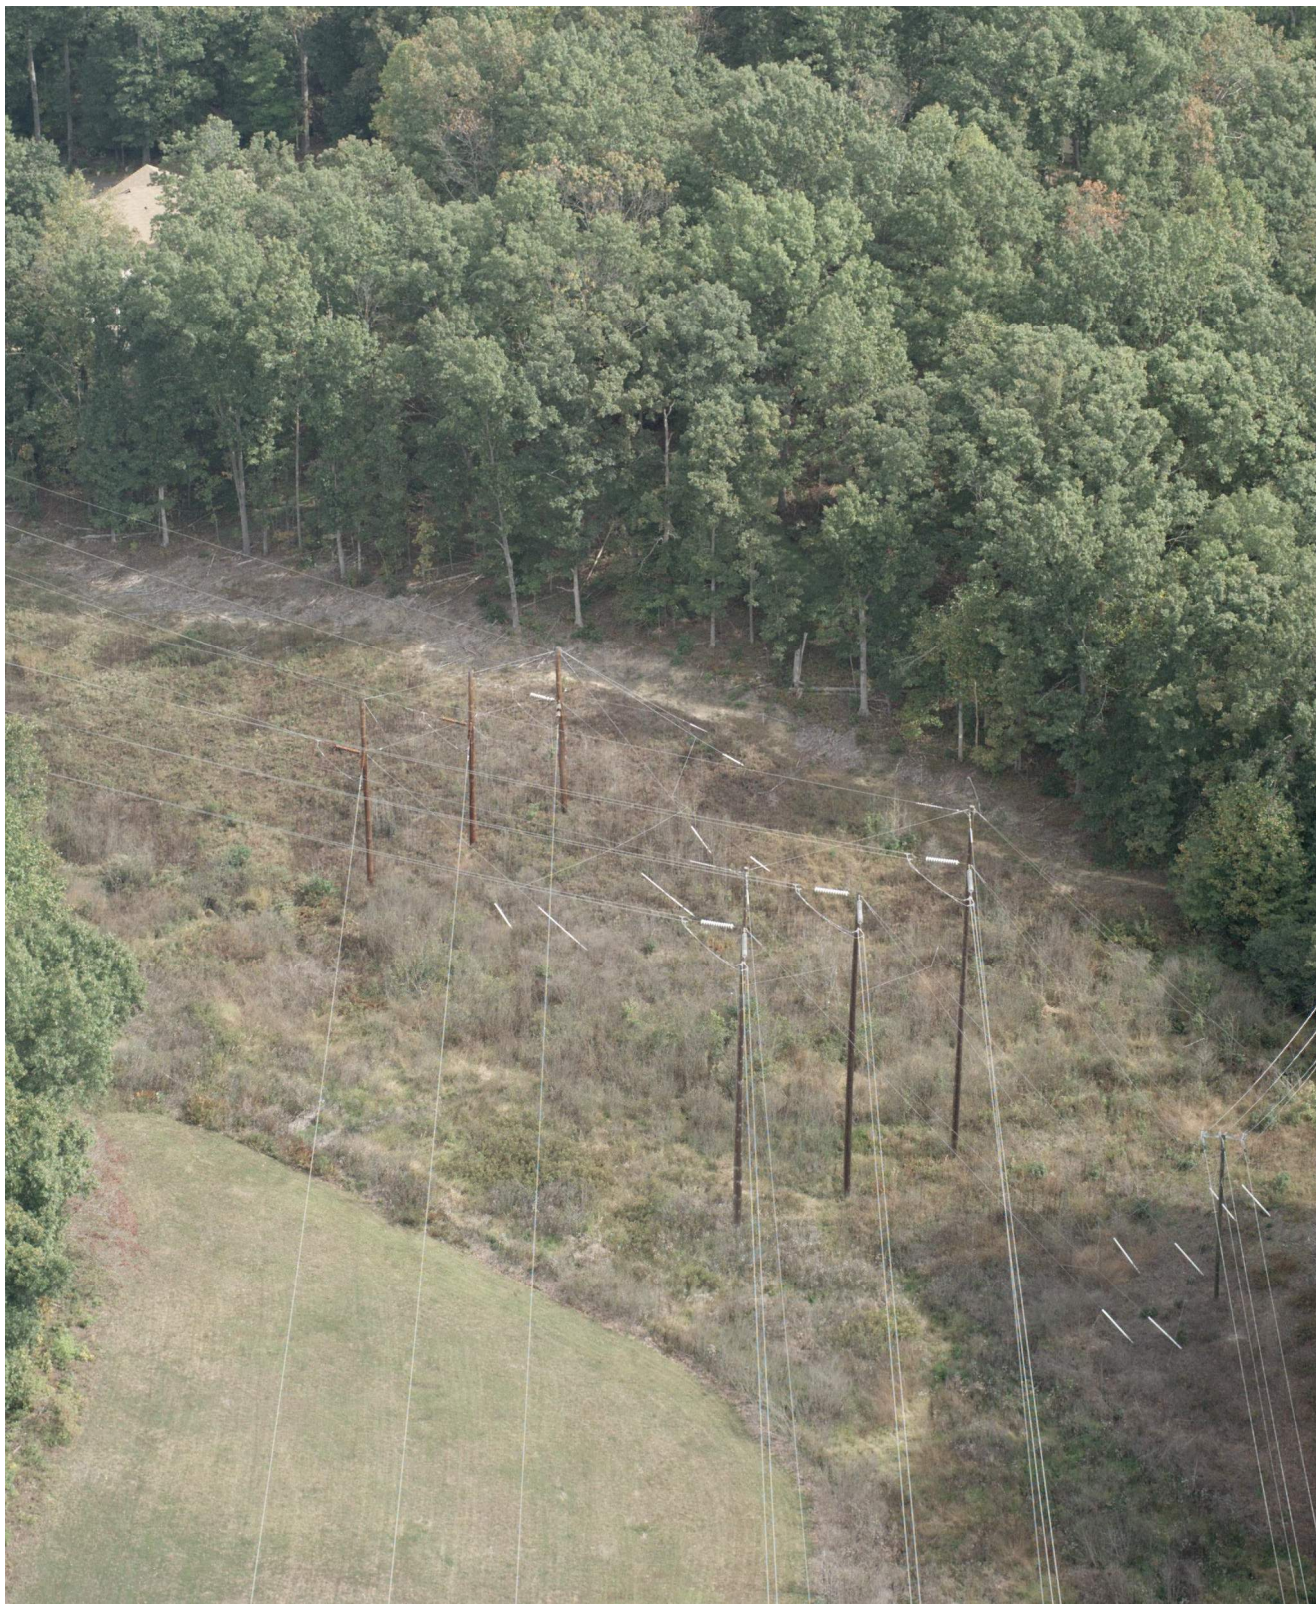
Attachment II.B.6.a.iii

Existing Structure Type:
115kV (Left) And 230kV (Right) Single Circuit
Wood 3-Pole (DDE)

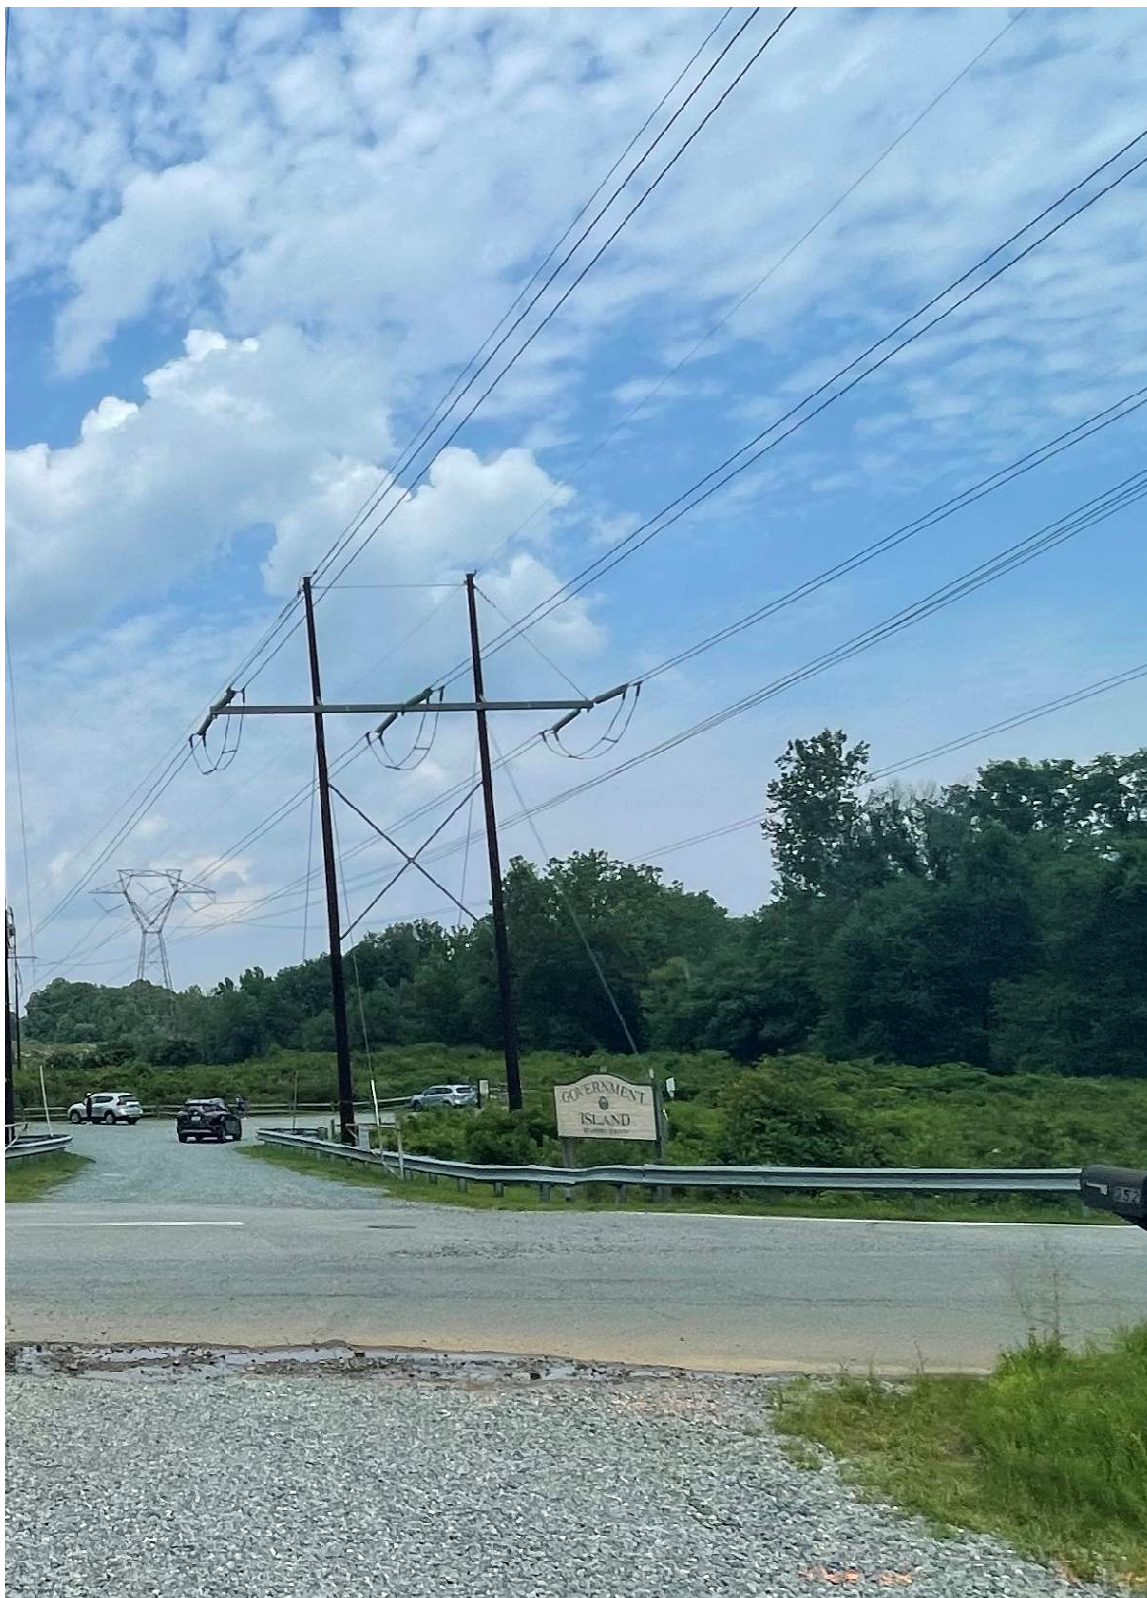
Attachment II.B.6.a.iv

Existing Structure Type:
230kV Single Circuit Steel H-Frame (DDE)

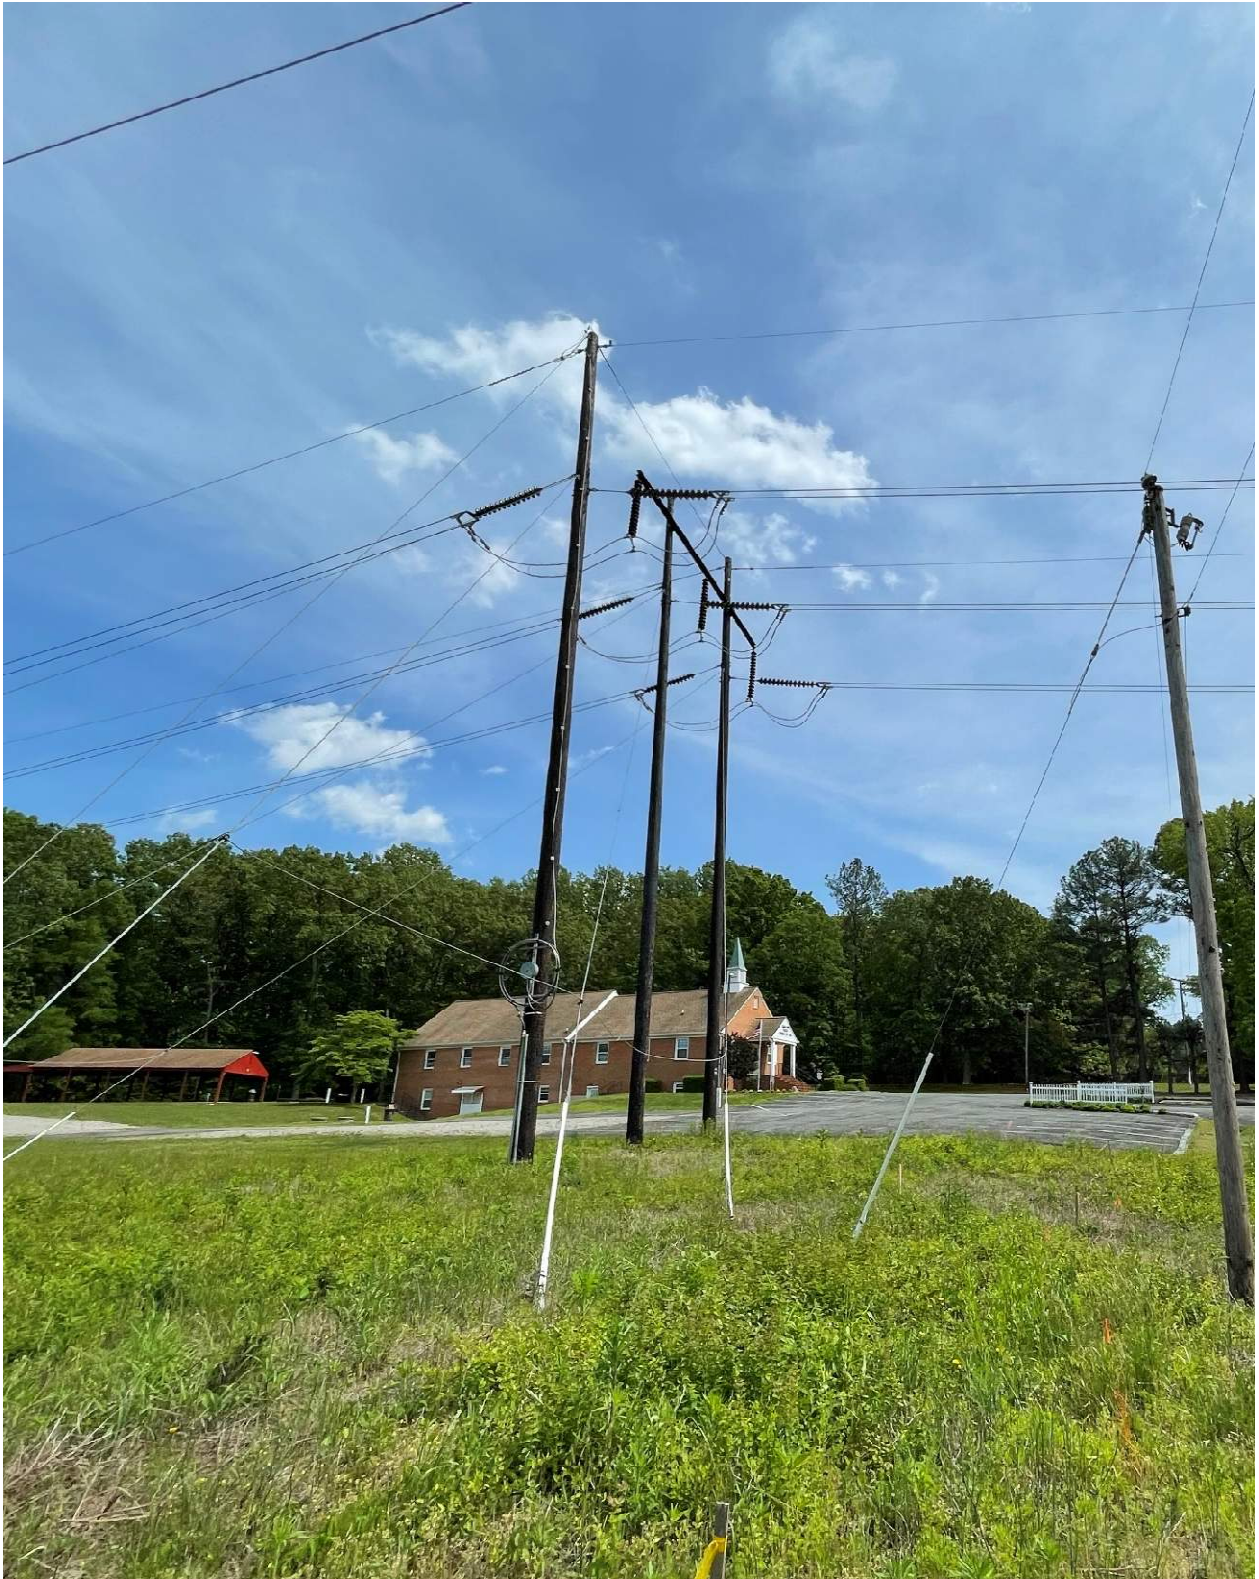
Attachment II.B.6.a.v

Existing Structure Type:
230kV Single Circuit Wood 3-Pole (DDE)

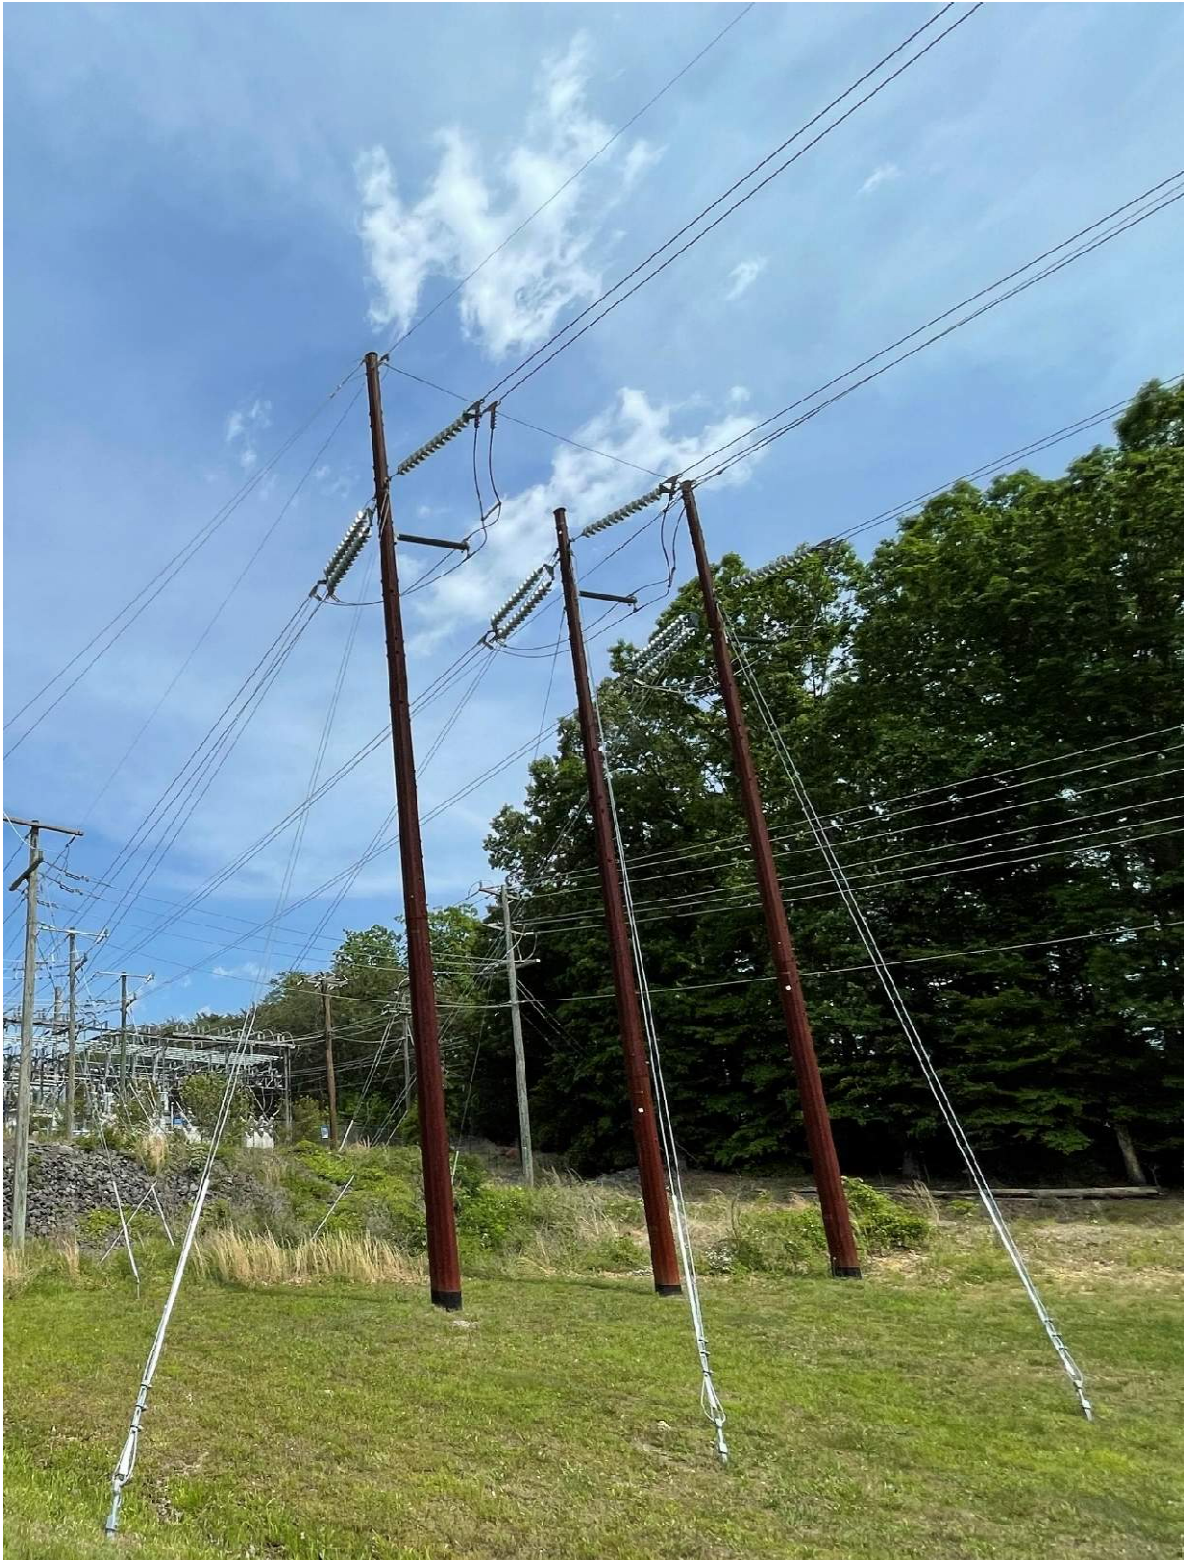
Attachment II.B.6.a.vi

Existing Structure Type:
230kV Single Circuit Steel 3-Pole (DDE)

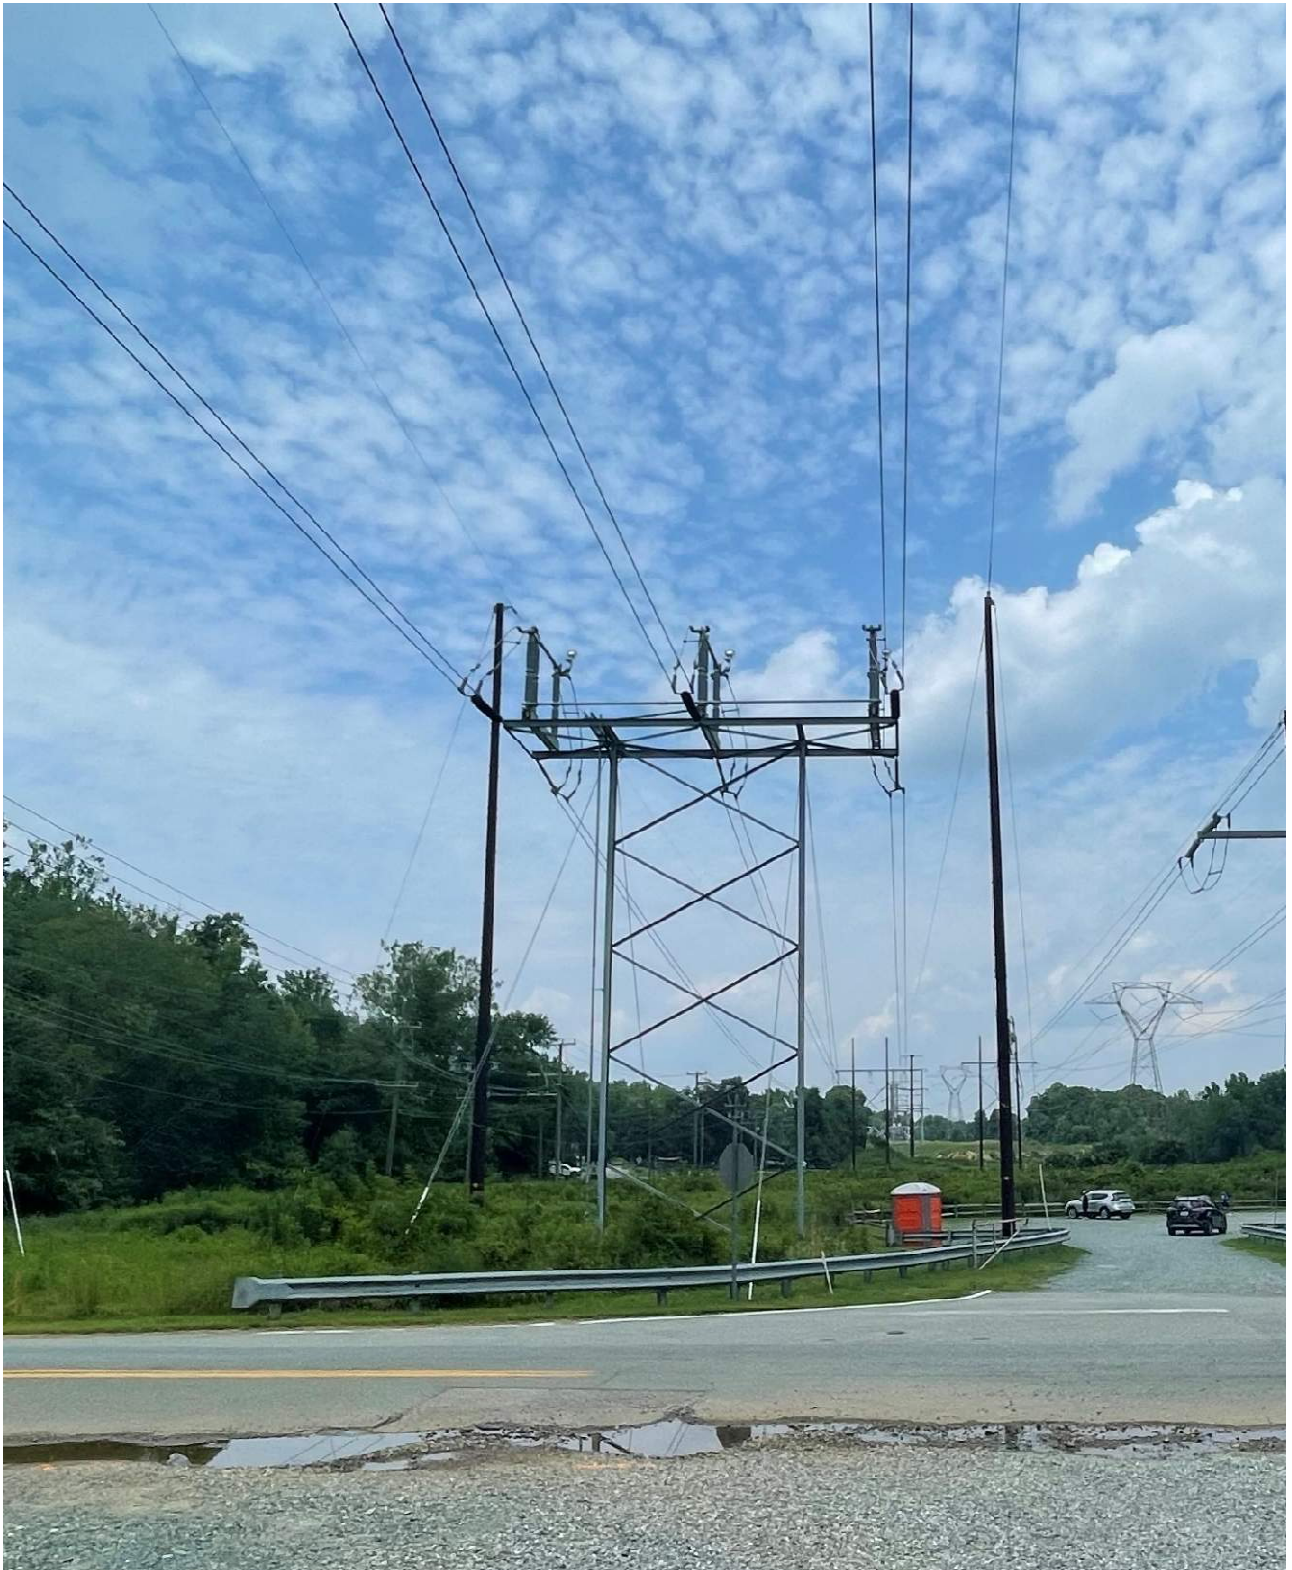
Attachment II.B.6.a.vii

Existing Structure Type:
230kV Single Circuit Steel Switch Structure
(DDE)

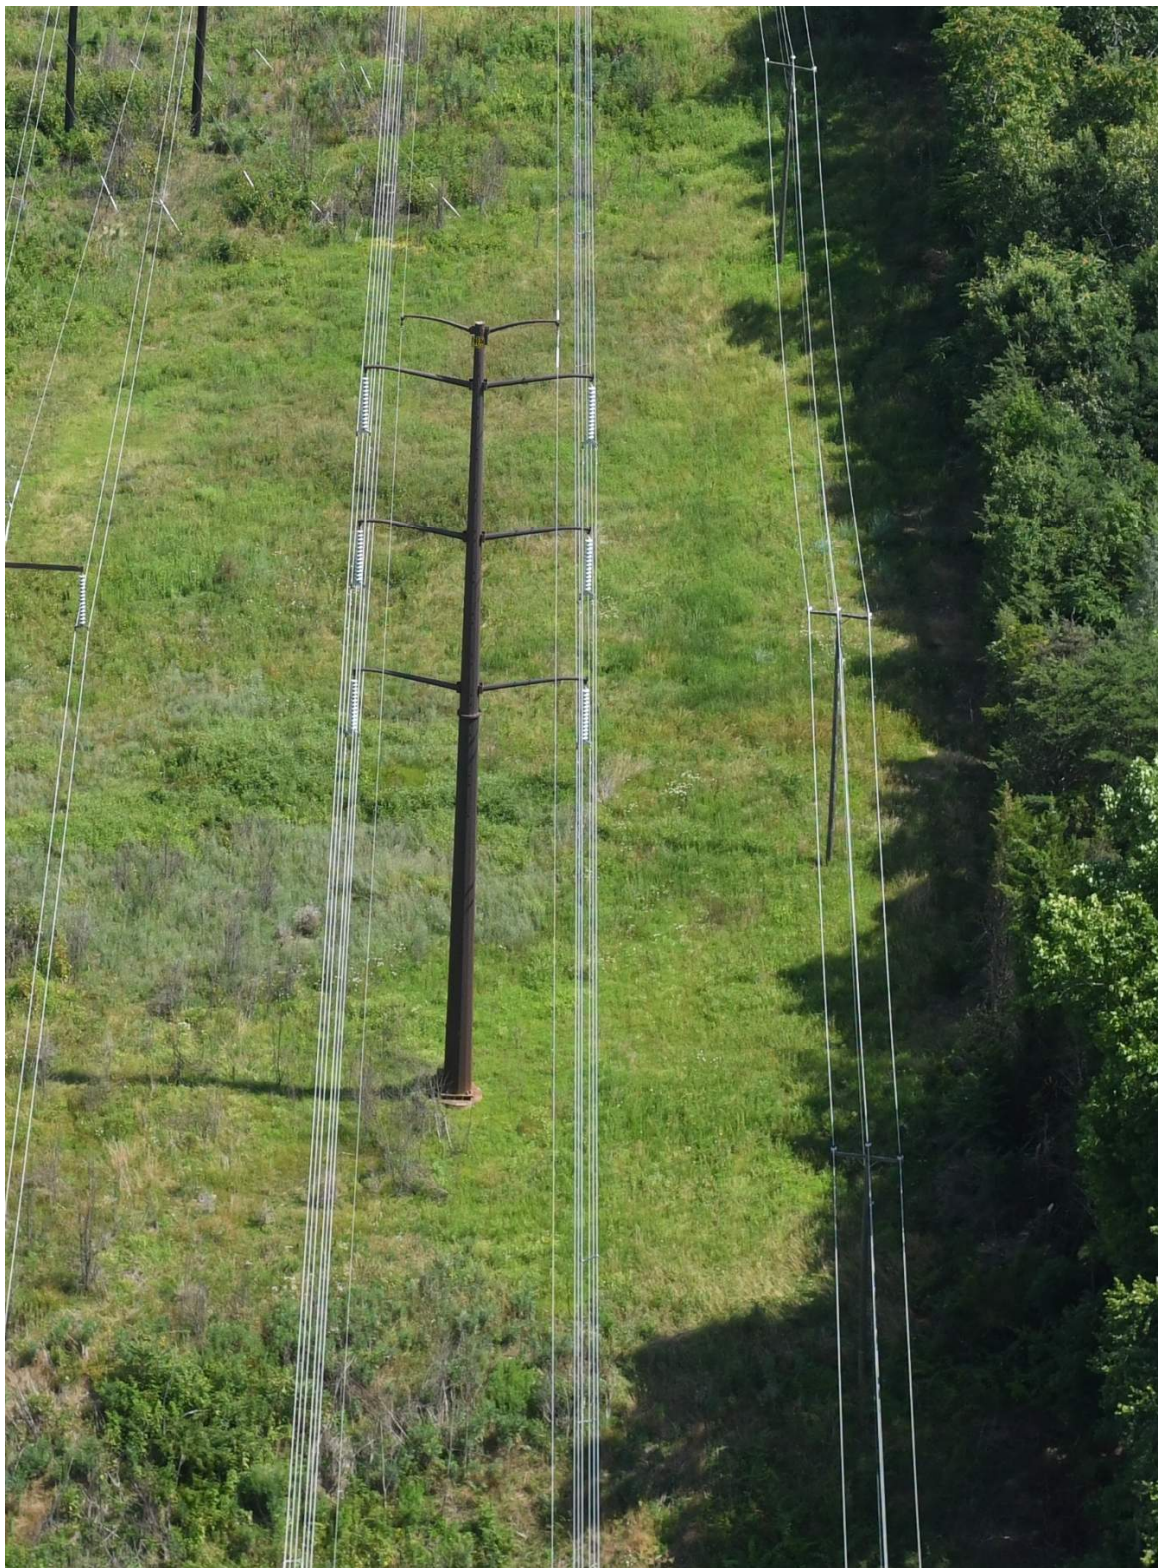
Attachment II.B.6.a.viii

Existing Structure Type:
230kV Double Circuit Steel Structure (Tangent)
