Re: Application of Virginia Electric and Power Company for Approval and Certification of Electric Transmission Facilities: Fredericksburg-Aquia Harbour Lines #29, #2104, and #2157 Partial Rebuild – Case No. PUR-2024-00035.

Application, Appendix,
DEQ Supplement, Direct
Testimony and Exhibits of
Virginia Electric and Power
Company

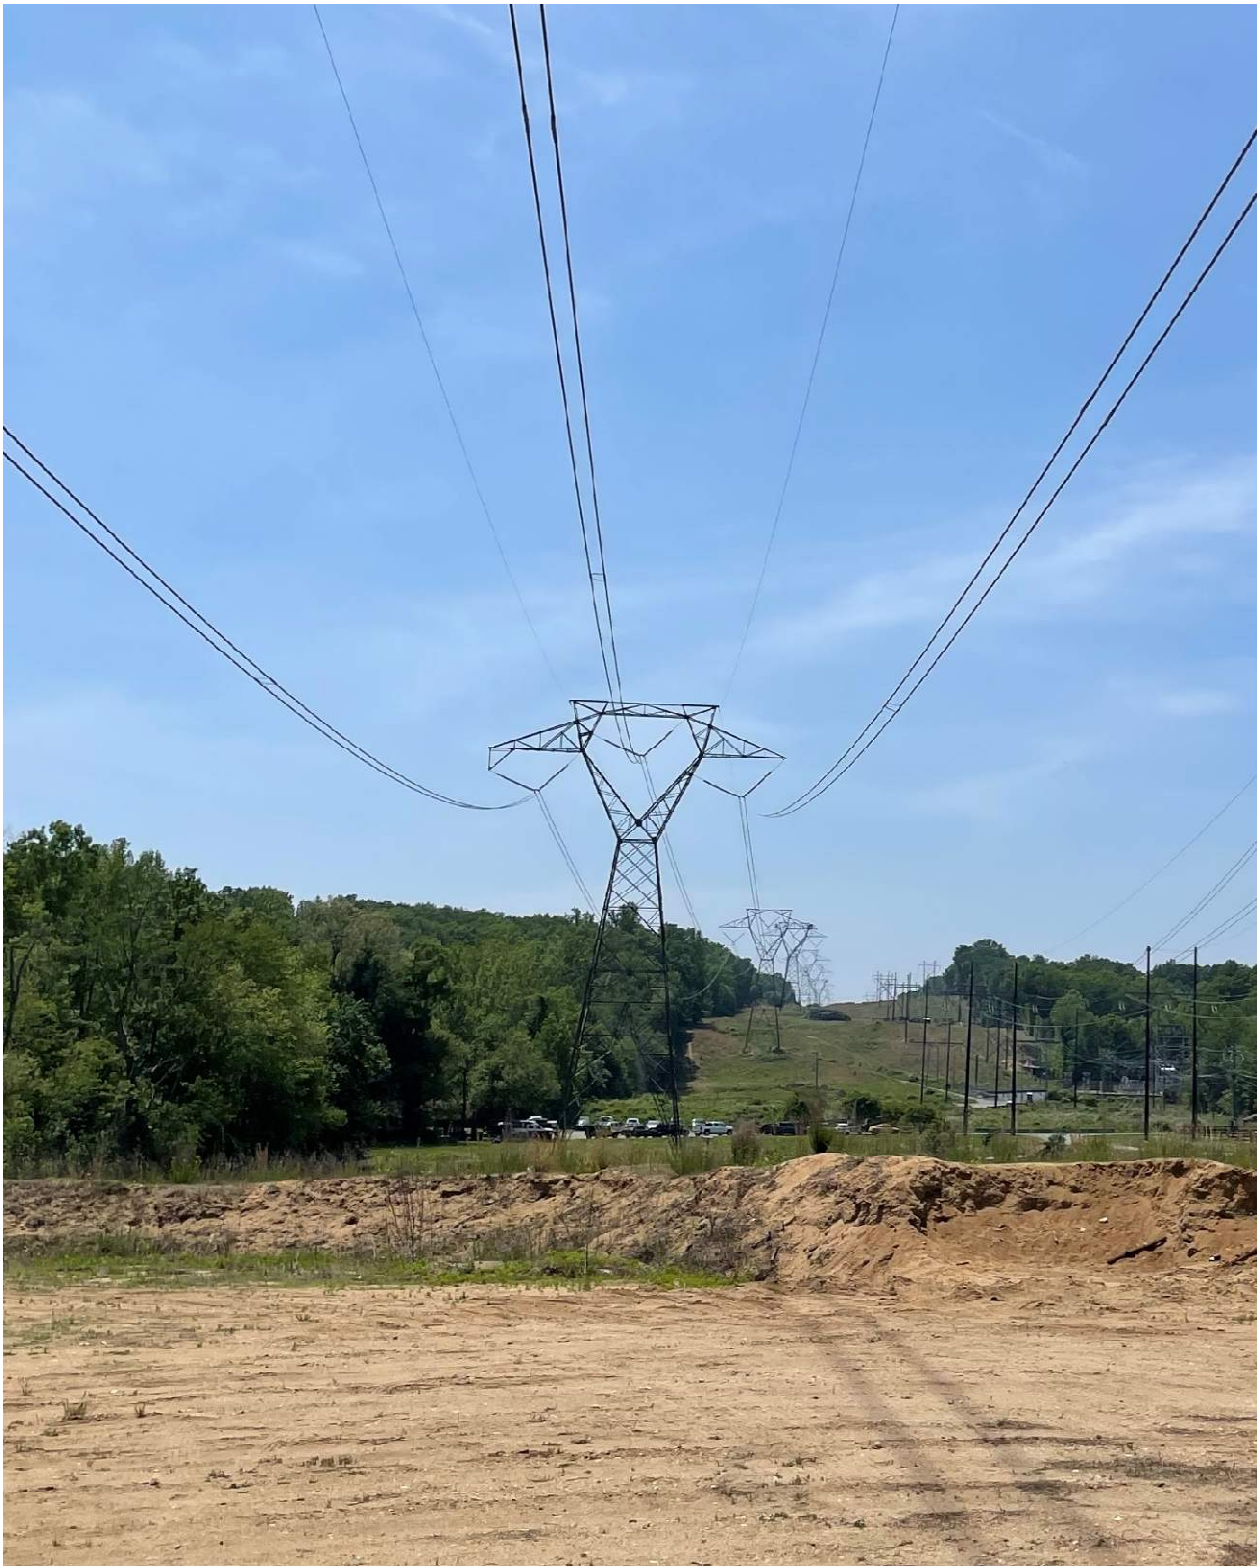
Attachment II.B.6.a.ix

Existing Structure Type:
500kV Single Circuit Steel Tower (Tangent)

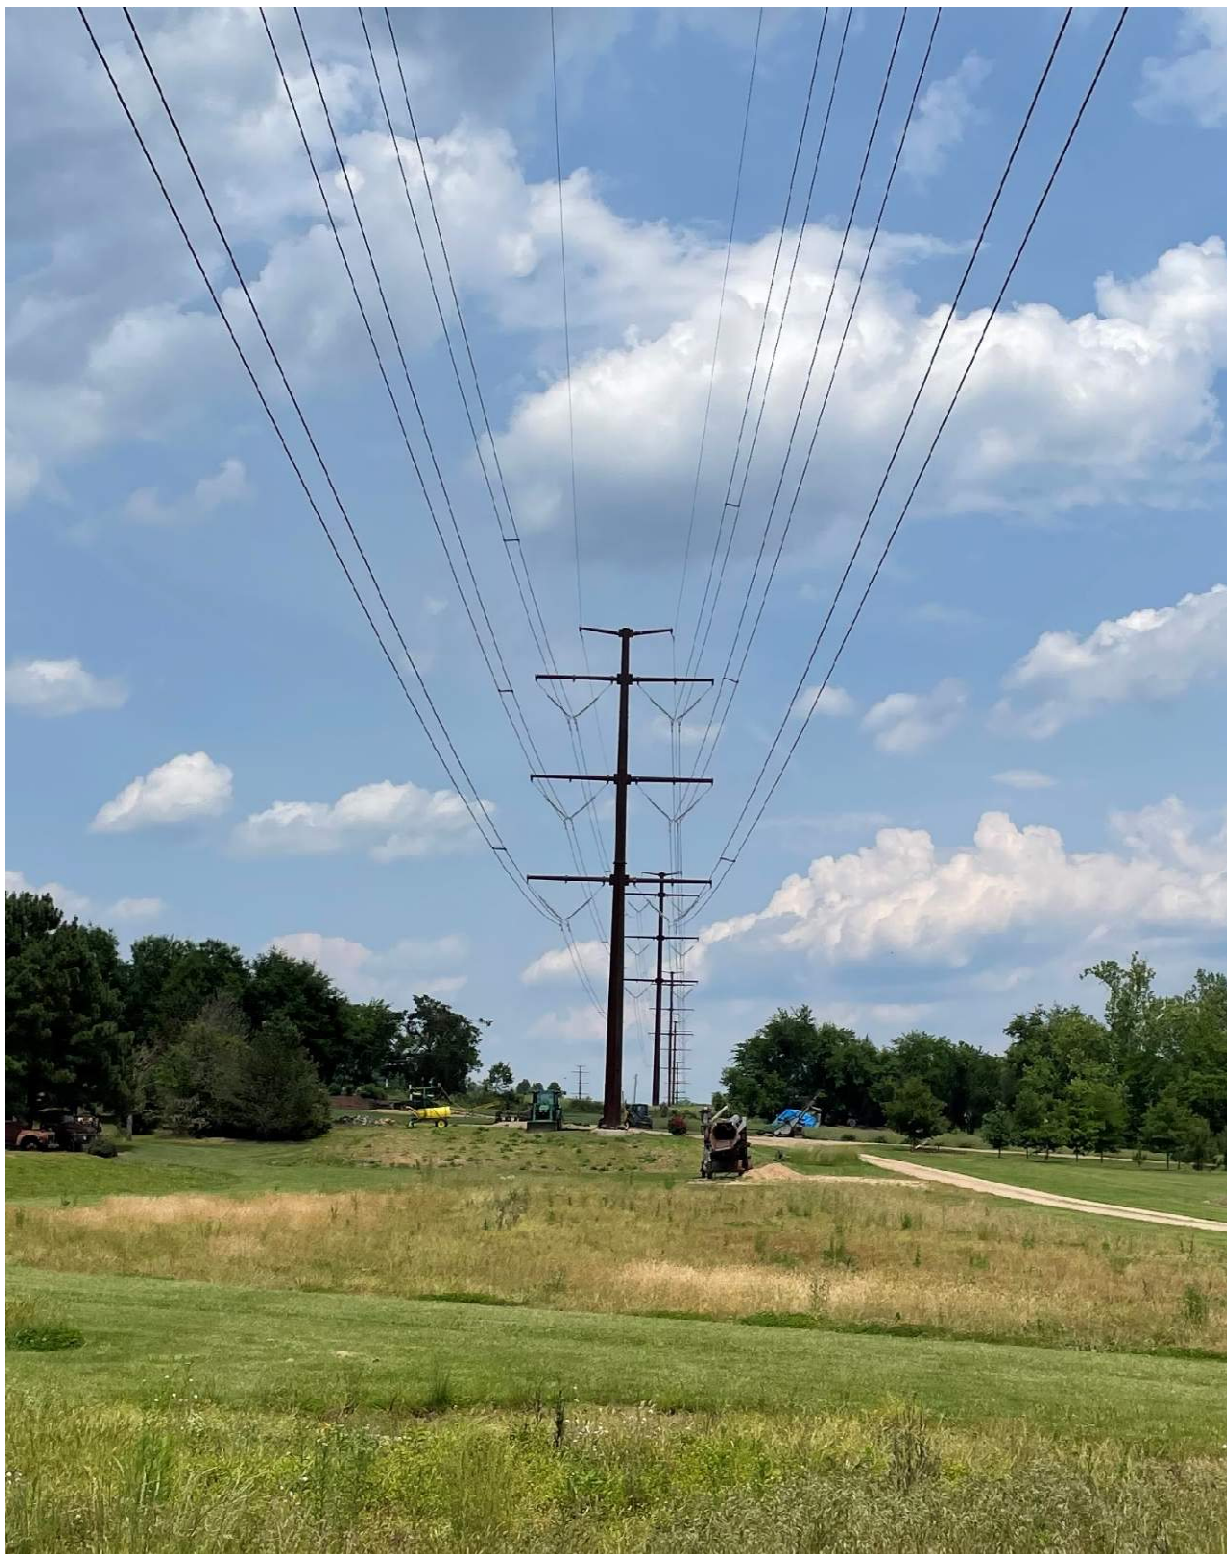
Attachment II.B.6.b.i

Existing Structure Type:
230kV Double Circuit Steel Monopole (Tangent)

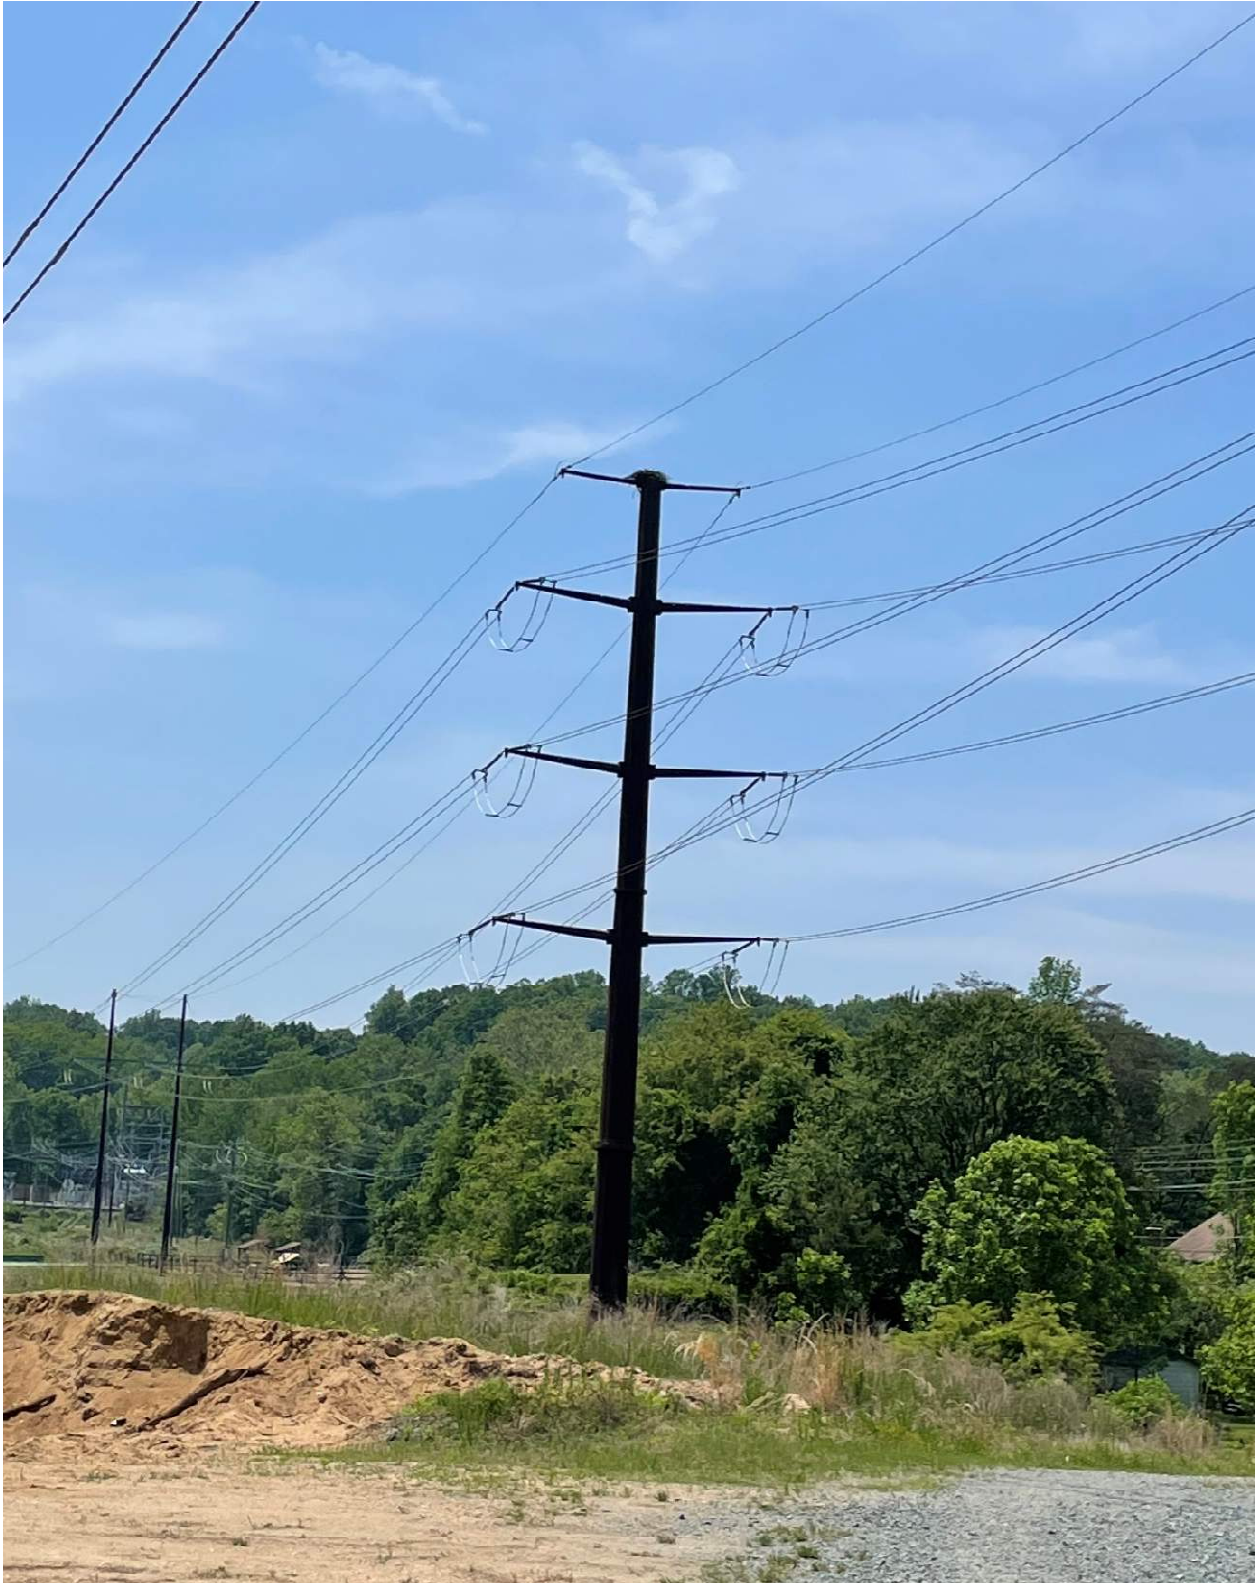
Attachment II.B.6.b.ii

Existing Structure Type:
230kV Double Circuit Steel Monopole (DDE)

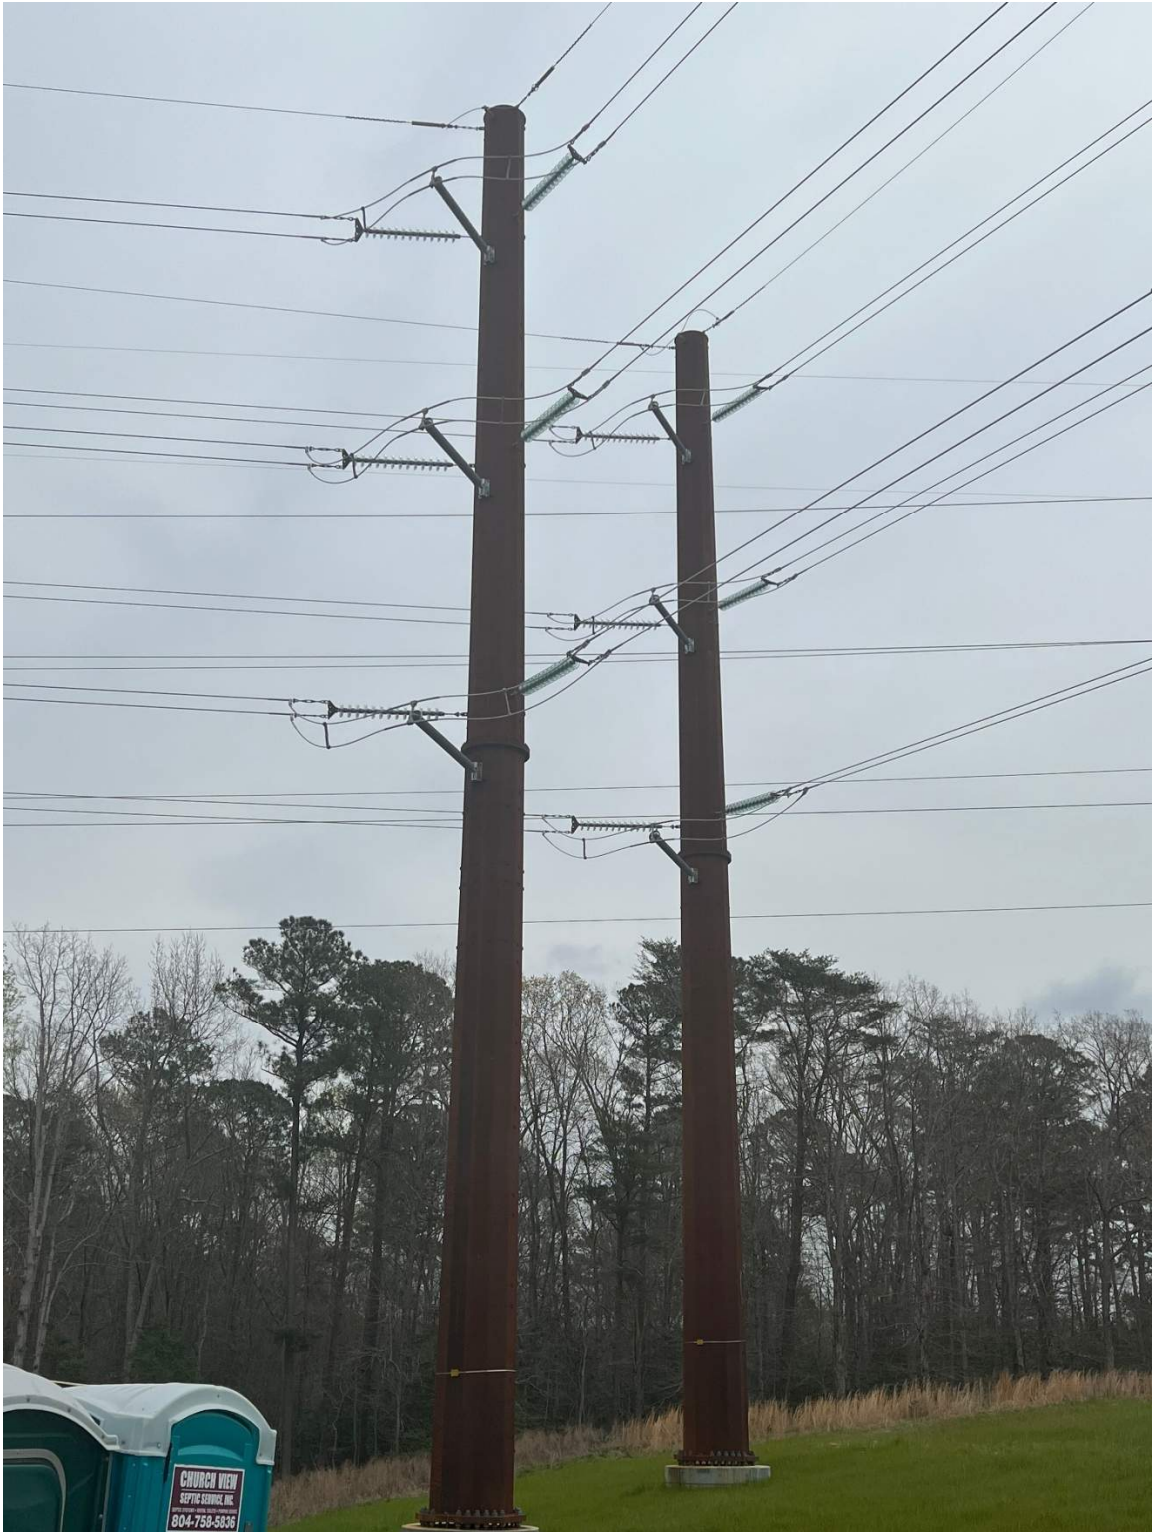
Attachment II.B.6.b.iii

Existing Structure Type:
230kV Double Circuit Steel 2-Pole (DDE)

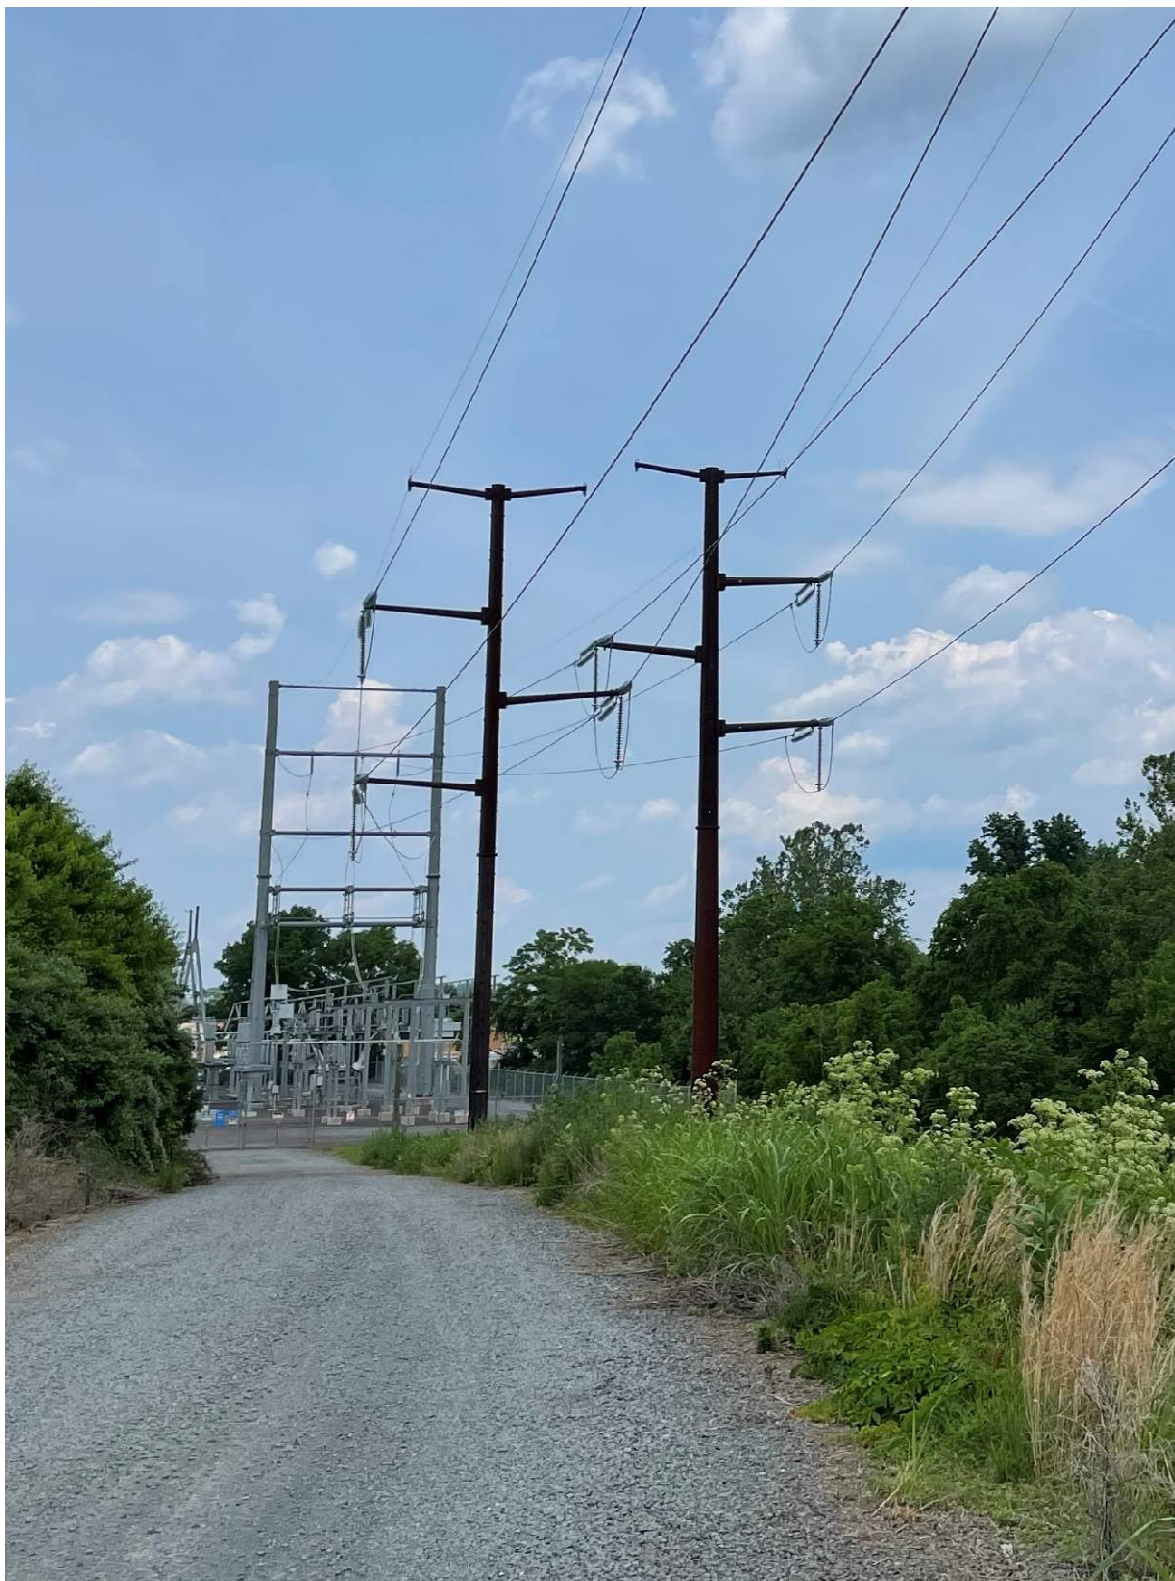
Attachment II.B.6.b.iv

Existing Structure Type:
230kV Double Circuit Steel Monopole w/
Staggered Arms (DDE)

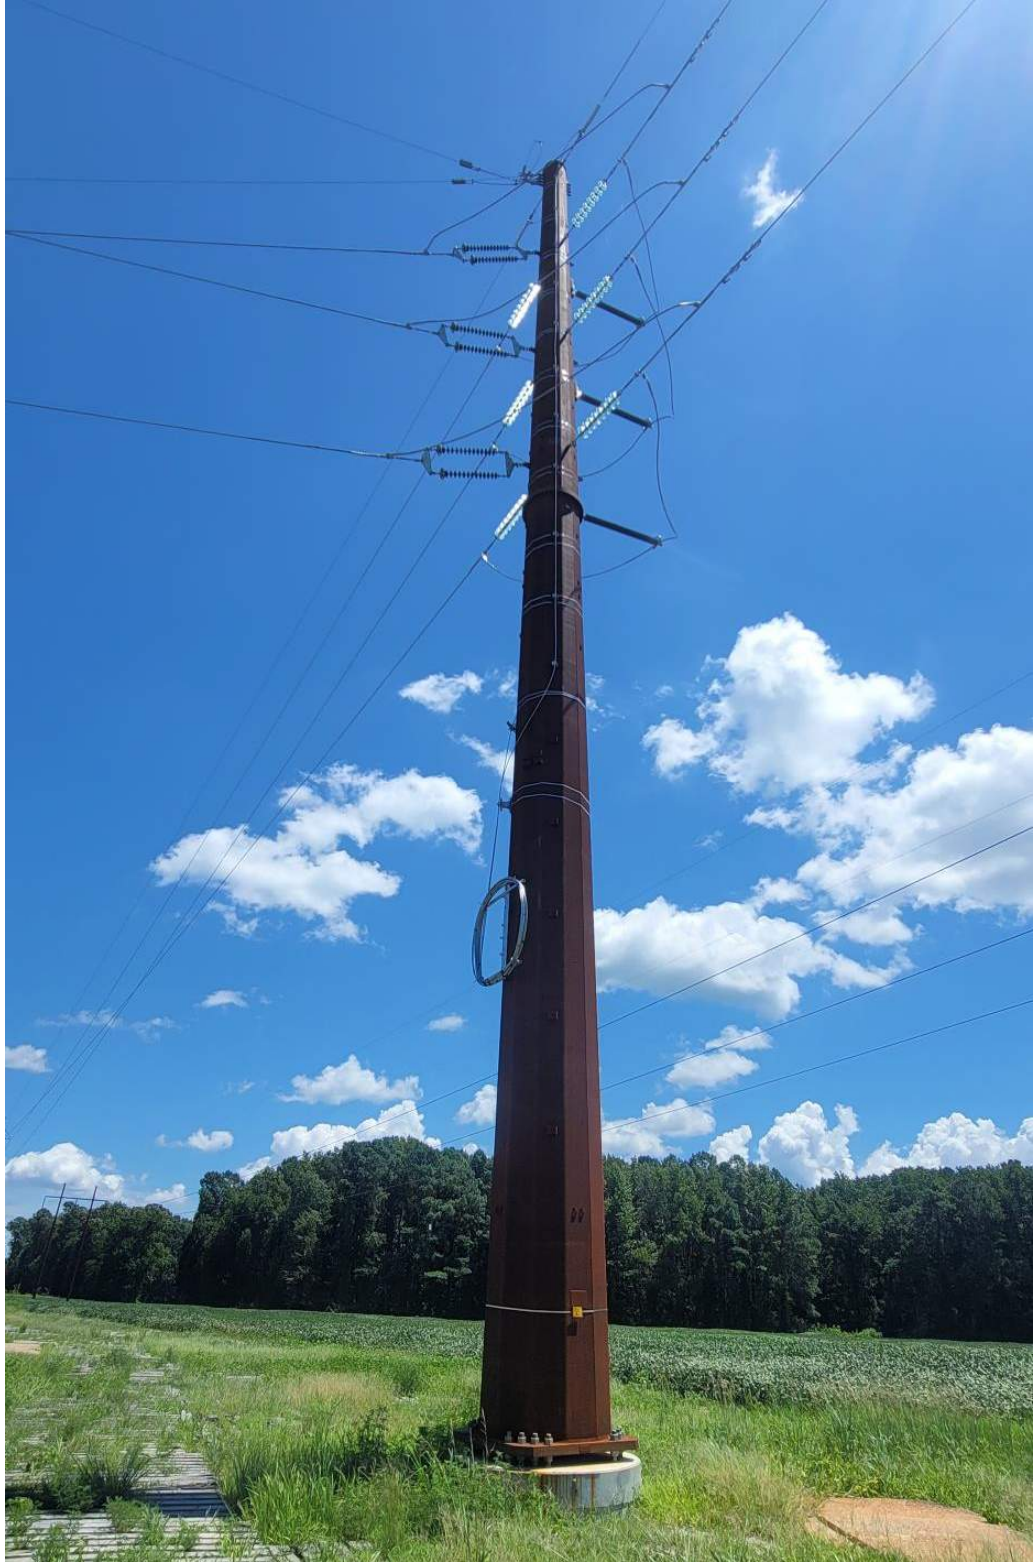
Attachment II.B.6.b.v

Existing Structure Type:
230kV Single Circuit Steel Monopole (DDE)

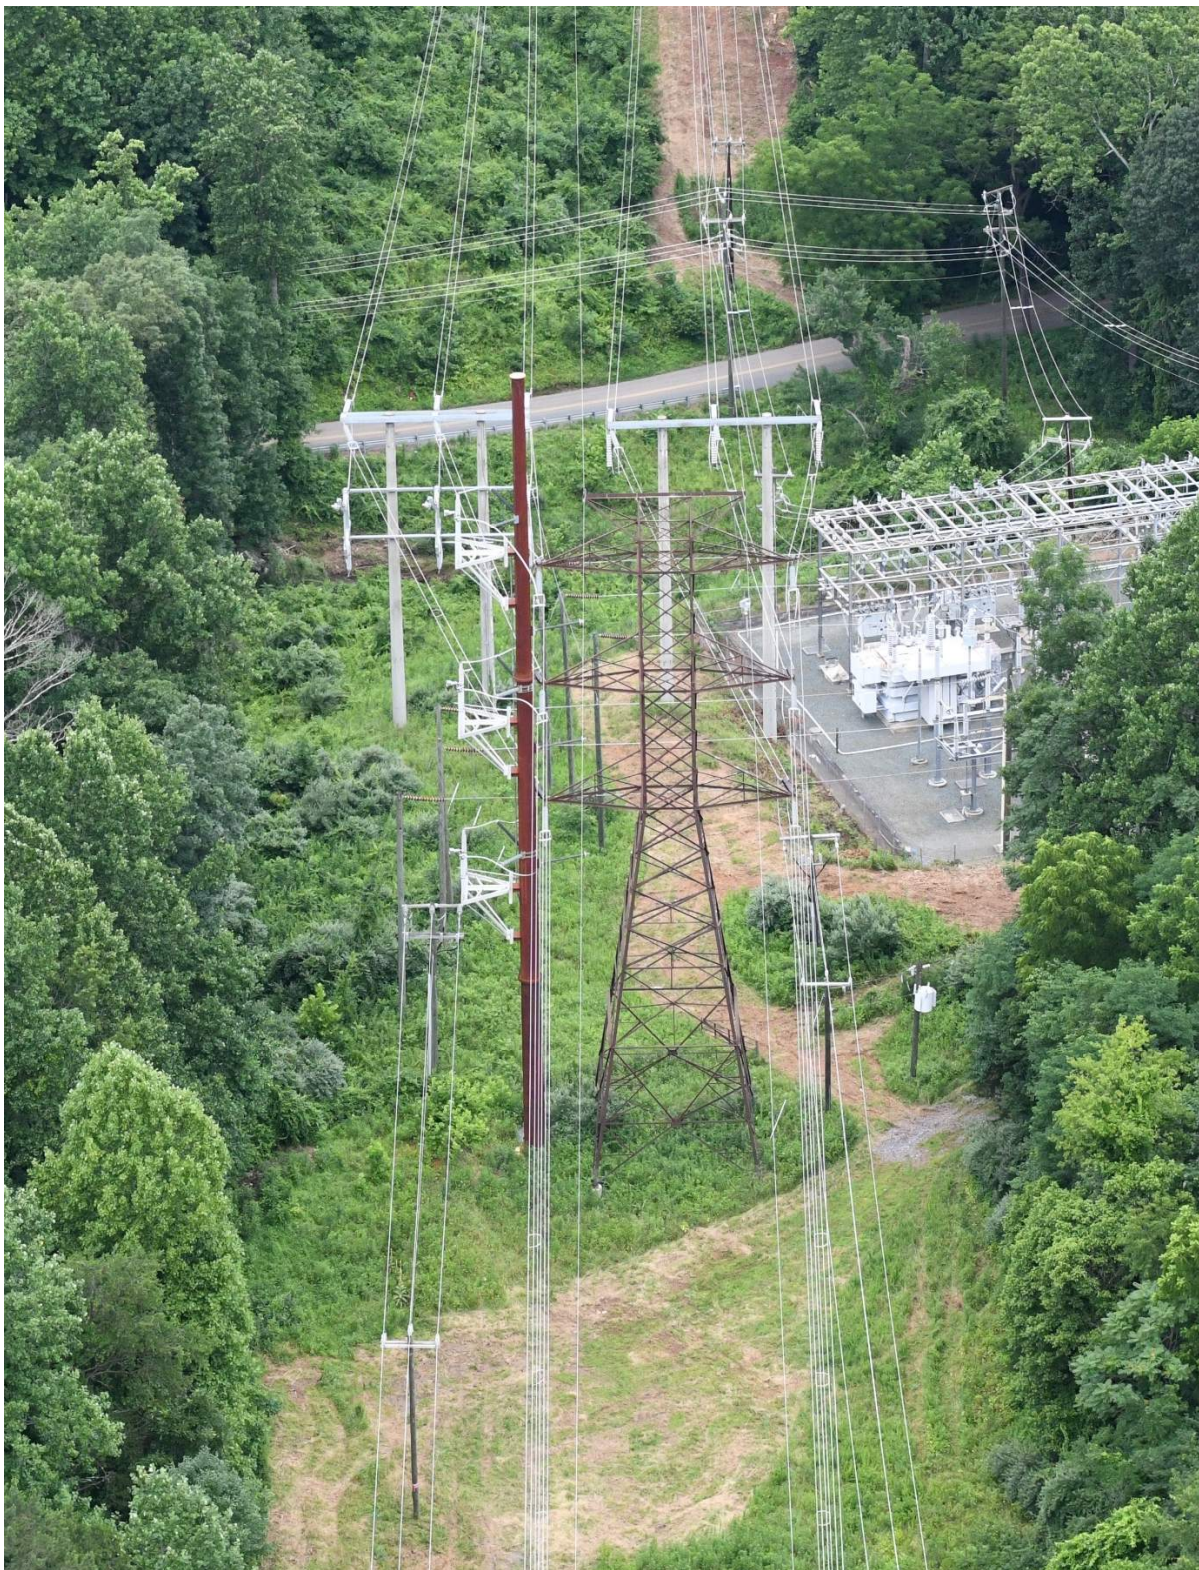
Attachment II.B.6.b.vi

Existing Structure Type:
230kV Single Circuit Steel Monopole Phase Over
Phase Switch (DDE)

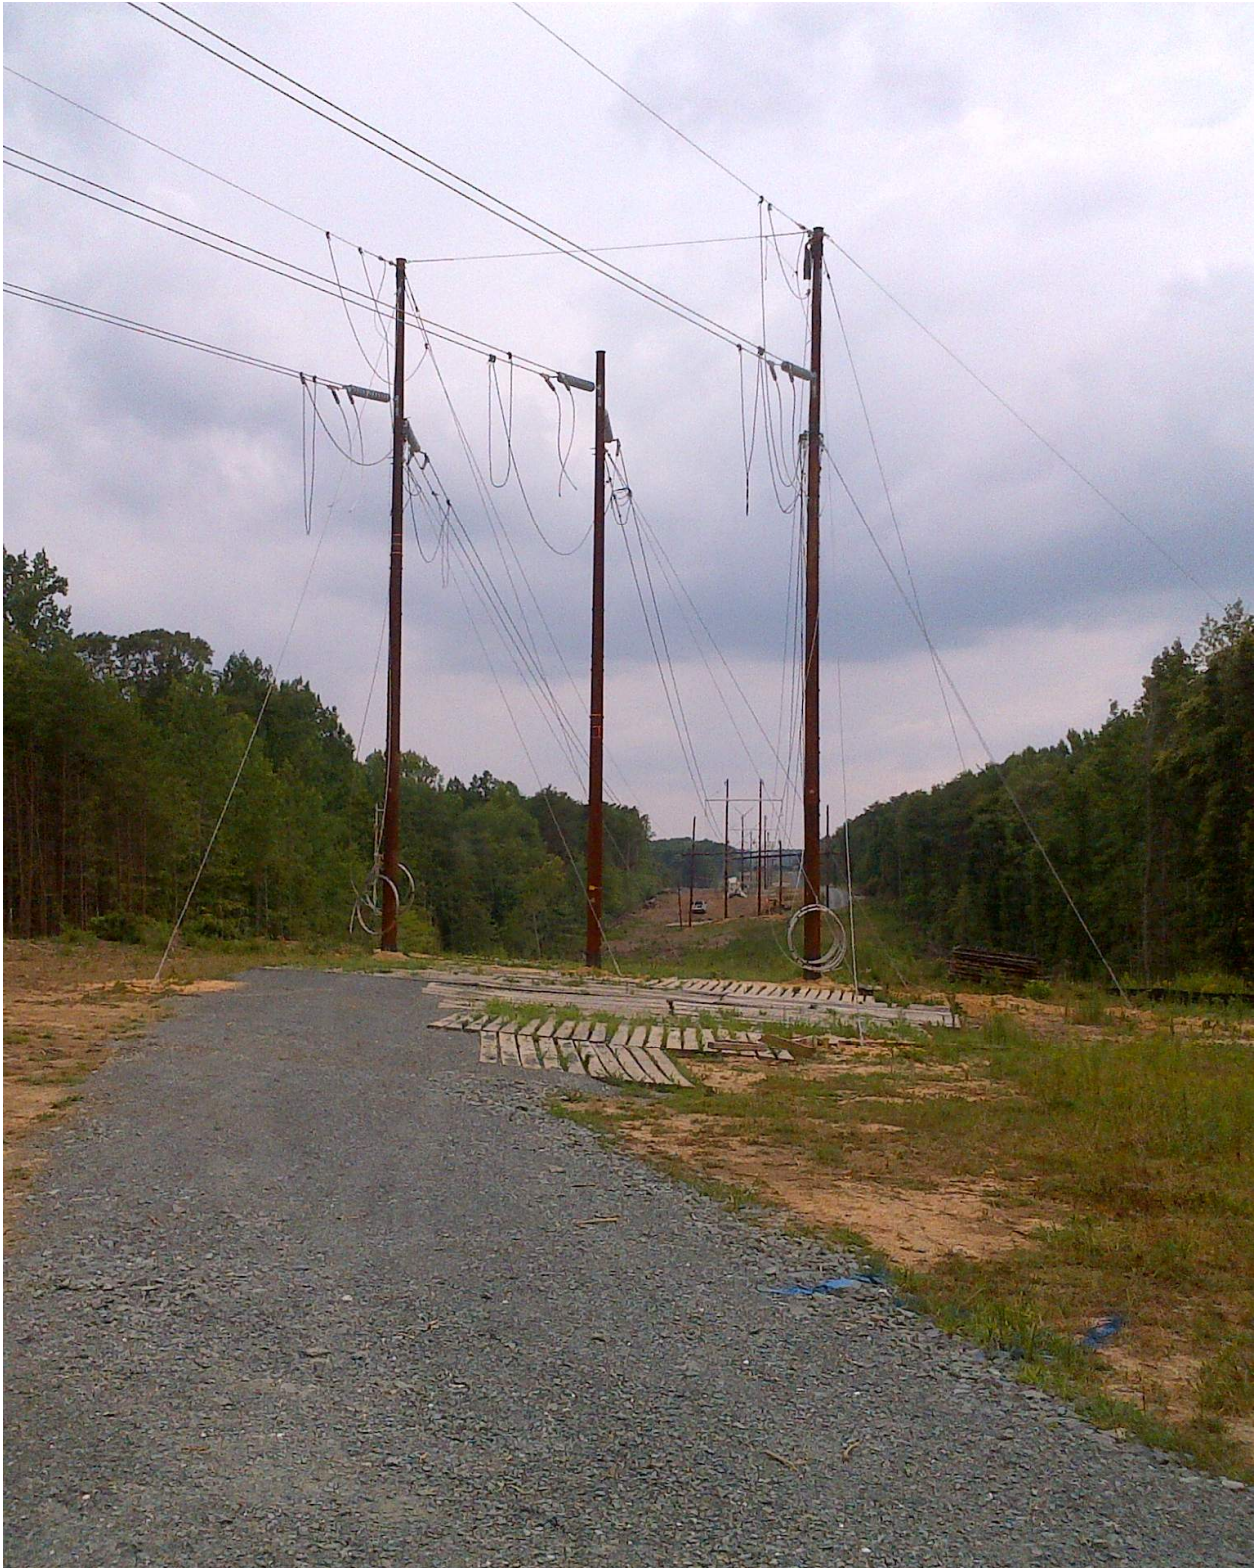
Attachment II.B.6.b.vii

Existing Structure Type:
230kV Single Circuit Steel 3-Pole Guyed (DDE)

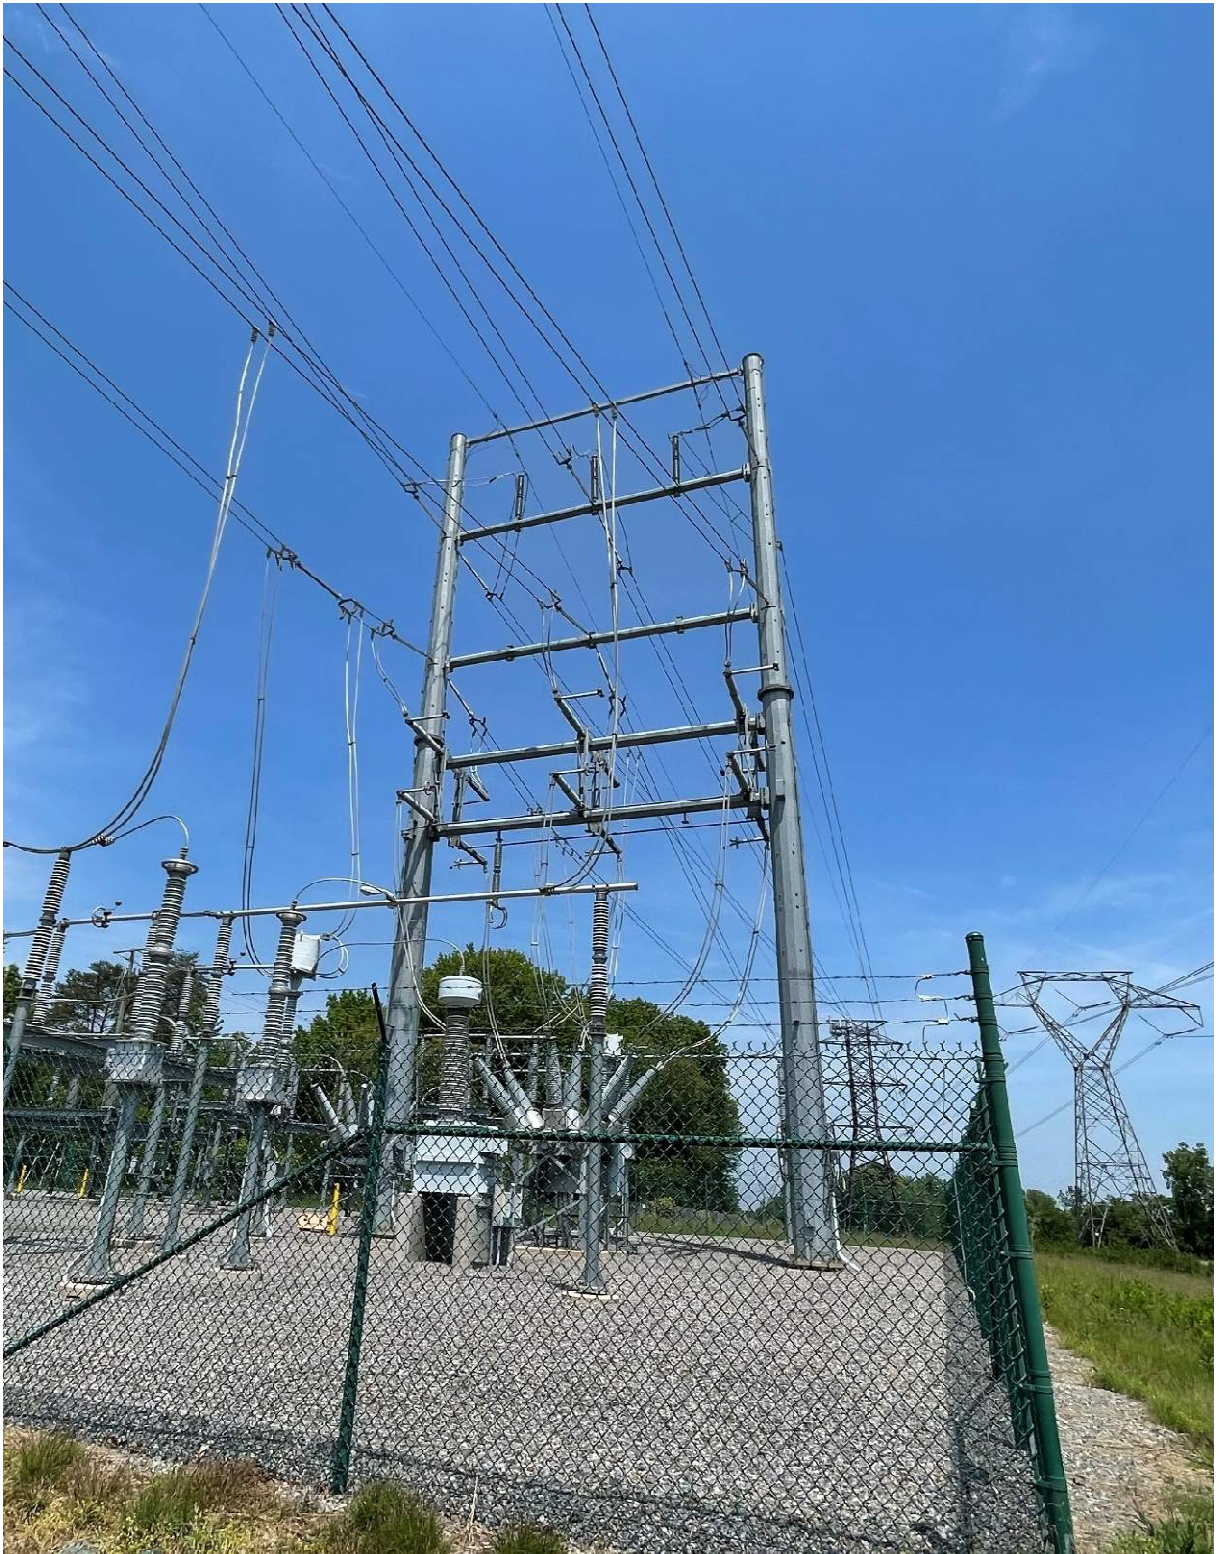
Attachment II.B.6.b.viii

Existing Structure Type:
230kV Double Circuit Steel Monopole (DDE)

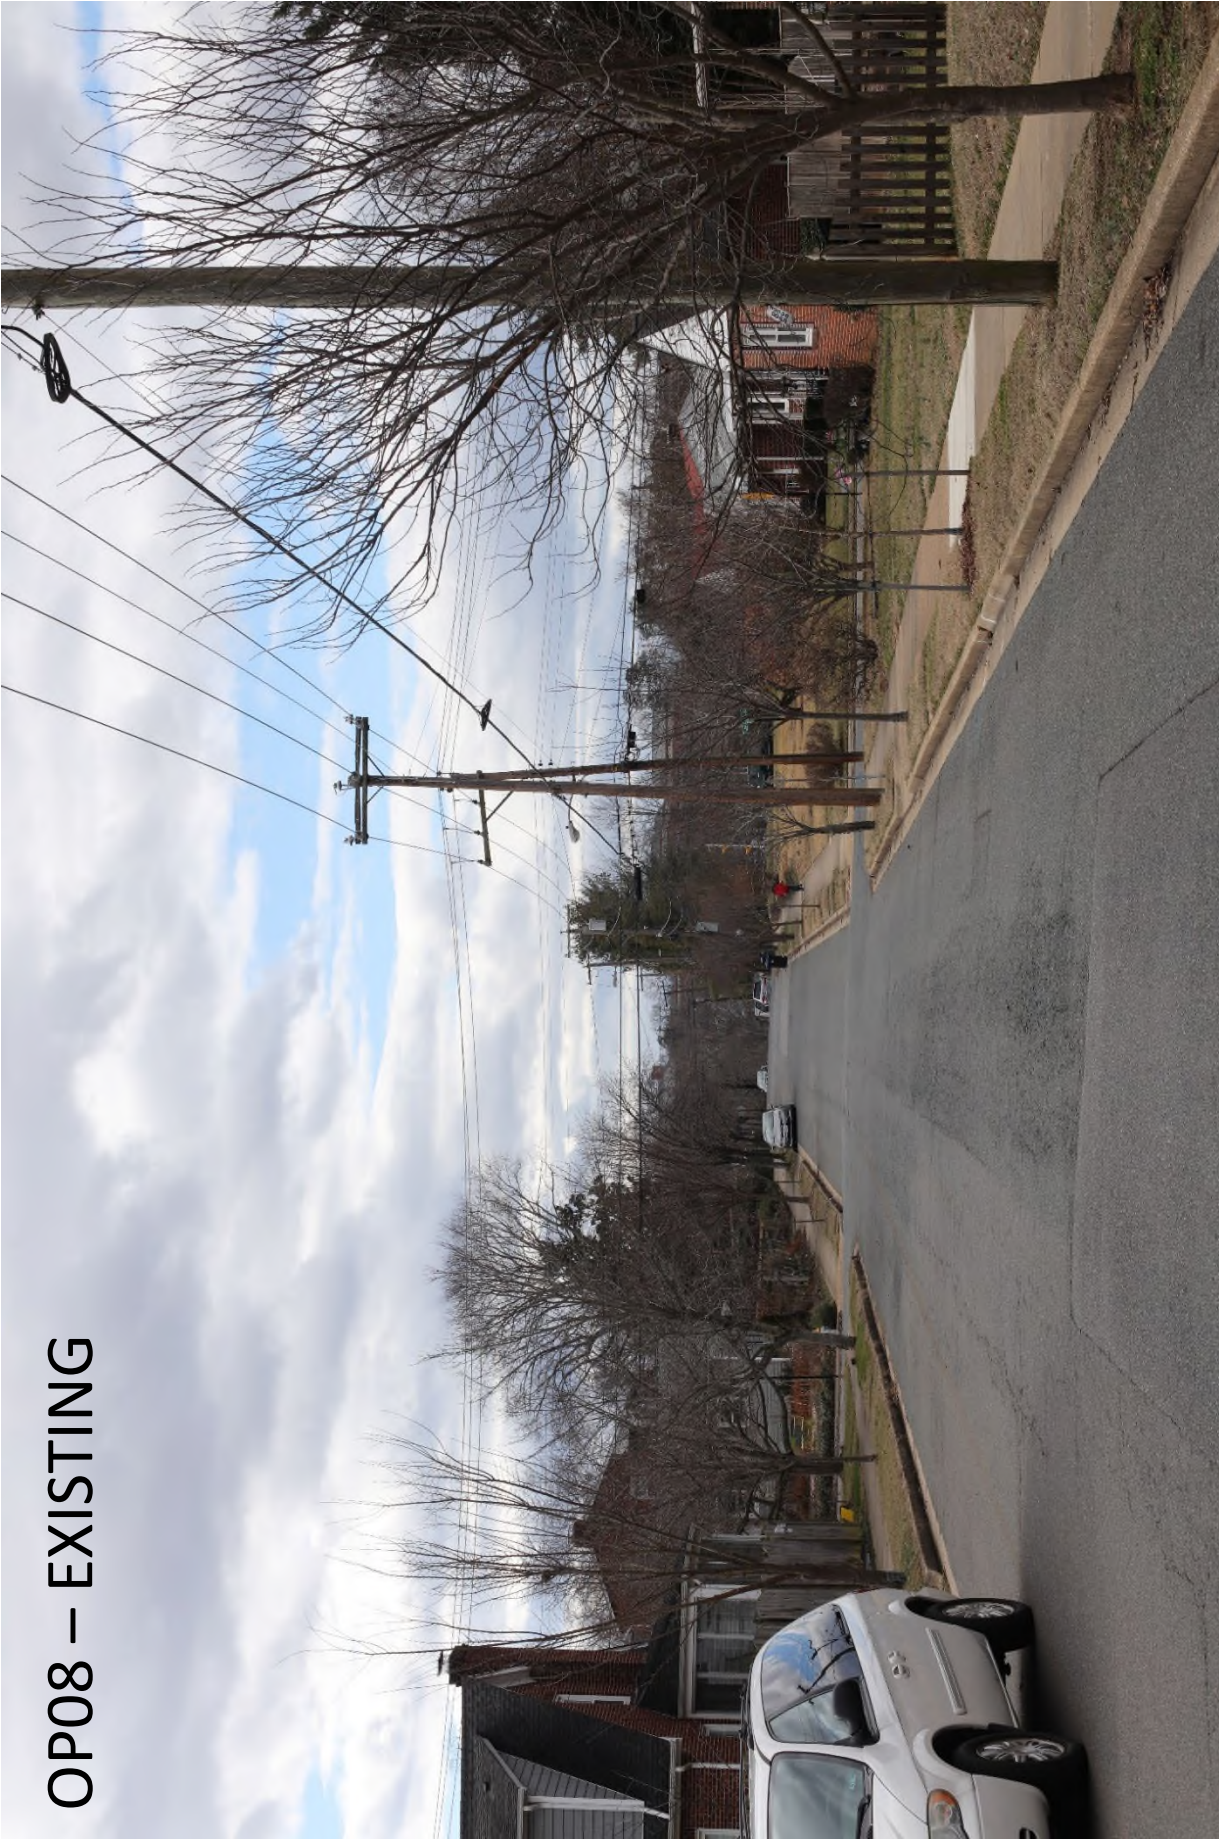
OP08 – EXISTING

OP 8 Existing
Elmhurst (DHR #111-5267)

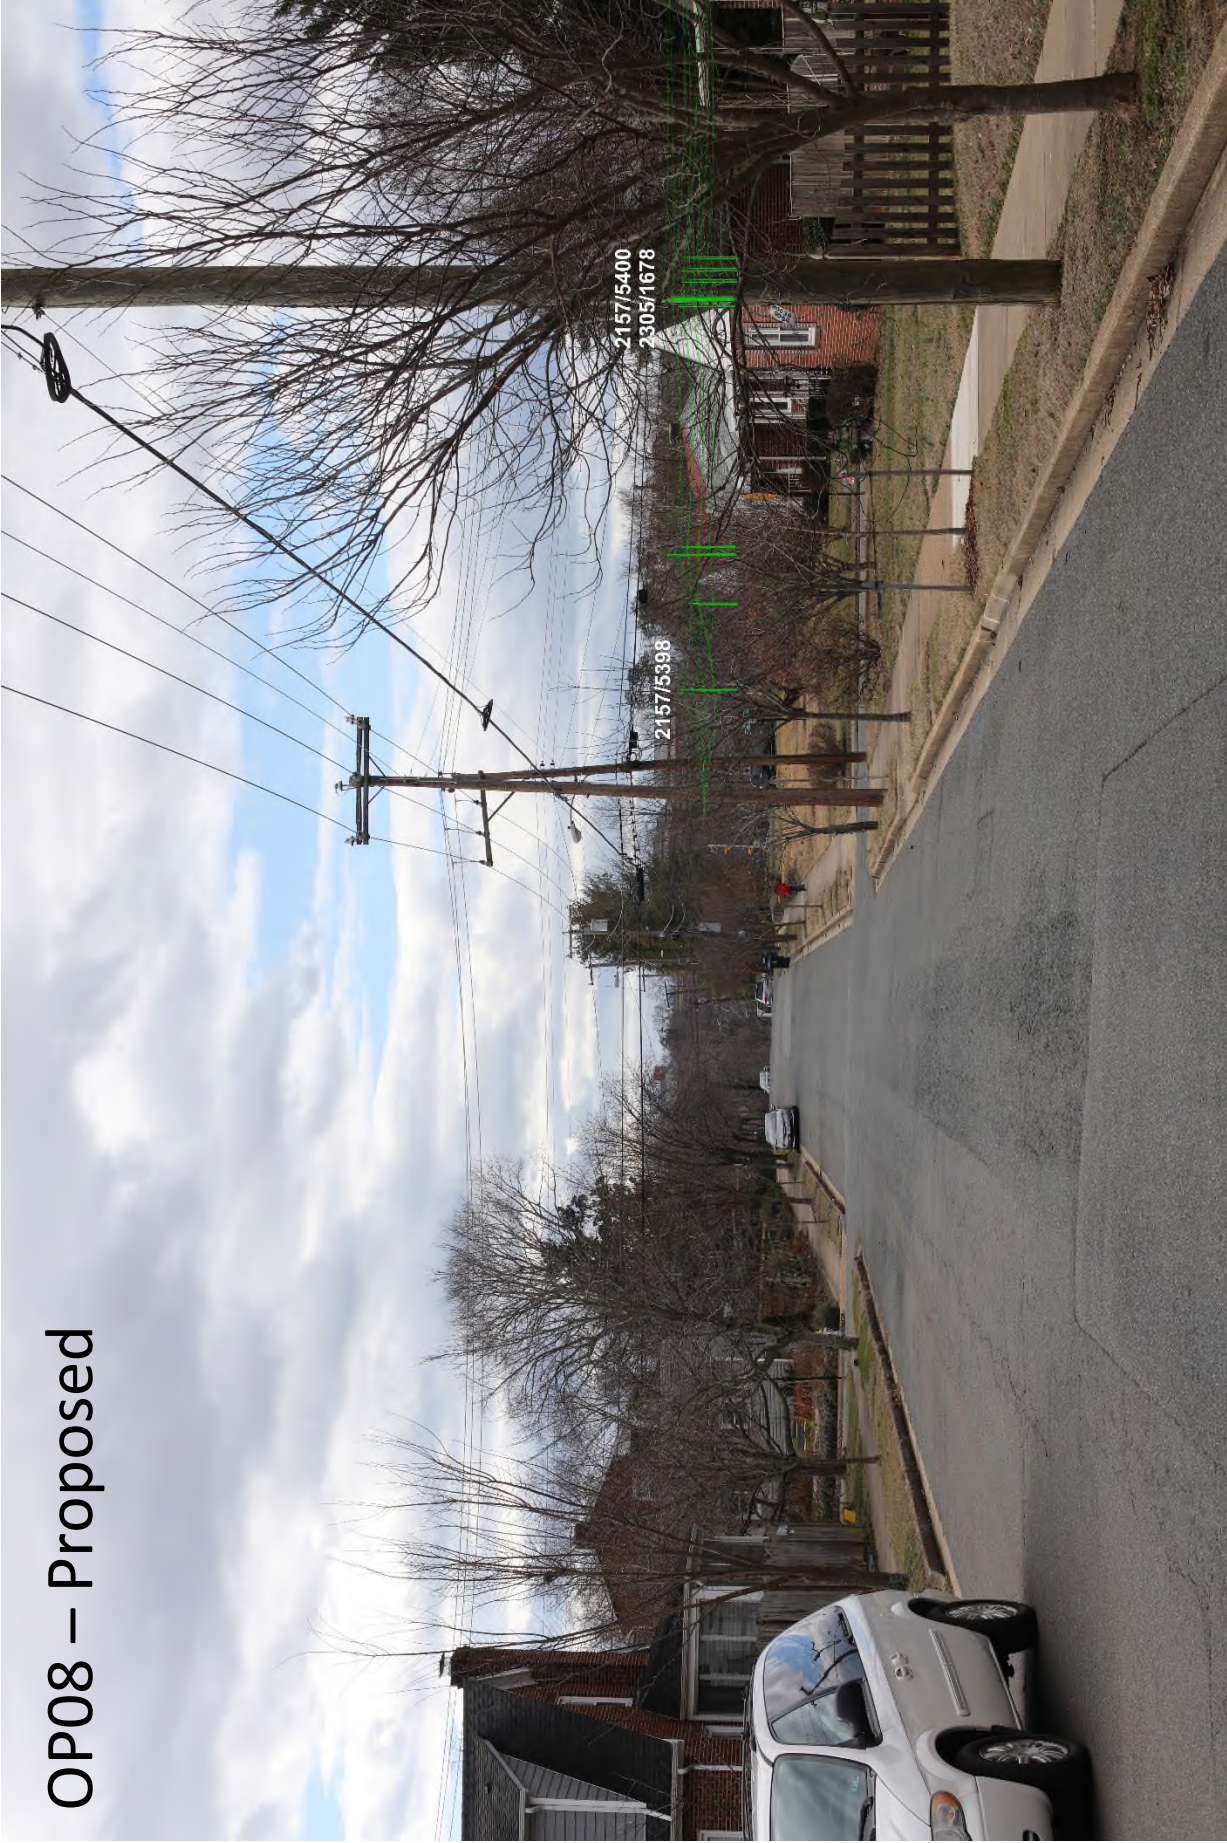
OP08 – Proposed

OP 8 Proposed
Elmhurst (DHR #111-5267)
