Re: Application of Virginia Electric and Power Company for Approval and Certification of Electric Transmission Facilities: Fredericksburg-Aquia Harbour Lines #29, #2104, and #2157 Partial Rebuild – Case No. PUR-2024-00035.

Application, Appendix,
DEQ Supplement, Direct
Testimony and Exhibits of
Virginia Electric and Power
Company

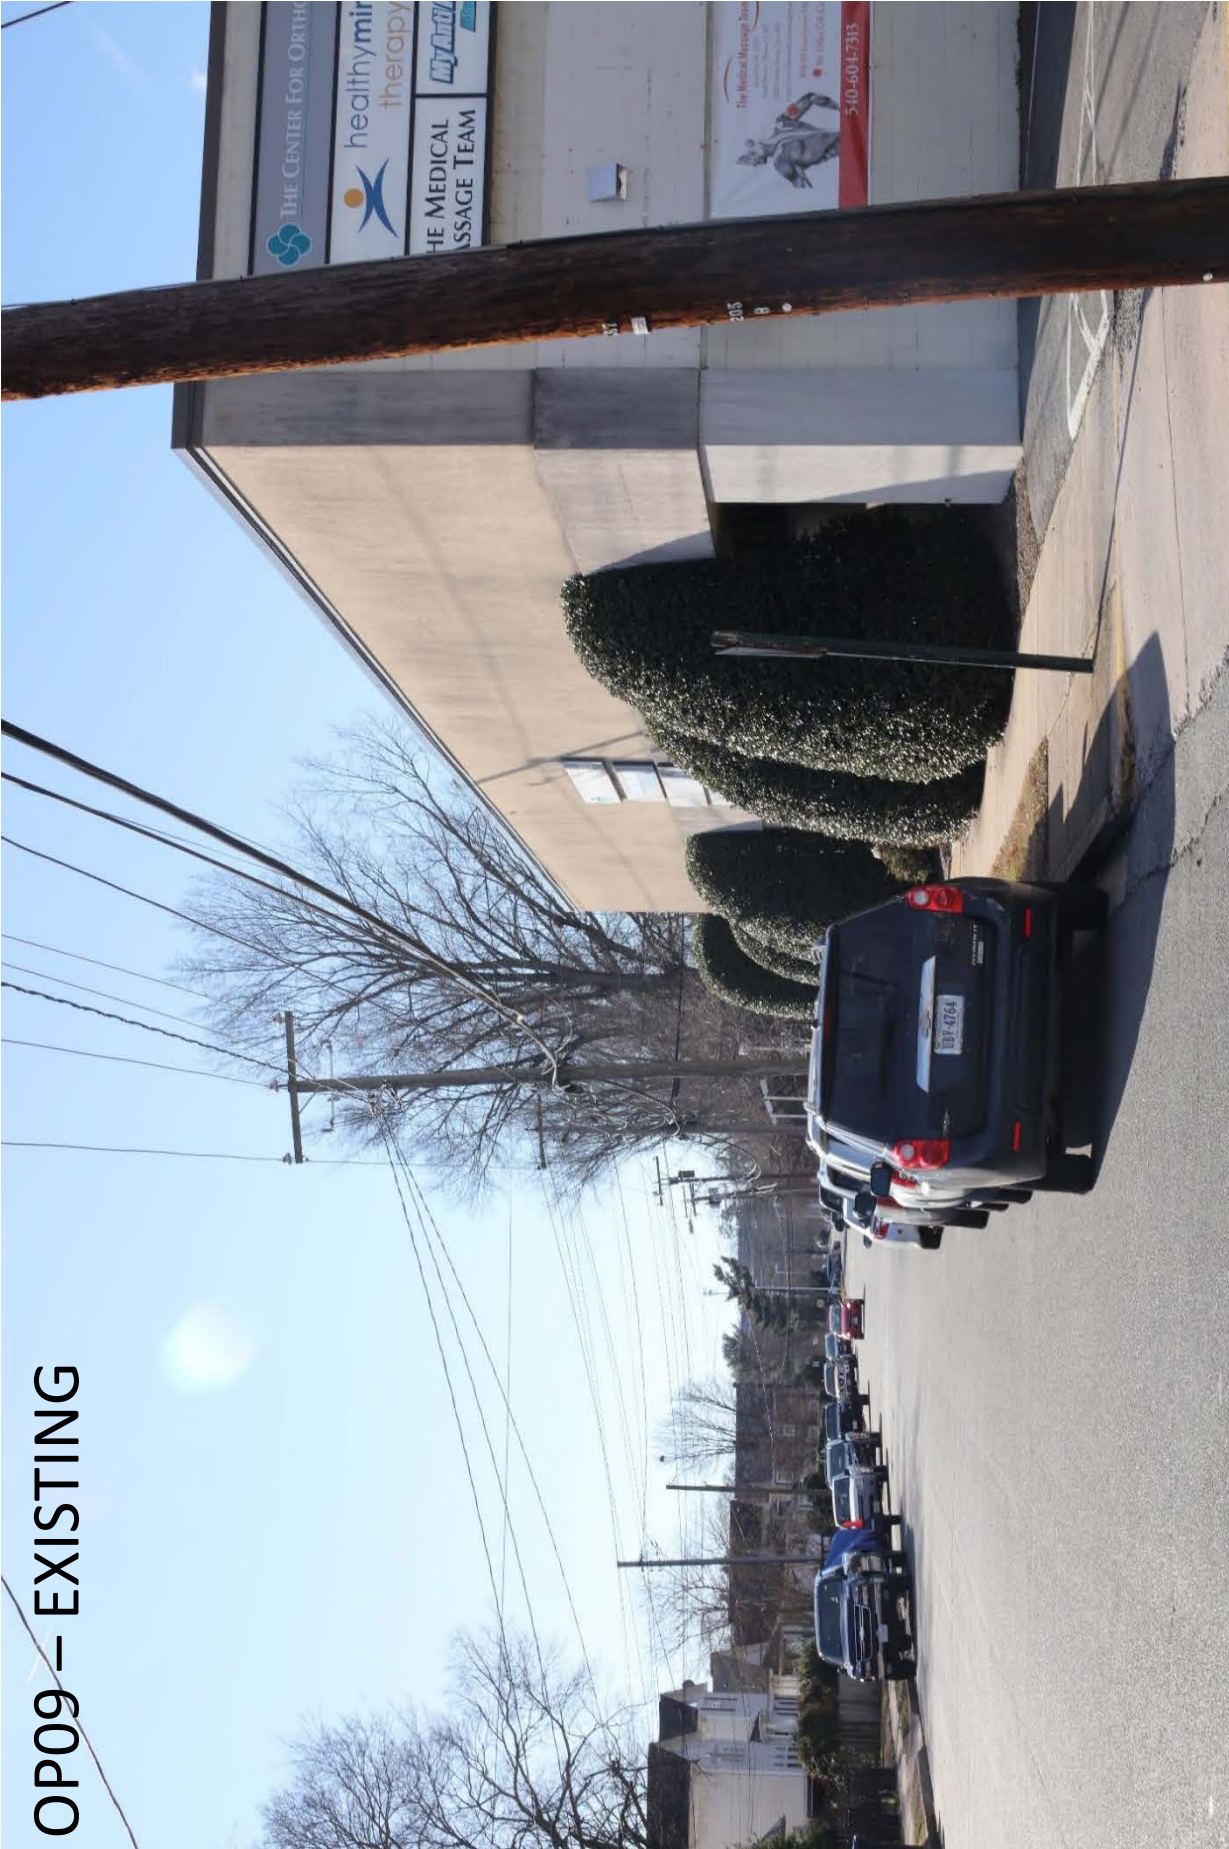
OP09 – EXISTING

OP 9 Existing
Carl's Frozen Custard (DHR #111-5007) & Battle of Fredericksburg I (DHR #111-5295)

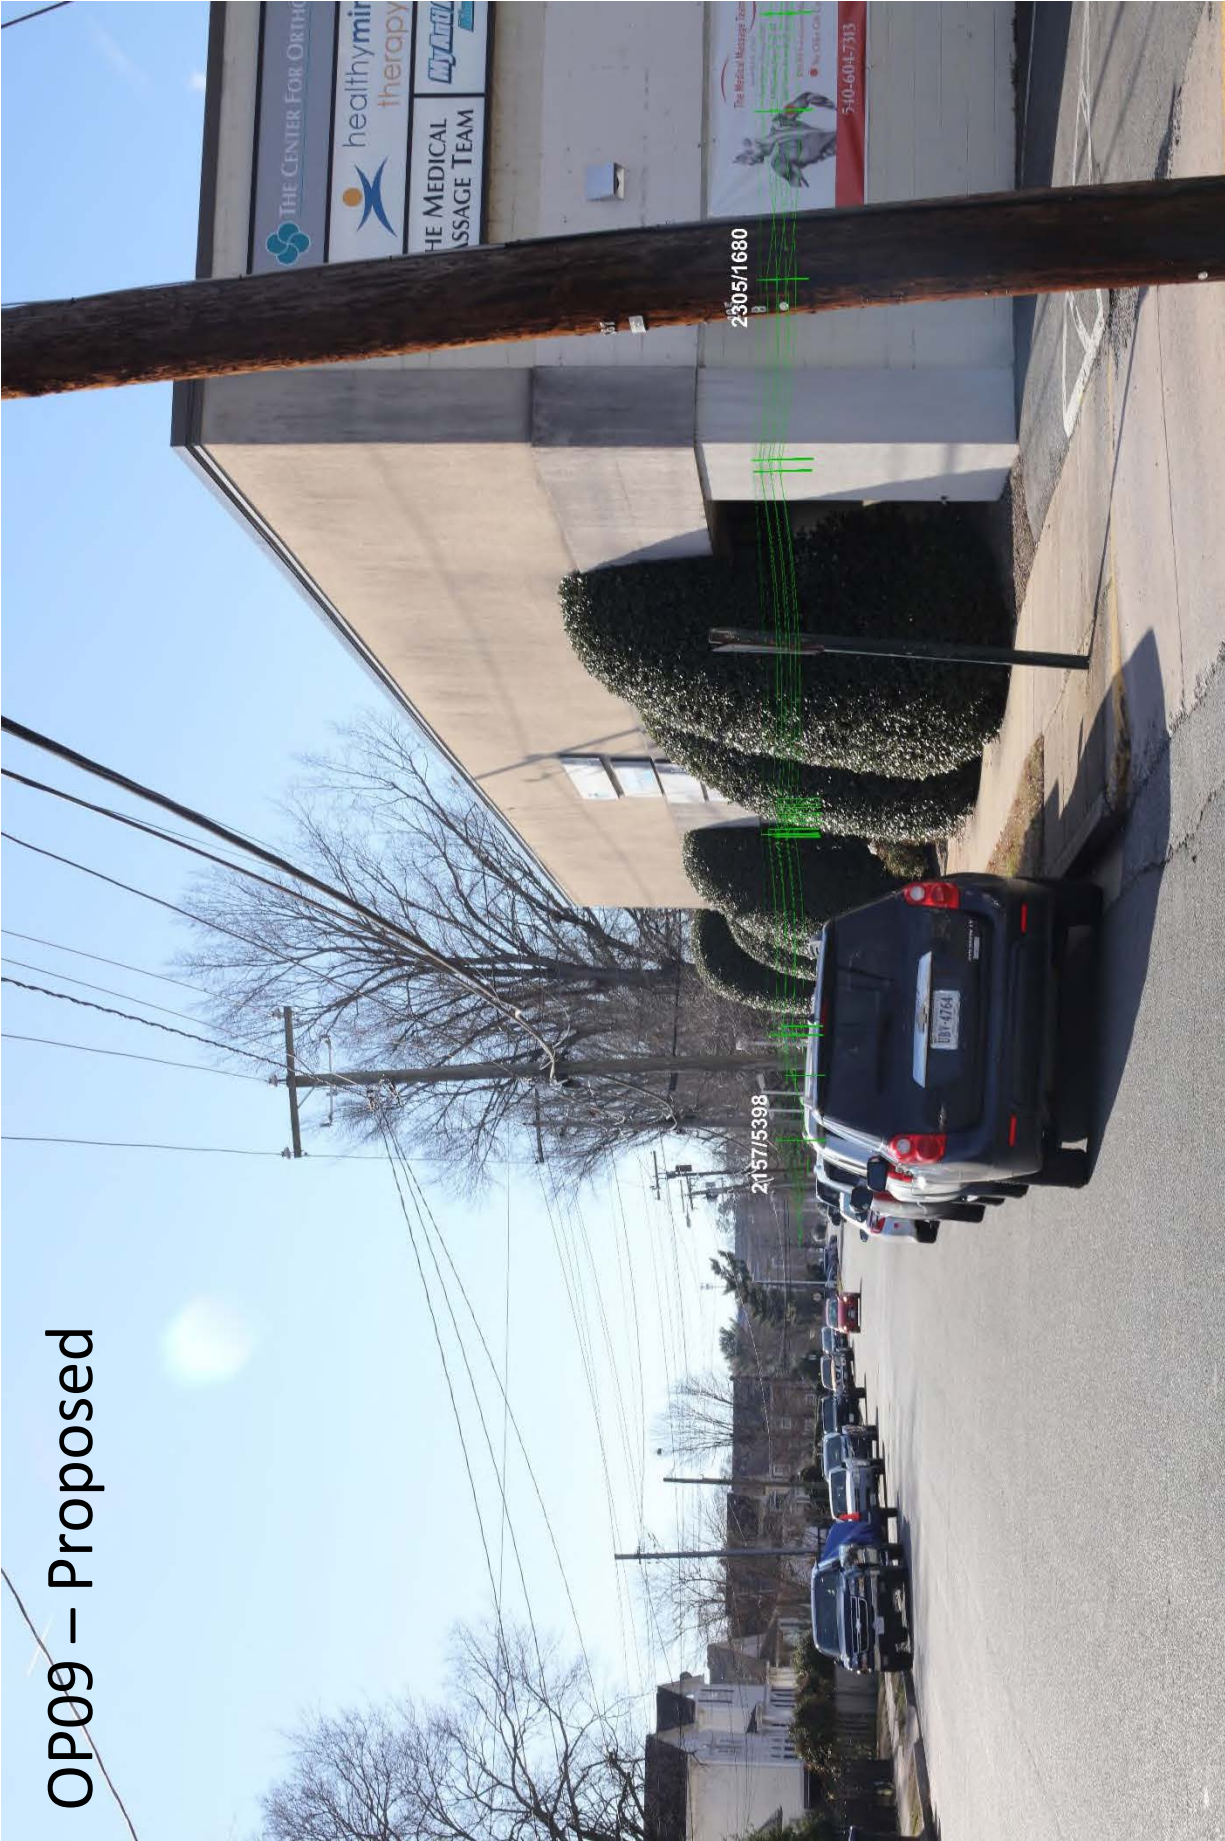
OP09 – Proposed

OP 9 Proposed
Carl's Frozen Custard (DHR #111-5007) &
Battle of Fredericksburg I (DHR #111-5295)

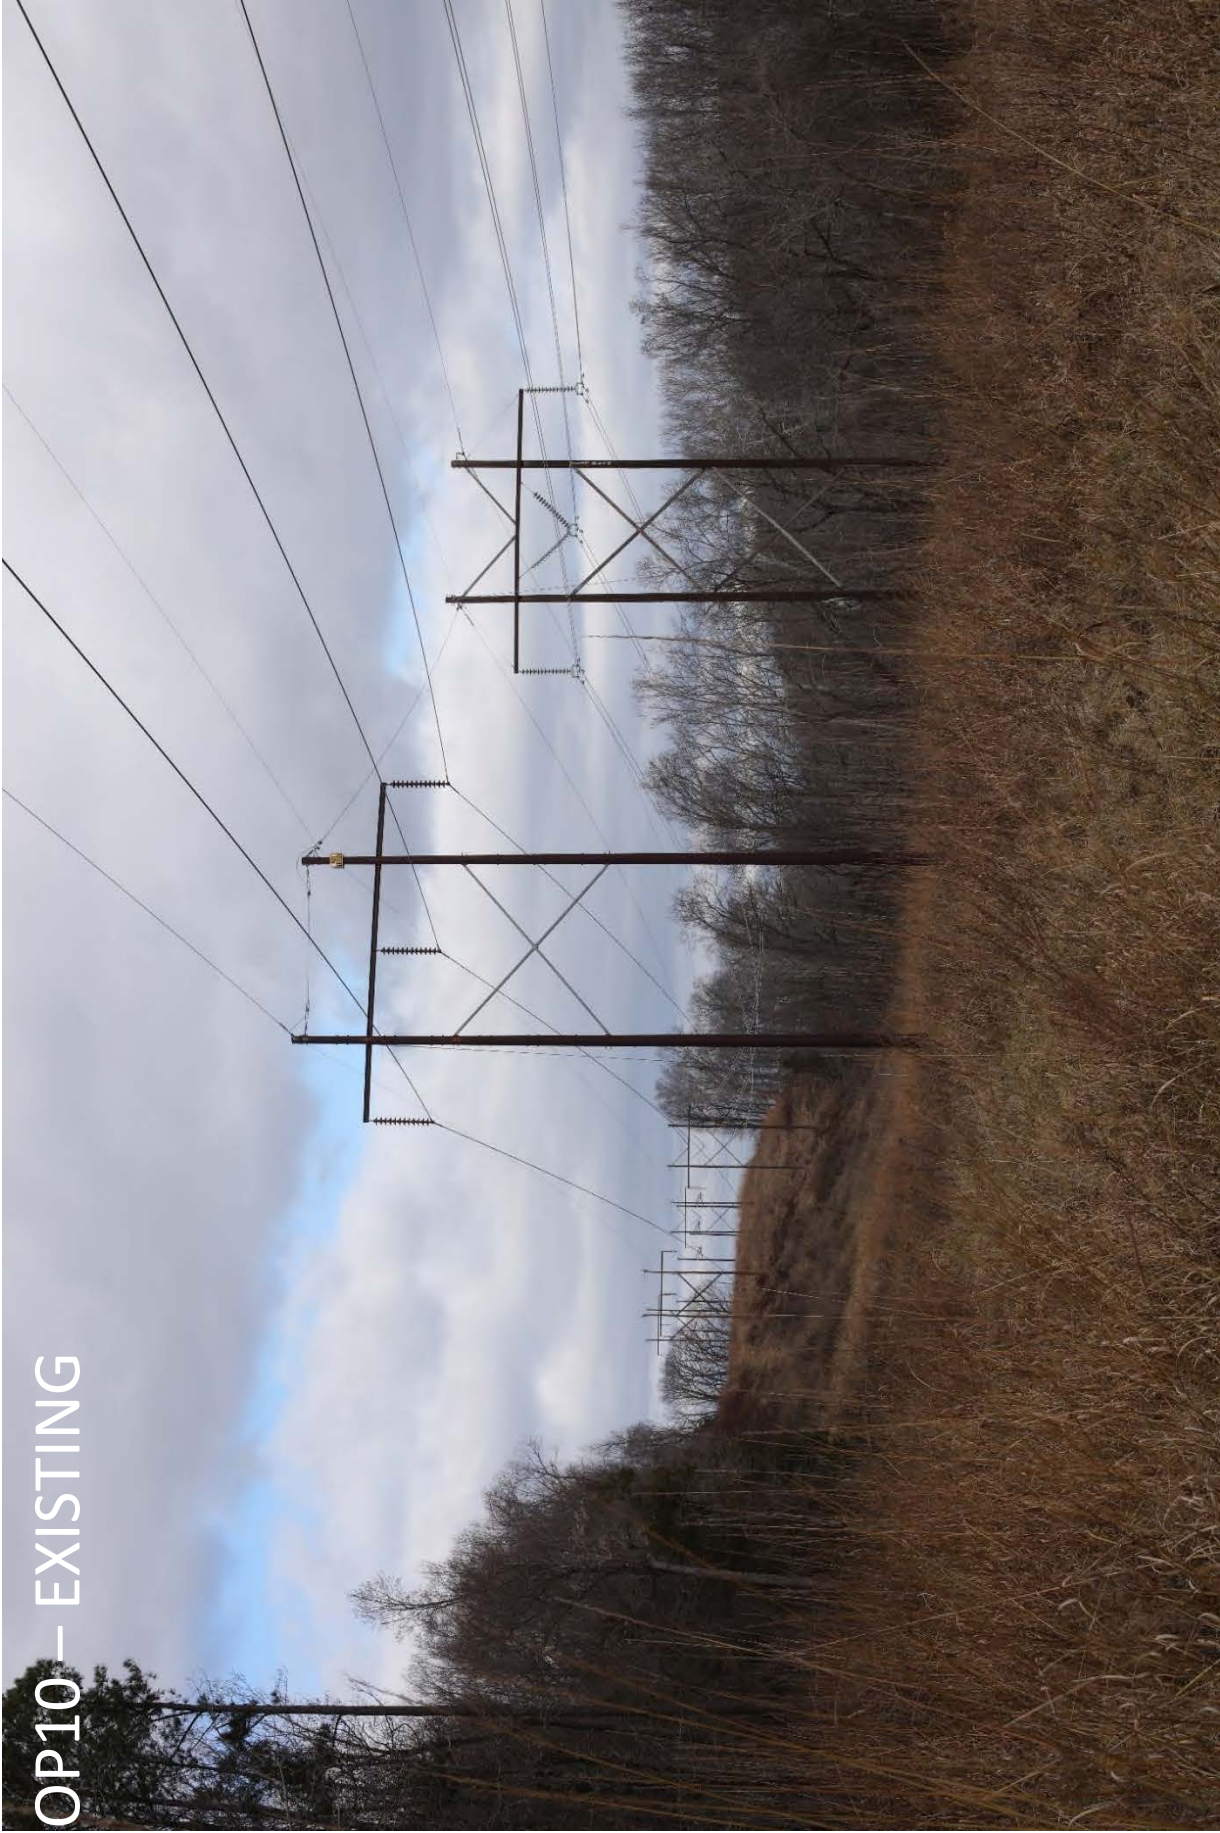
OP10 - EXISTING

OP 10 Existing
Fredericksburg and Spotsylvania Battlefields NMP (DHR #111-0174), Fall Hill (DHR #111-0149),
Battle of Fredericksburg I (DHR #111-5295), Battle of Fredericksburg II (DHR #111-5296) &
Salem Church Battlefield (DHR #088-5181)

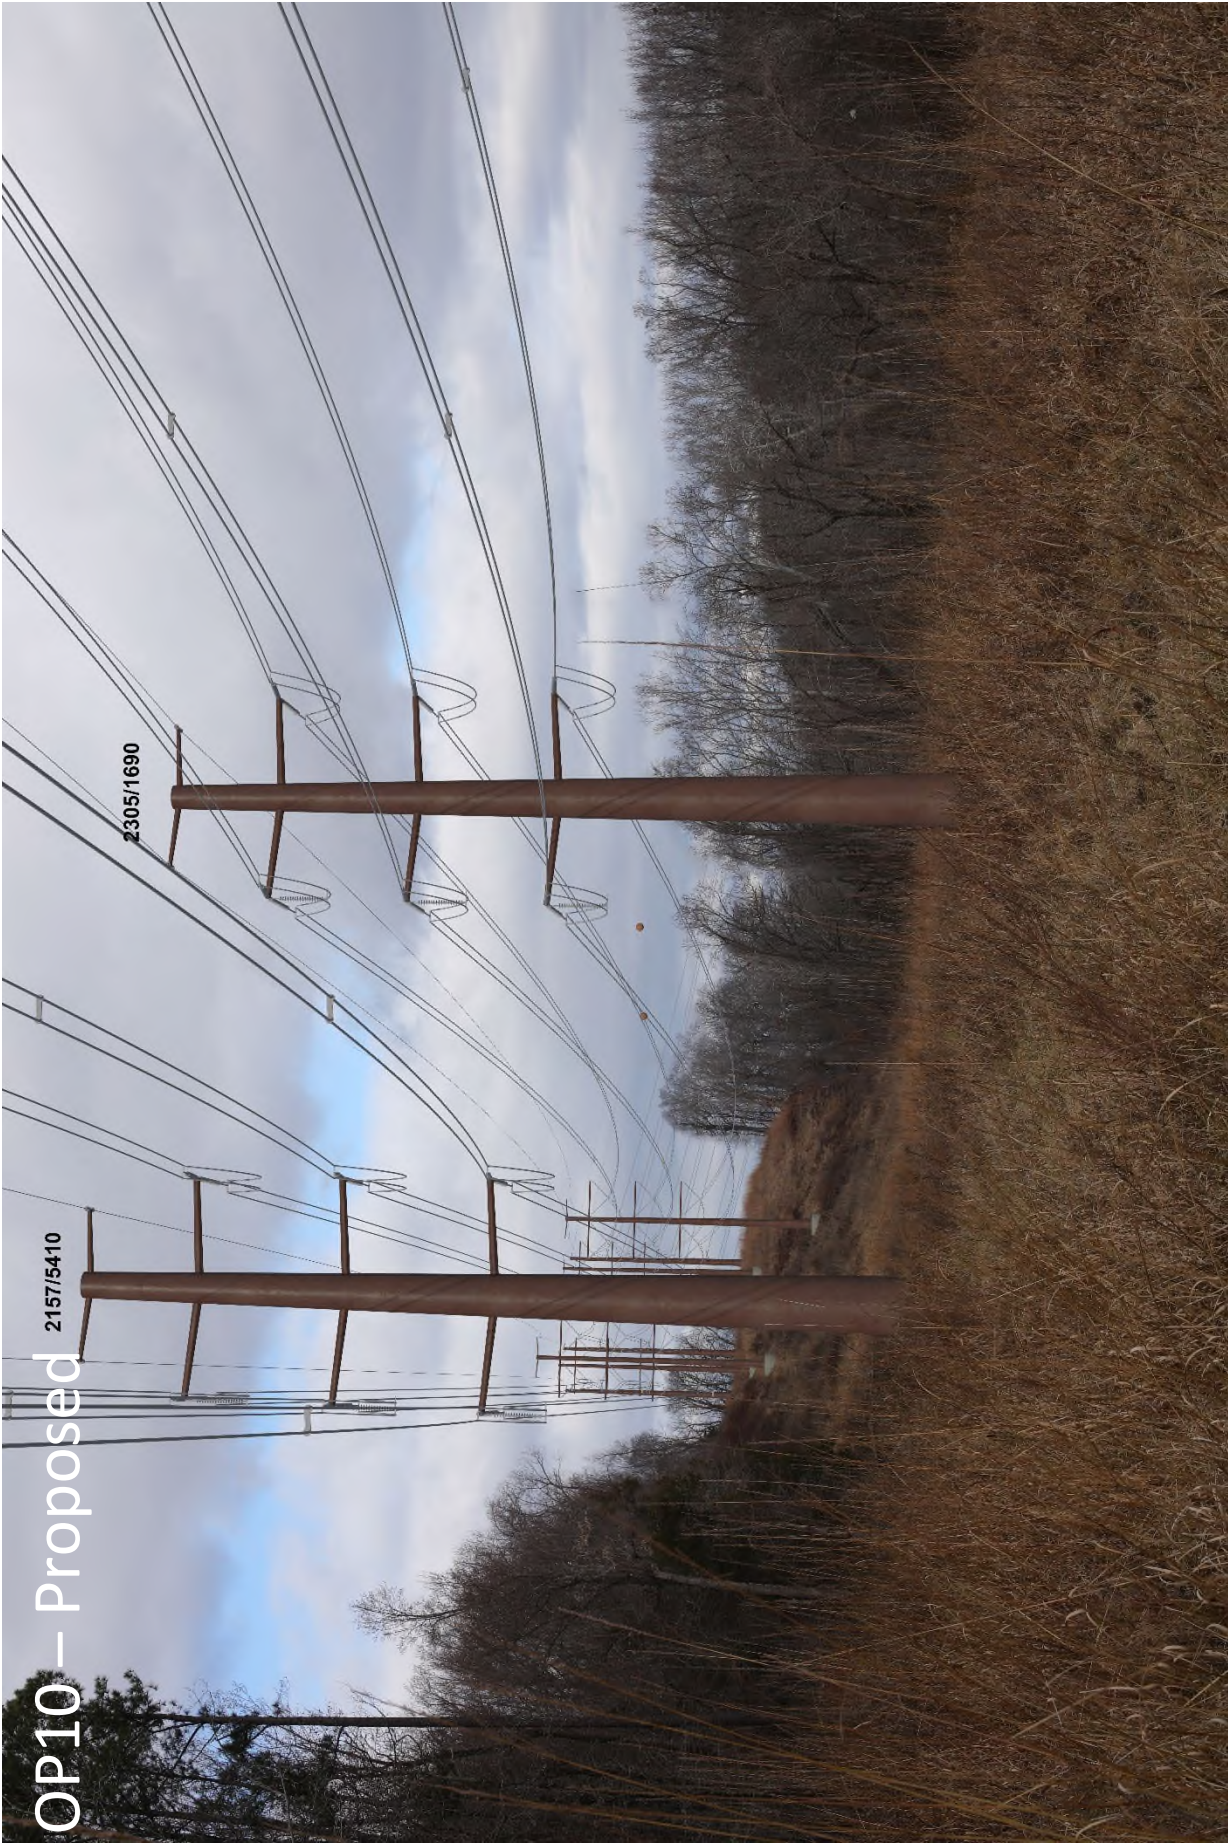
OP10 – Proposed

OP 10 Proposed
Fredericksburg and Spotsylvania Battlefields NMP (DHR #111-0174), Fall Hill (DHR #111-0149),
Battle of Fredericksburg I (DHR #111-5295), Battle of Fredericksburg II (DHR #111-5296 &
Salem Church Battlefield (DHR #088-5181)

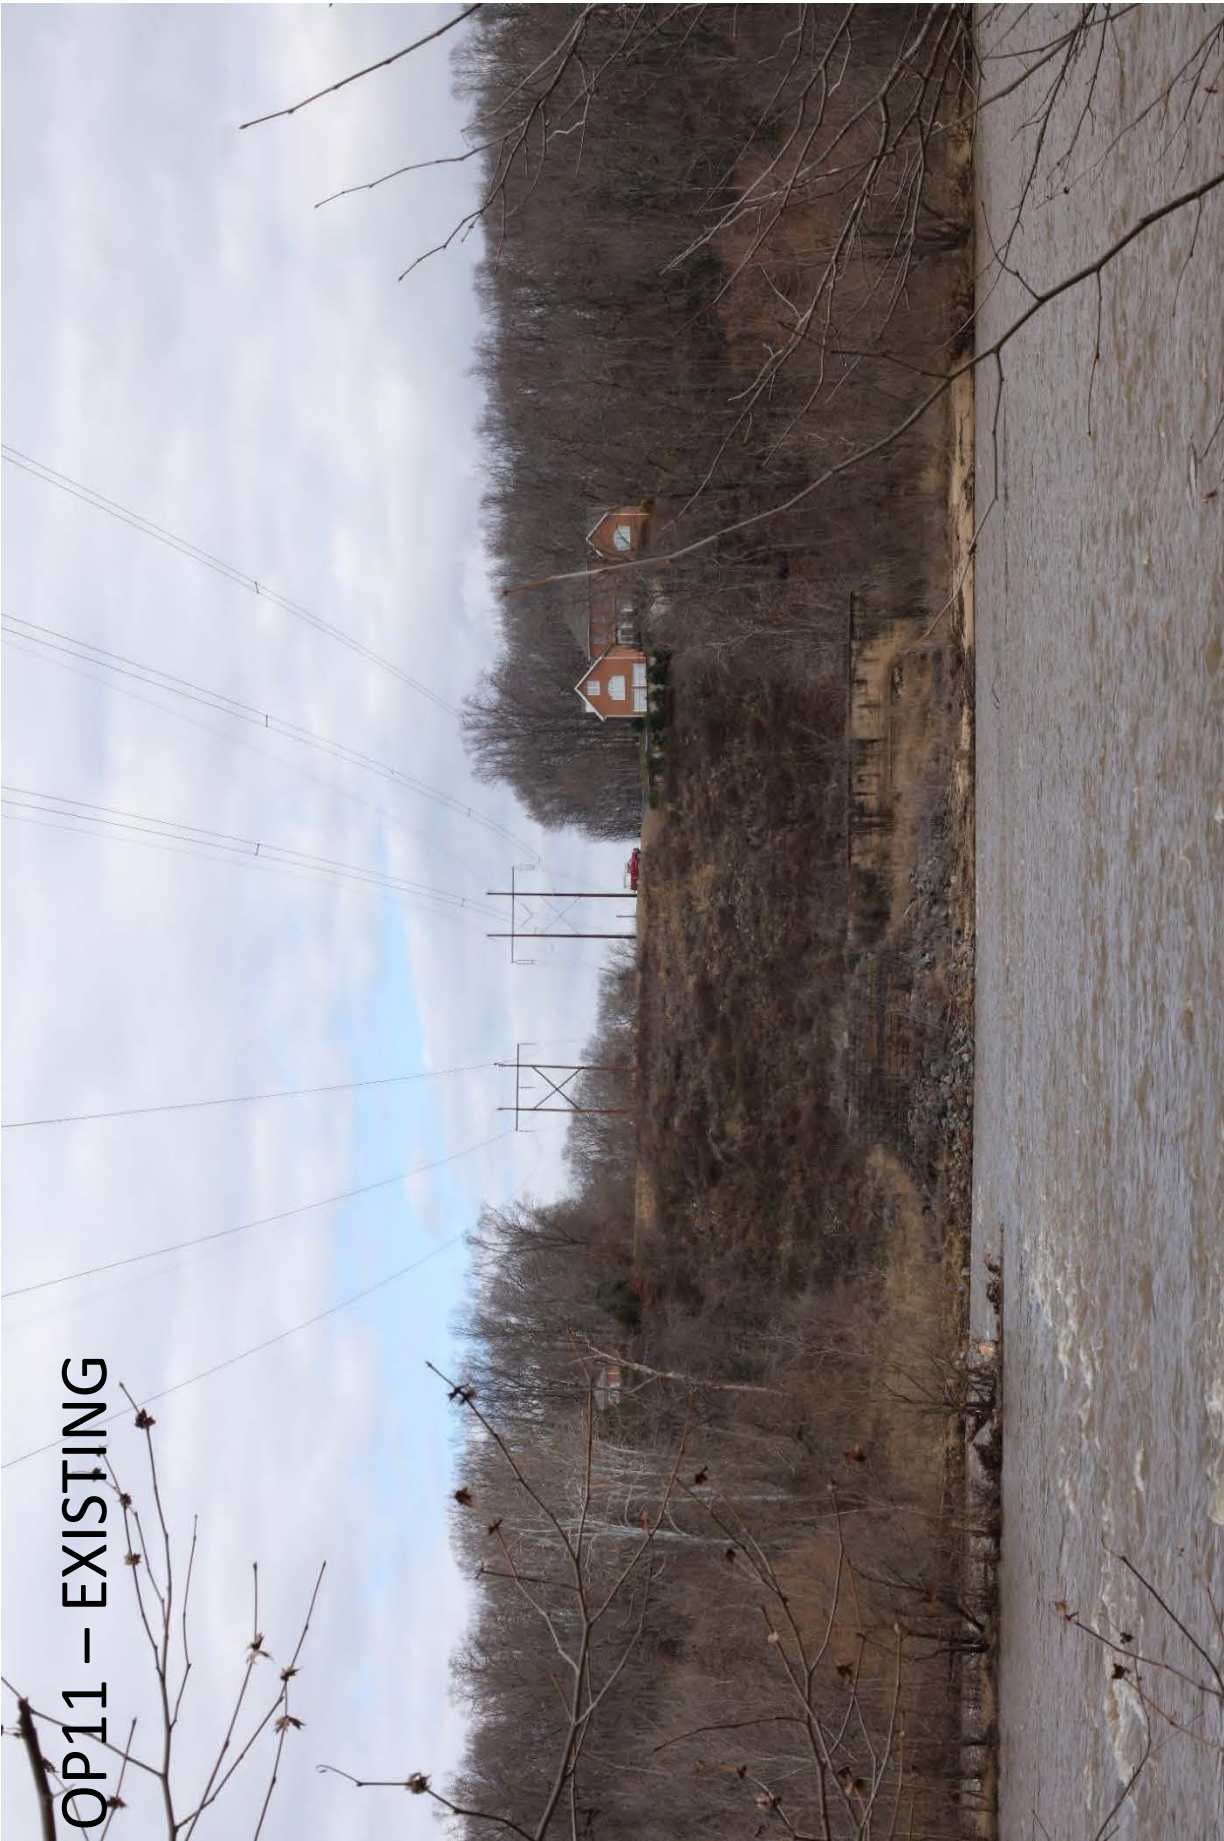
OP 11 Existing
Rappahannock Canal (DHR #111-5297) & Battle of Fredericksburg II (DHR #111-5296)
