Re: Application of Virginia Electric and Power Company for Approval and Certification of Electric Transmission Facilities: Aquia Harbour – Possum Point Lines #29, #252, #2083, and #568 Rebuild – Case No. PUR-2024-00142.

Dominion Energy has identified the need to rebuild approximately 12.0 miles of 115kV Line #29 and 230kV Line #252 between Aquia Harbor to Possum Point and the approximately 1.7 miles of 115kV tap line to Quantico Substation based on the Company's End of Life Criteria.

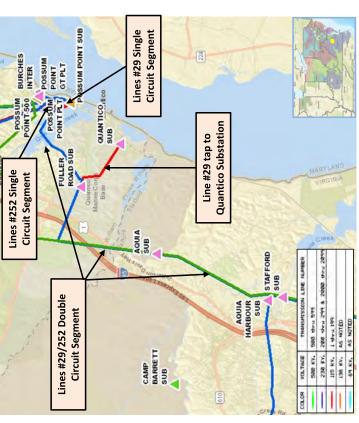
Dominion Energy has identified the need to rebuild approximately 12.0 miles of 115kV Line #29 and 230kV Line #252 between Aquia Harbour Switching Station to Possum Point and the approximately 1.7 miles of 115kv tap line to Quantico Substation based on the Company's End of Life Criteria.

- Lines #29 and #252 were mostly constructed on double circuit CORTEN steel structures in 1978. The 115 kV tap line to Quantico Substation was constructed on wood structures in 1978.
- A recent field inspection indicated continued degradation of structures where steel members are delaminating and cracking, and wood structures are showing woodpecker damages.
- Industry guidelines indicate equipment life for wood structures is 35-55 years, conductor and connectors are 40-60 years, and porcelain insulators are 50 years. A 50-year cycle for CORTEN steel structures is often cited.
  - Line #29 is the only feed to the customers at Quantico Substation.

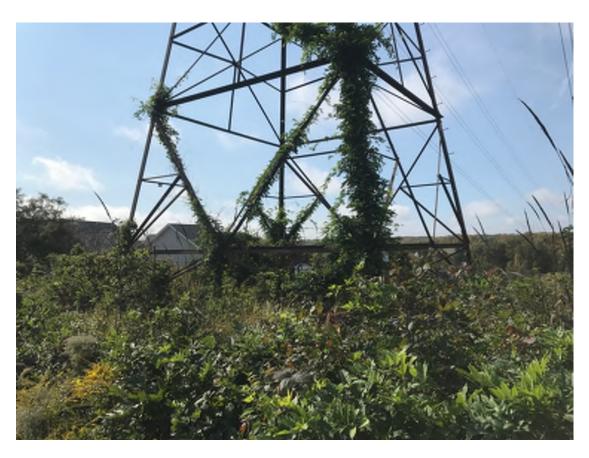
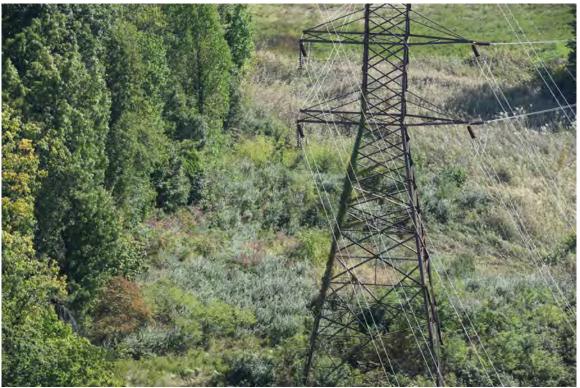
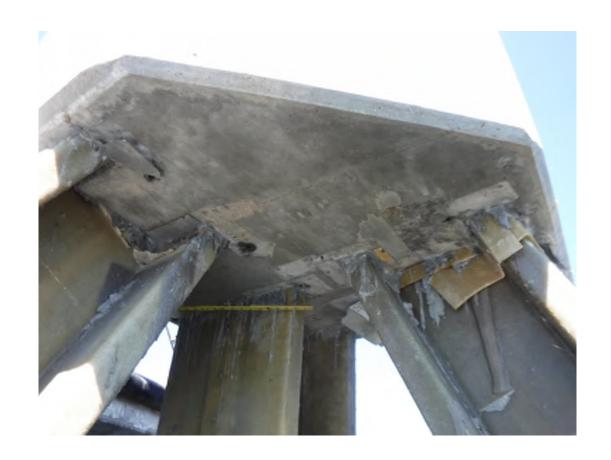
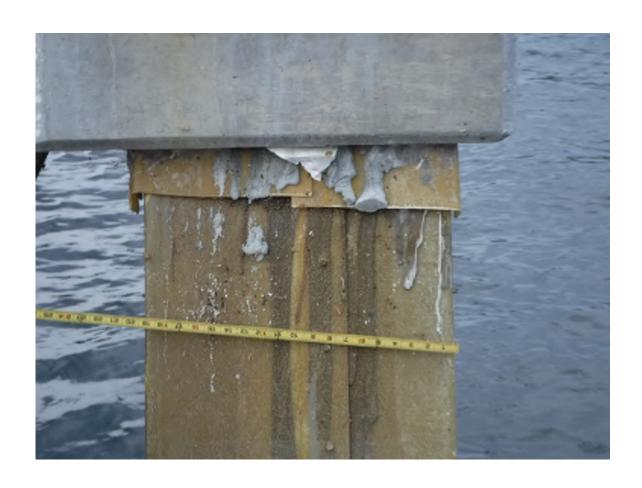
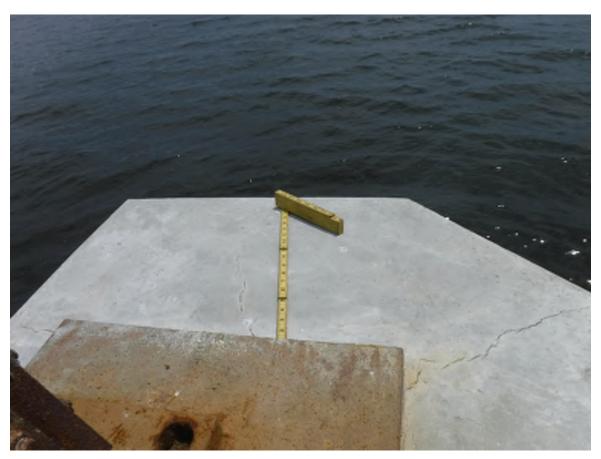
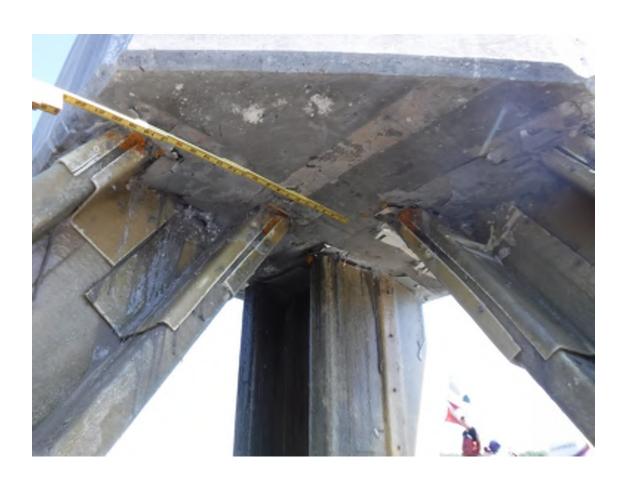
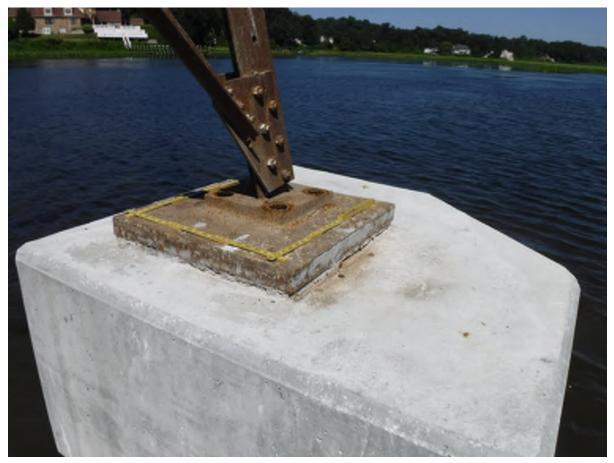
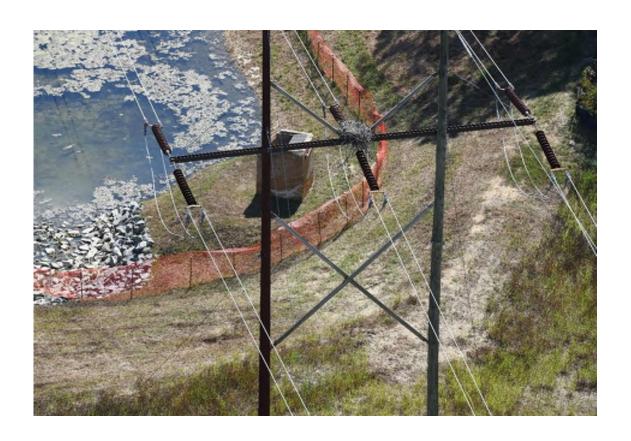
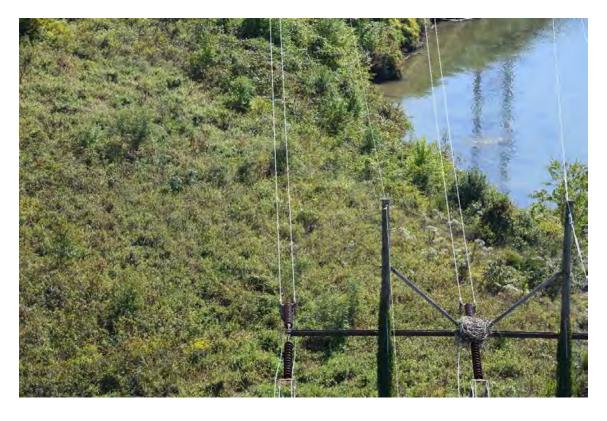
See <u>Attachment I.L.1</u> for photographs of the deterioration of structures on Lines #29 and #252. Section I.A provides further detail on the condition of these deteriorating structures. See <u>Attachment I.L.2</u> for sample inspection records of Lines #29 and #252.

- Lines #29 and #252 were mostly constructed on double circuit CORTEN steel structures in 1978. The 115kV tap line to Quantico Substation was constructed on wood structures in 1978.
- A recent field inspection indicated continued degradation of structures where steel members are delaminating and cracking, and wood structures are showing woodpecker damage.
- Industry guidelines indicate equipment life for wood structures is 35-55 years, conductor and connectors are 40-60 years, and porcelain insulators are 50 years. A 50-year cycle for CORTEN steel structures is often cited.
  - Line #29 is the only feed to the customers at Quantico Substation.

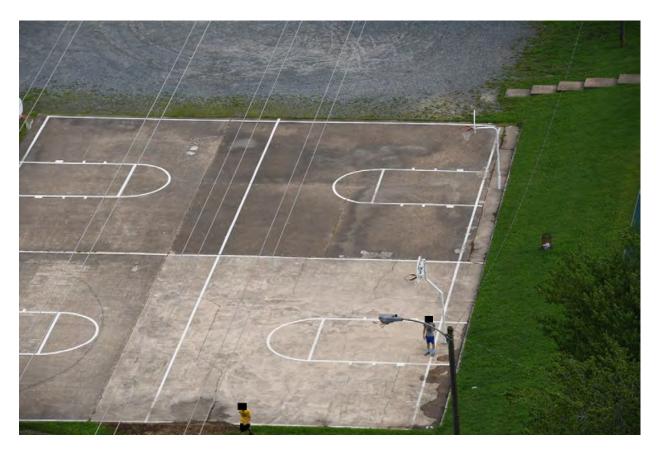
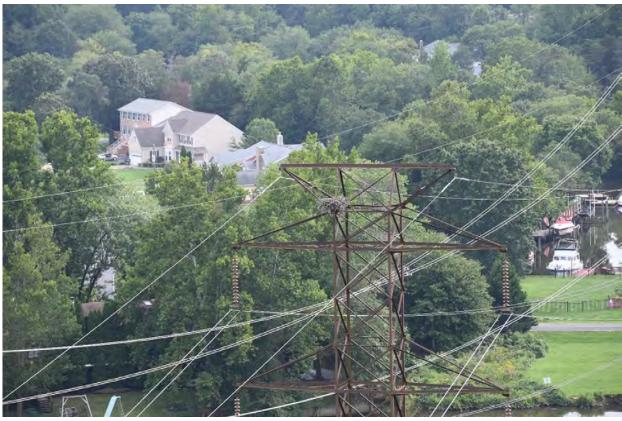
Line 29 and 252

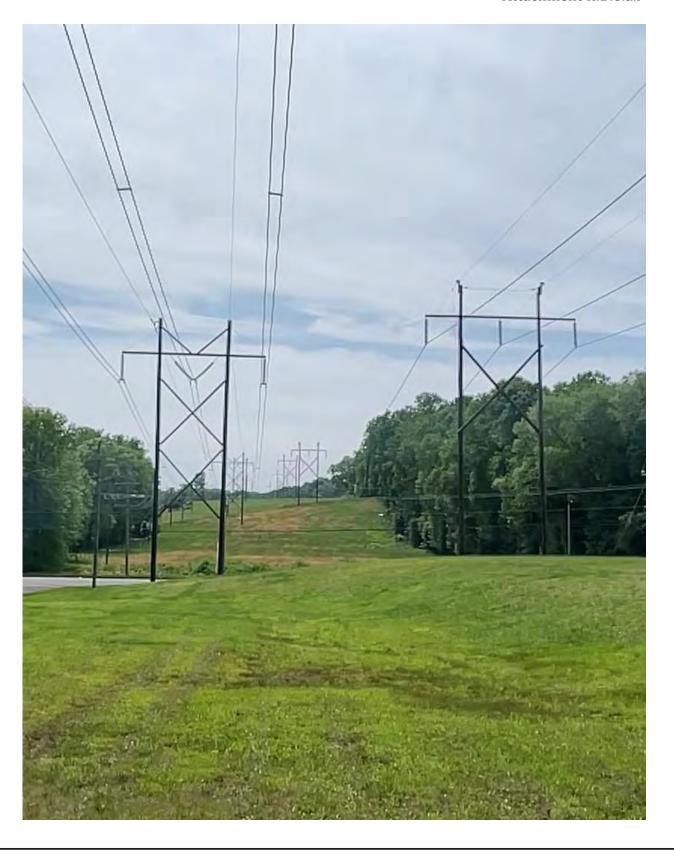
Existing Structure Type: 230kV (Left) And 115kV (Right) Single Circuit Wood H-Frame (Tangent)

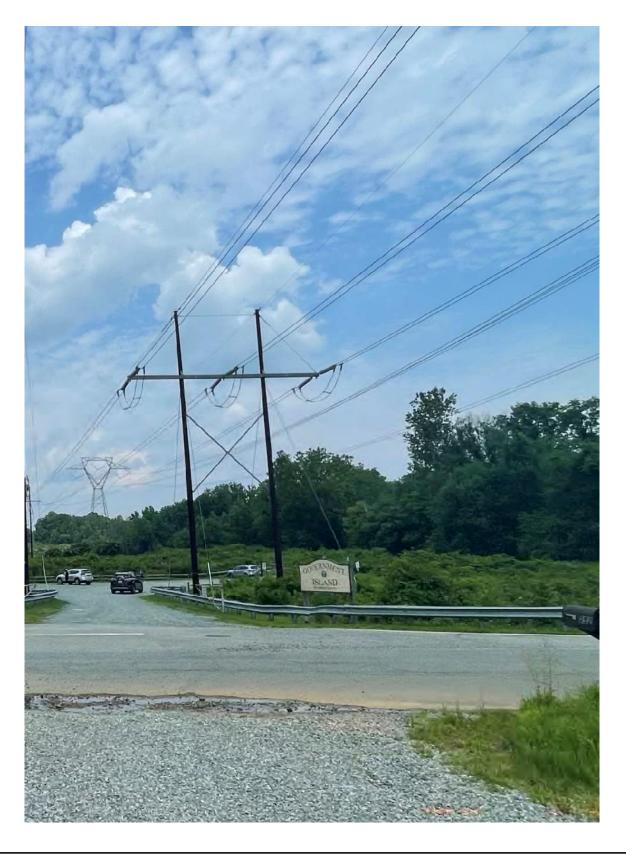
Existing Structure Type: 115kV (Left) And 230kV (Right) Single Circuit Wood 3-Pole (DDE)

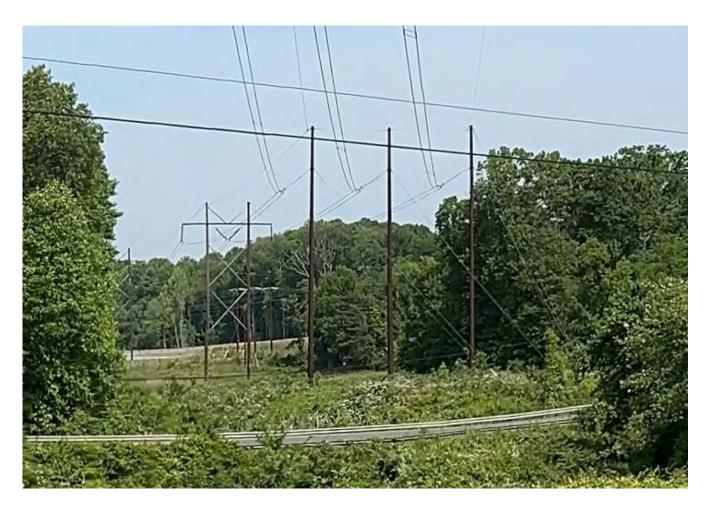
Existing Structure Type: 230kV Single Circuit Steel H-Frame (DDE)

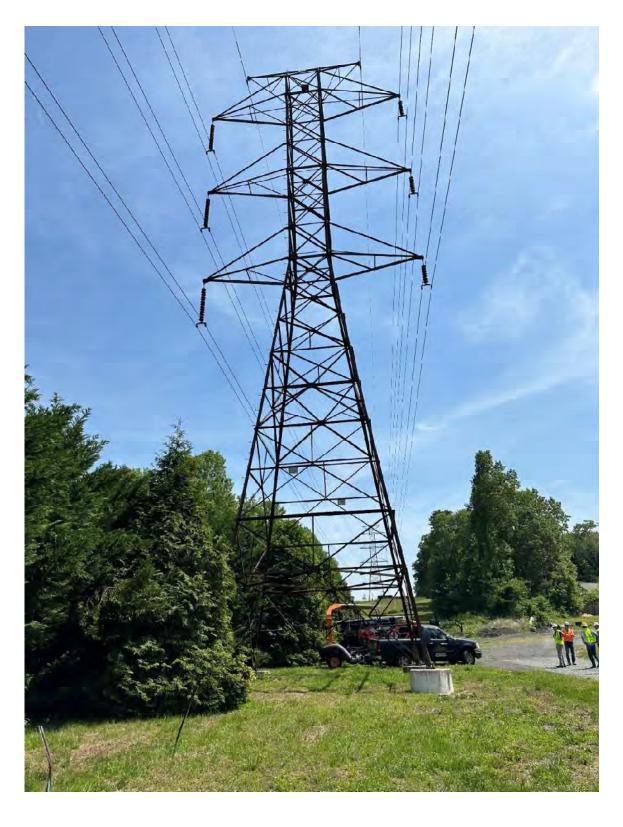
Existing Structure Type: 230kV Single Circuit Steel 3-Pole (DDE)

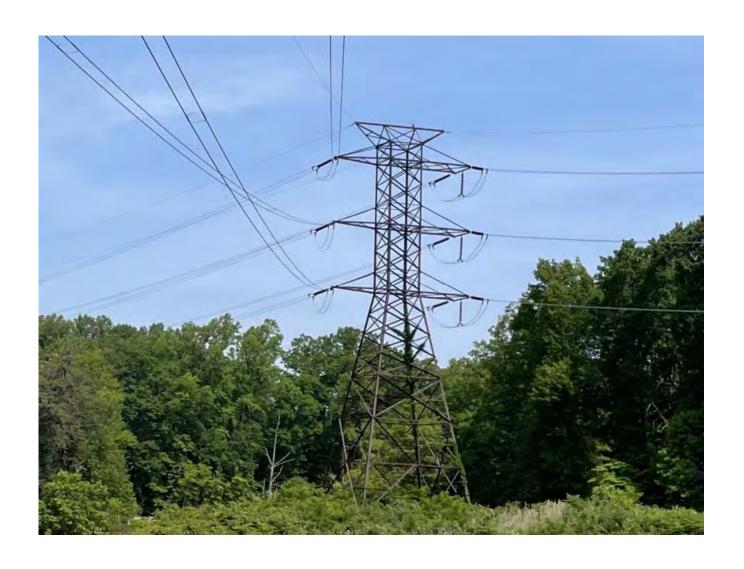
Existing Structure Type: 230kV Double Circuit Steel Tower (Tangent)

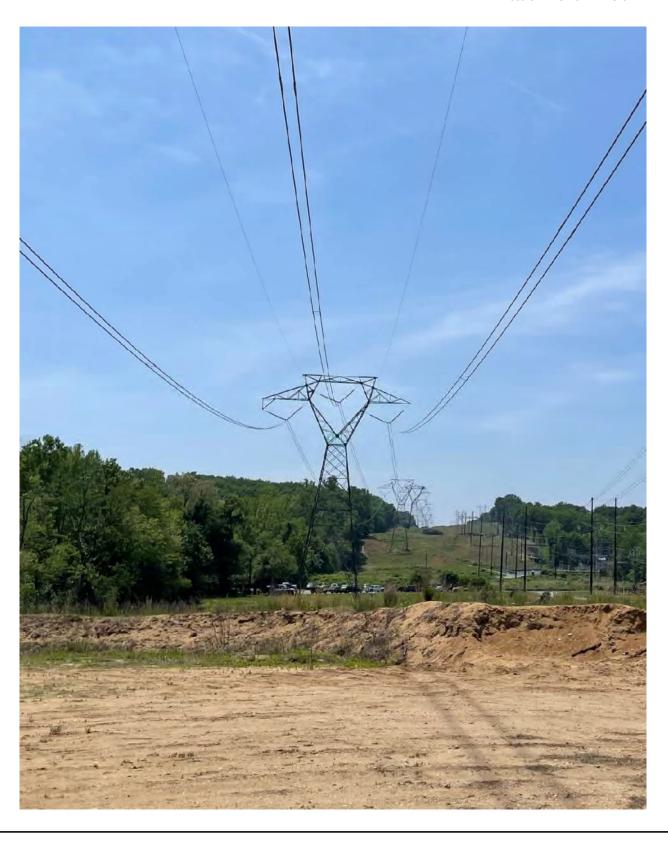
Existing Structure Type: 230kV Double Circuit Steel Tower (DDE)

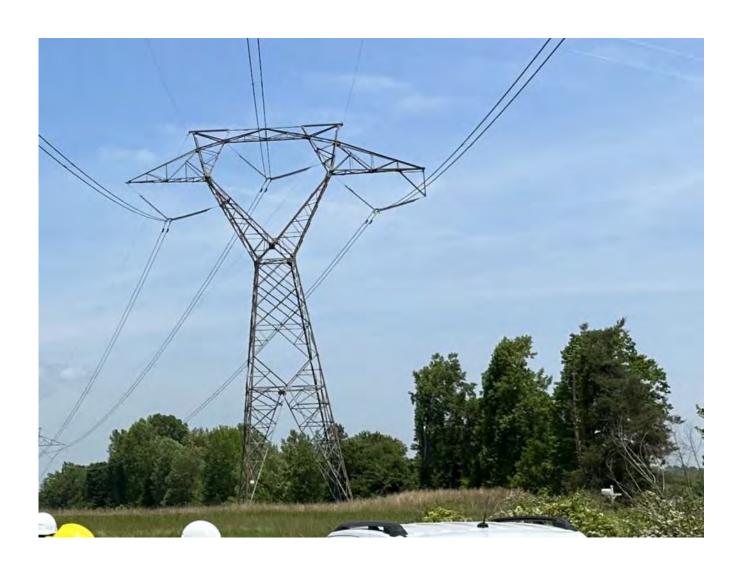
Existing Structure Type: 500kV Single Circuit Steel Tower (Tangent)

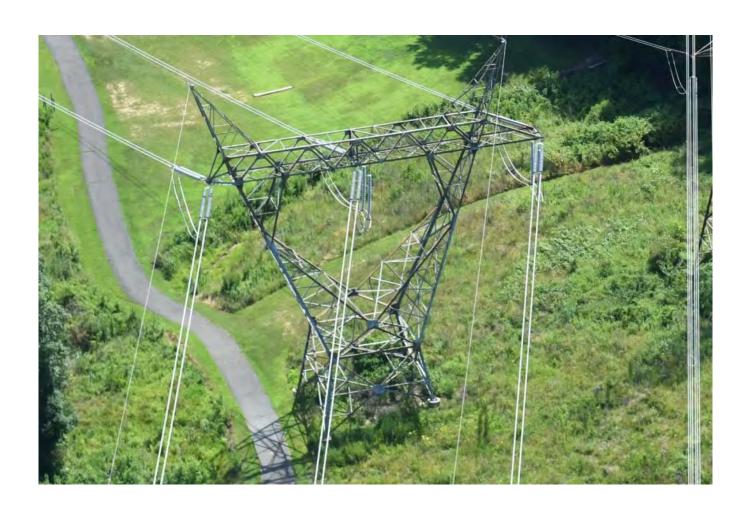
Existing Structure Type: 500kV Single Circuit Steel Tower (DDE)

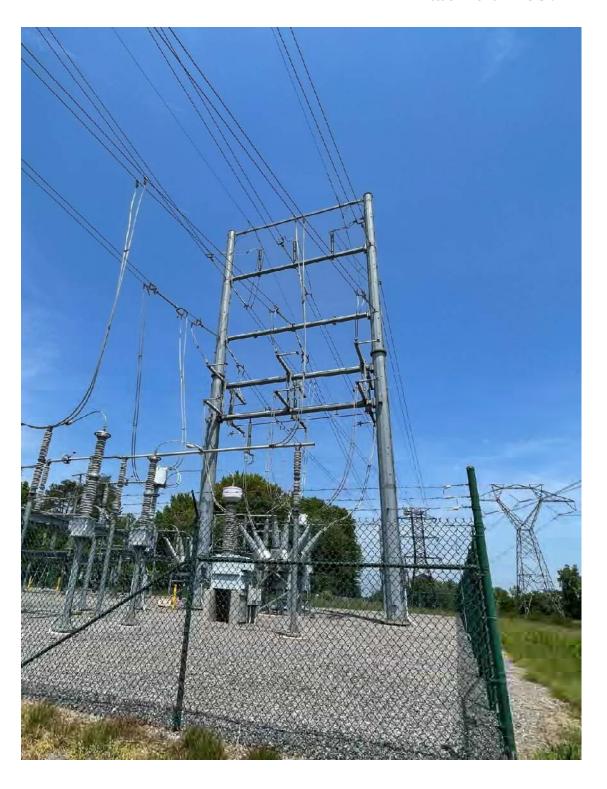
Proposed Structure Type: 230kV Single Circuit Steel Monopole (Tangent)
