*Application of Virginia Electric and Power Company for approval and certification  
of electric transmission facilities: 500 kV Septa-Yadkin Line #579 Rebuild and  
230 kV Suffolk-Thrasher Line #2110 Partial Rebuild*  
**Case No. PUR-2025-00104**

SEPTA-YADKIN 500 kV LINE #579  
REBUILD AND SUFFOLK-  
THRASHER 230 kV LINE #2110  
PARTIAL REBUILD

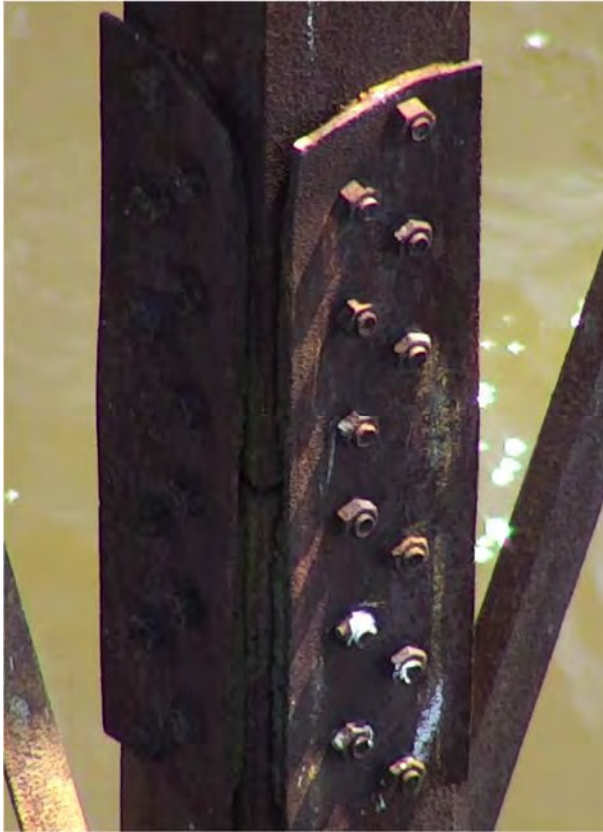
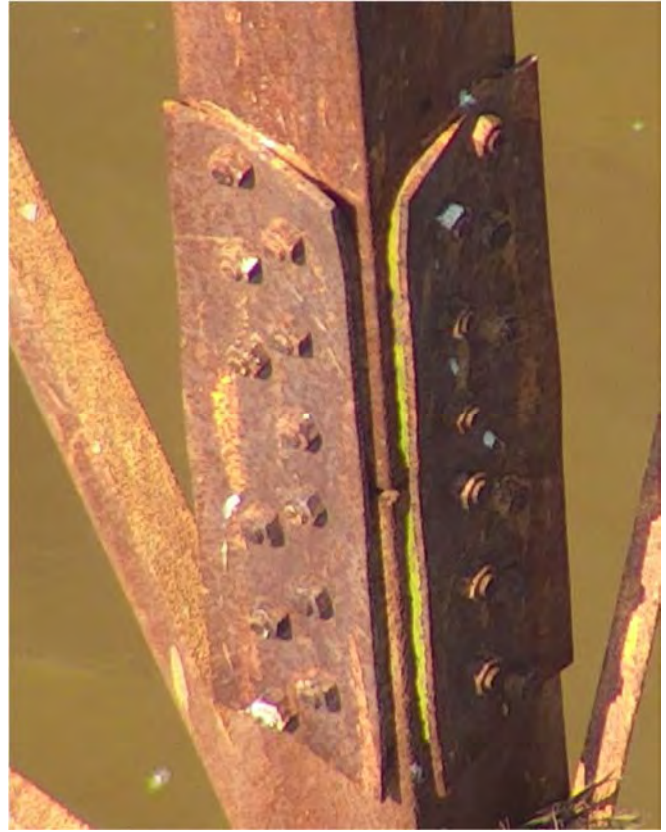
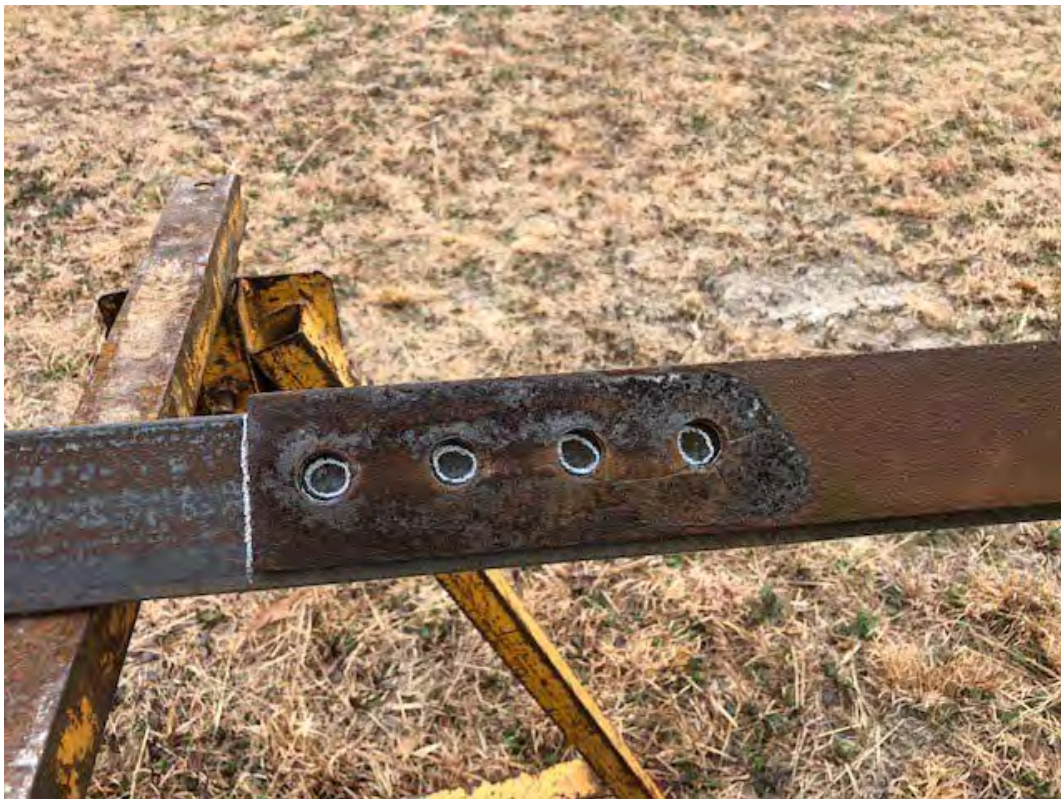
**Severe Packout & Steel Damage**

Extensive rehab was conducted in 2022 under project 58408V70. Rehabbing corten lines on a 12 year cycle. Currently there are a total of thirteen (13) structure-related open notifications (approximately %7 of structures).

Response: The proposed Rebuild Project will replace aging infrastructure that is approaching the end of its service life. See Attachment I.L.1 for an overview of the rebuild, representative pictures of the deterioration of structures supporting Line #579, and non-structural related outstanding notifications. See also Attachment I.L.2 for the Transmission Specification Book containing the COR-TEN® Tower Monitoring Program for Septa-Yadkin Line #579 and Attachment I.L.3 for Weathering Steel Tower Inspection/Rehabilitation Data Sheets.

Located between Septa and Yadkin Substations, Line #579 is at its end of service life. Originally constructed in 1985, TL579 was installed on weathering (corten) steel lattice towers. Industry guidelines indicate TL579 towers are at their end of serviceable life. Rebuild project 992993 has been initiated to assure Dominion Energy can maintain and improve reliable electric service to customers served by TL579. The proposed Rebuild Project will remove aging infrastructure, which the Company has determined is no longer cost-effective to continue to repair and replace on an individual basis and replace it with current 500 kV construction standards.

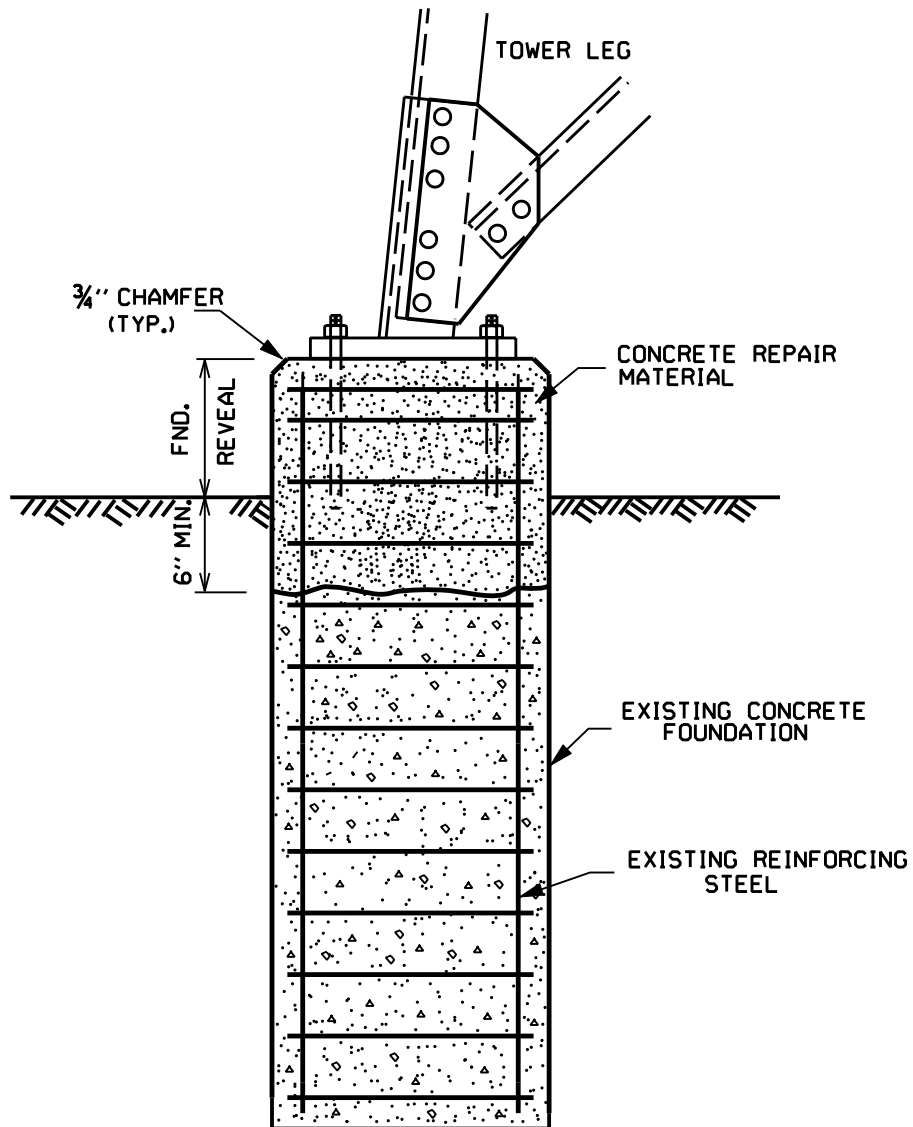
**FOUNDATION REPAIR & RESTORATION  
REPAIR "FR-4"**

- 1.) THE FOUNDATION REPAIR AND RESTORATION SHALL BE IN ACCORDANCE WITH THE ATTACHED WRITTEN SPECIFICATIONS.
- 2.) THE ALLOWABLE DEPTH OF THE REPAIR BELOW GROUND IS CLOSELY DEPENDENT ON THE HEIGHT OF THE FOUNDATION REVEAL. THE STRUCTURAL ENGINEER SHALL BE NOTIFIED OF THE HEIGHT OF THE FOUNDATION REVEAL PRIOR TO ANY REPAIR WORK.
- 3.) ONLY ONE FOUNDATION ON THE STRUCTURE SHALL BE REPAIRED AT ANY ONE TIME UNLESS OTHERWISE STATED.
- 4.) ALL FOUNDATION REPAIR WORK ON ANY ANGLE OR DOUBLE DEADEND STRUCTURE SHOULD BE CLOSELY COORDINATED THROUGH THE STRUCTURAL ENGINEER.
- 5.) THE TOWER LEG SHALL BE SUPPORTED PRIOR TO REMOVING DETERIORATED CONCRETE.

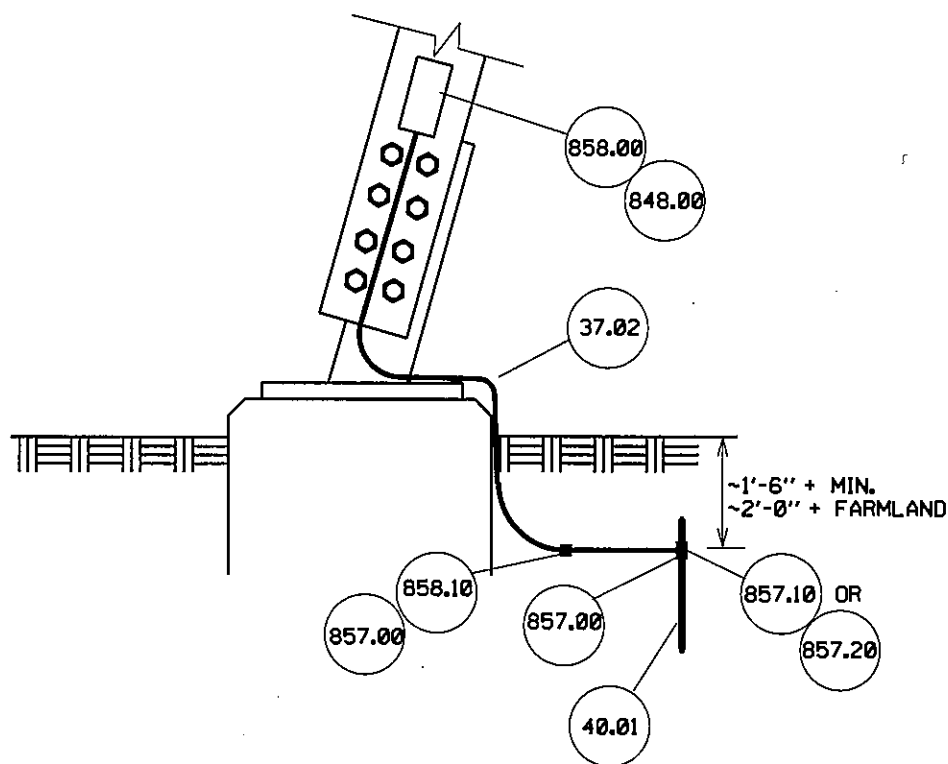
REPAIR GROUNDING AT ALL TOWER LEGS

QTY	ITEM NO.	STOCK NO.	DESCRIPTION	ULT. STR.
*	37.02	42177693	WIRE, CCS #4 SOLID	
*	40.01	57.8785	GROUND ROD, CU, 5/8" X 6'	
*	848.00	71.5995	#65 WELD METAL	
*	857.00	42134611	#25 WELD METAL	
*	857.10	42126879	CADWELD, #4 CU TO 5/8" ROD	
*	857.20	42126880	CADWELD, #4 CU TO 5/8" ROD	
*	858.00	42204510	#4 TO TOWER LEG CONN.	
*	858.10	42204511	#4/#4 MOLD CONN.

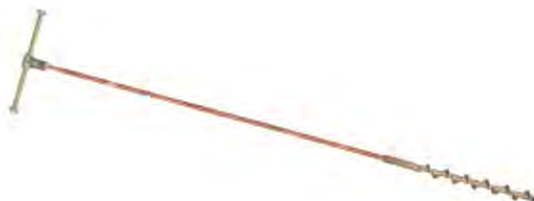
Catalog No.	Description	Weight
G3370	Screw Ground Rod	7-3/4 lb./3.5 kg.

The Chance Screw Ground Rod provides a temporary ground where a system ground is not available. When installed, the 6' spiraled ground rod develops less resistance than straight ground rods. However, actual effectiveness depends upon soil properties. The reusable Ground Rod is copper clad. The helix (spiral) and handle are bronze. For truck-grounding applications, see kit below.

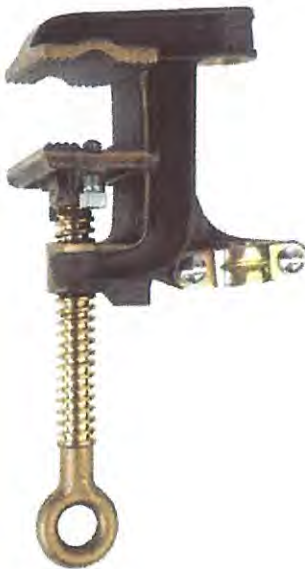
### Tower & Flat-Face :: C6002232

**C6002232**  
 Bronze body  
 Serrated jaws  
 Smooth jaws,  
 Bronze eyescrew with Acme threads,  
 Drilled for 5/8-11 UNC threaded ferrule

ELECTRICAL RATINGS	
Continuous Current (AMPS)	400
Fault Current 15 Cycles (AMPS)	43,000
Fault Current 30 Cycles (AMPS)	30,000
Recommended Torque (in.-lb.)	250
Main Line Range - Max.	1 1/2" Angles 1 1/2" Flat
Main Line Range - Min.	1/8"
Jumper Range - Max.	4/0 Grd. Cable w/Threaded Stud
Jumper Range - Min.	#2 Grd. Cable w/Threaded Stud
Weight Each	2 lb./0.9 kg.
ASTM Designation	Type I Class B Grade 5

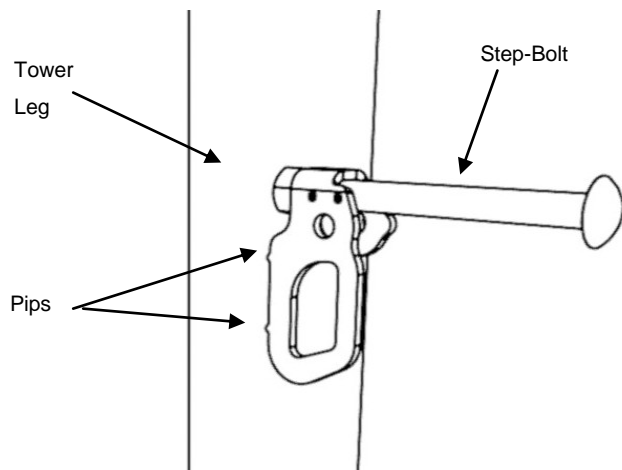
- Before starting installation, establish that the structure and step bolts are capable of supporting the expected fall arrest forces and are in good condition. I.e. free of corrosion, distortion (bending) and securely fixed.
- Removal of the step-bolt is not required if it is in good condition, otherwise it should be replaced.
- Inspect the **S-K2™** for damage, cracks or corrosion before attachment to the step-bolt.

- Place the **S-K2™** over the step-bolt in the correct vertical orientation with the lower edge angled down towards the tower body and the pips against the tower leg as shown on Fig1. The **S-K2™** must be vertical as shown.
- Insert the supplied bolt and washer through the fixing hole in the **S-K2™** until it engages with the fixed nut and hand tighten. Use the supplied bolt and washer only, do not use any other bolts or washers. Fig 2.
- Ensure that the **S-K2™** is vertical and the pips are against the tower before using a suitable wrench to tighten the bolt sufficiently to prevent it rotating on the step bolt when hand pressure is applied. Torque to approximately 26 lbf ft (35 Nm)
- Ensure that the **S-K2™** will not rotate or slide along the step bolt when hand pressure is applied.

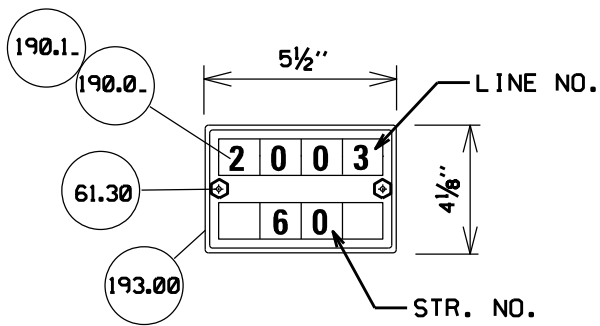
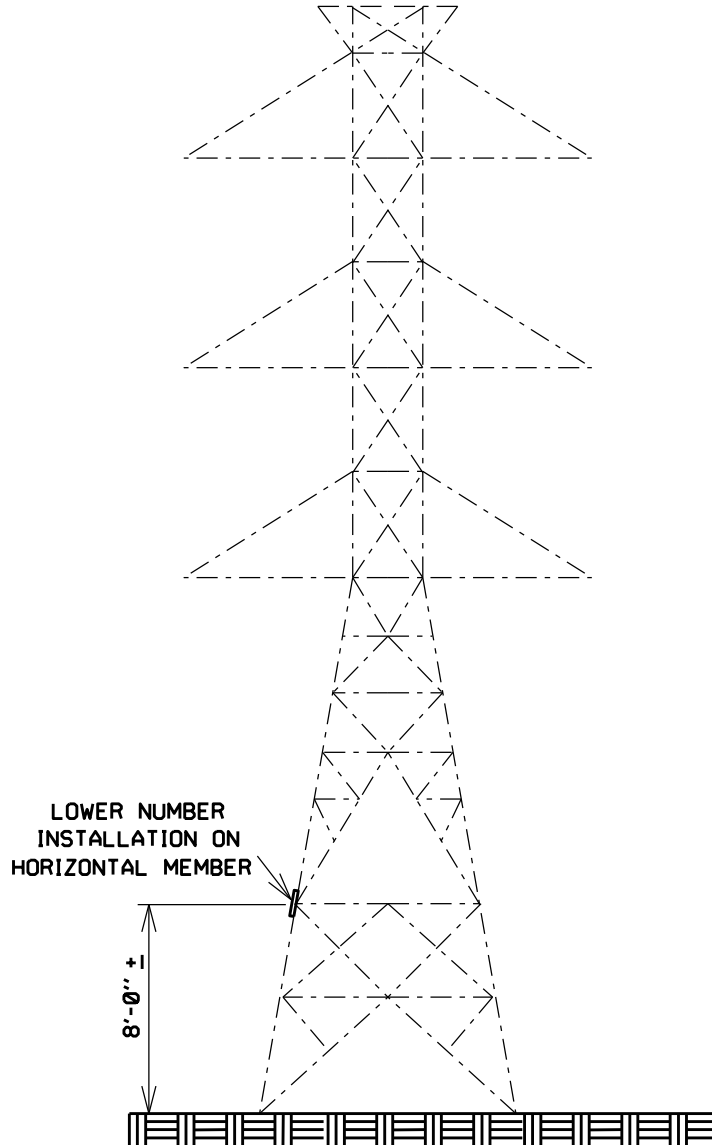
LOWER NUMBERING PLATE

1. SEE DWG. 80.010, INSTRUCTIONS FOR STRUCTURE NUMBERING.
2. ITEM 61.30 IS SUPPLIED WITH A FLAT WASHER, LOCK WASHER, AND NUT, TO BE USED TO ATTACH THE LOWER NUMBER PLATE.

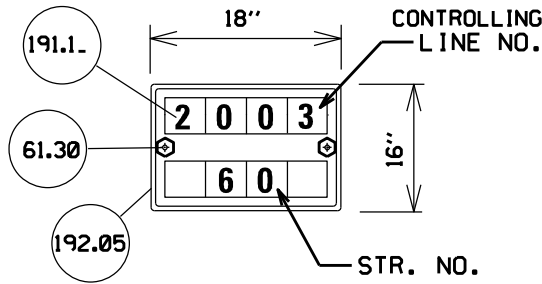
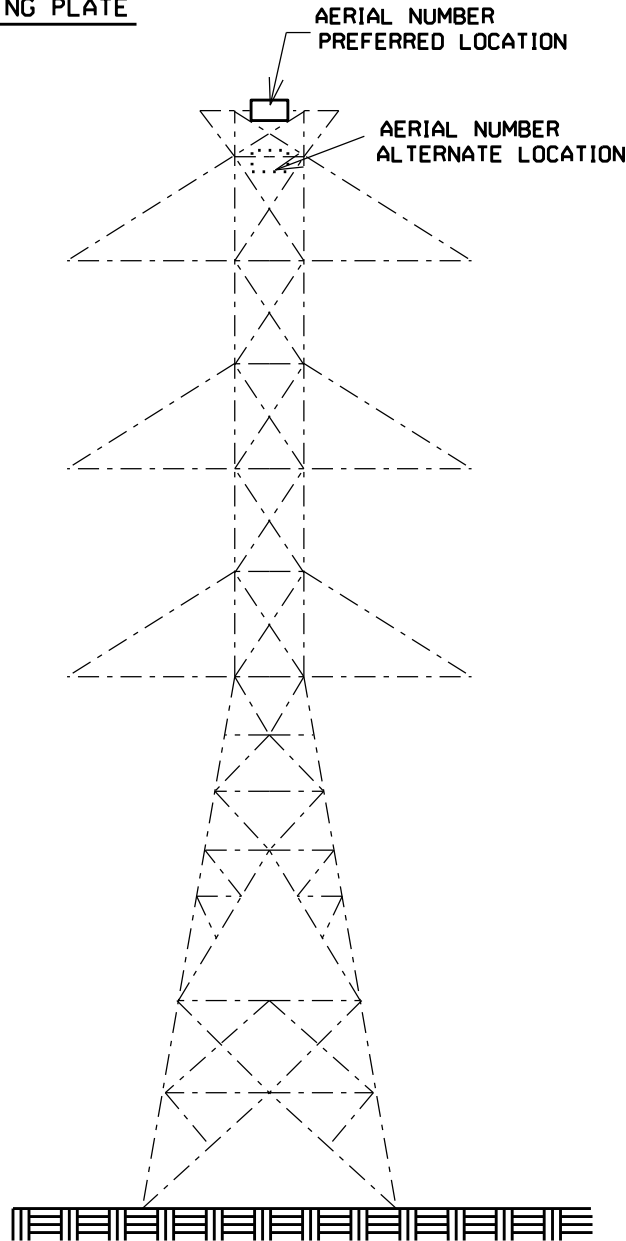
AERIAL NUMBERING PLATE

1. WHEN MORE THAN ONE CIRCUIT IS INSTALLED, THE CONTROLLING LINE NUMBER WILL BE DETERMINED BY THE TRANSMISSION LINES DEPARTMENT.
2. SEE DWG. 80.010, INSTRUCTIONS FOR STRUCTURE NUMBERING.
3. ITEM 61.30 IS SUPPLIED WITH A FLAT WASHER, LOCK WASHER, AND NUT, TO BE USED TO ATTACH THE AERIAL NUMBER PLATE.

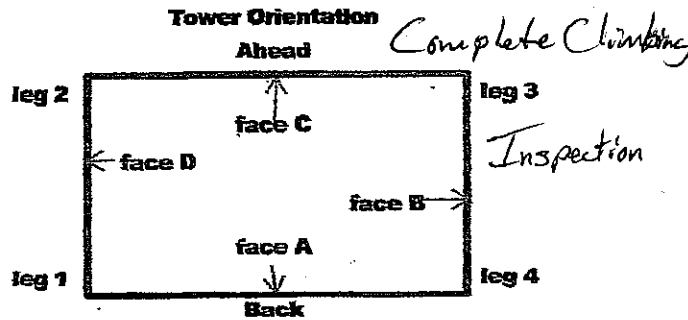
Line Number: 579Structure No: 7Structure Type: SLT+30'LEBack Substation: SeptaAhead Substation: YAKin

Groundline Inspection						Date: _____		
Severe Corrosion		Steel Measurements			Foreman: _____			
	Yes	No	Reading 1	Reading 2	Action Code	See spec book for explanation of foundation codes	Fnd Code	Action Code
Leg 1	—	✓	VG	VG	P			
Leg 2	—	✓	VG	VG	P			
Leg 3	—	✓	VG	VG	P			
Leg 4	—	✓	VG	VG	P

Step Bolt Clips Added:		<input checked="" type="checkbox"/> Yes <input type="checkbox"/> No		Quantity: <u>40</u>	
	Damage	Face	Member	Corrective Action	Remark
1	P	BD	10x2	BP-NB-GW	
2	P	BD	11x2	BP-NB-GW	
3	C	D	115Lx1	LF	Ladder
4	C	D	115Rx1	LF	Ladder
5	P	AC	213x2	BP-NB-GW	
6	P	BD	674x4	BP-NB-GW	
7	P	AC	673x4	BP-NB-GW	
8	O	AB	Leg 2	G	Grounded Rod wire Cadweld
9	O	CD	Leg 4	G	Grounded Rod wire Cadweld
10					
11					
12					
13					
14					
15					
16					
17					
Damage Code		Corrective Action Code		Remark Code:	
MB: Missing Bolt		R: Repaired		G: Grounded Str	
B: Bent		RP: Replaced		RS: Removed Lower Step Bolts	
C: Cracked		LF: Left as Found		BP: Beat Packout	
TM: Thin Member				NS: New Danger/Aerial/Number Signs	
O: Other				IP: Installed Package Per Specs	
				FP: Flipped /Straightened Plates

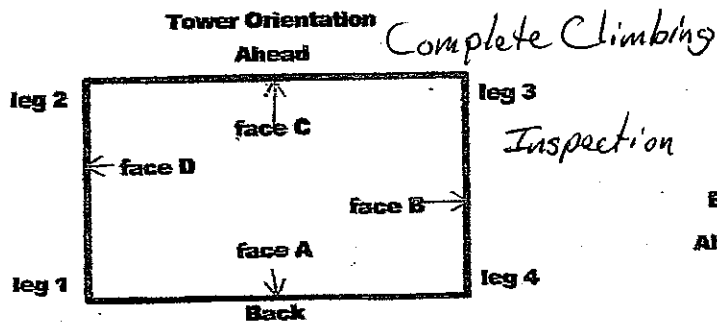
Structure No: 8

Groundline Inspection				
Severe Corrosion		Steel Measurements		
	Yes	No	Reading 1	Reading 2
Leg 1	<input checked="" type="checkbox"/>	<input type="checkbox"/>	VG	VG
Leg 2	<input checked="" type="checkbox"/>	<input type="checkbox"/>	VG	VG
Leg 3	<input checked="" type="checkbox"/>	<input type="checkbox"/>	VG	VG
Leg 4	<input checked="" type="checkbox"/>	<input type="checkbox"/>	VG	VG

Step Bolt Clips Added:		Yes	No	Quantity: 48	
	Damage	Face	Member	Corrective Action	Remark
1	P	BD	10x2	BP-NB-GW	
2	P	BD	11x2	BP-NB-GW	
3	C	D	115Lx1	LF	Ladder
4	C	D	115Rx2	LF	Ladder
5	P	AC	213x2	BP-NB-GW	
6	P	AC	673x4	BP-NB-GW	
7	P	BD	674x4	BP-NB-GW	
8	O	AB	Leg 1	G	Ground rod wire each weld
9	O	CD	Leg 3	G	Ground rod wire each weld
10					
11					
12					
13					
14					
15					
16					
17

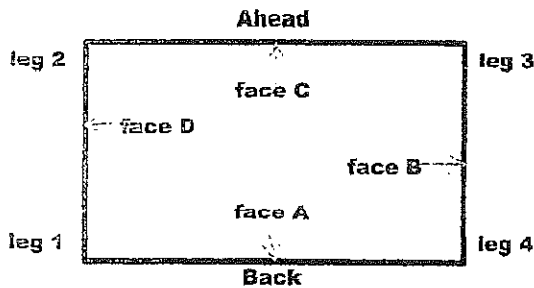
Structure No: 10

Groundline Inspection				
Severe Corrosion		Steel Measurements		
	Yes	No	Reading 1	Reading 2
Leg 1		✓	↓	↓
Leg 2		✓	↓	↓
Leg 3		✓	↓	↓
Leg 4		✓	Good	VG
		Action Code		
		P

Step Bolt Clips Added:		<input checked="" type="checkbox"/> Yes		<input type="checkbox"/> No		Quantity: <u>38</u>	
	Damage	Face	Member	Corrective Action	Remark		
1	P	Bd	10x2	R	BP - NB - GW		
2	P	Bd	11x2	R			
3	P	AC	219x4	R			
4							
5							
6							
7							
8							
9					Install Grounds		
10					Leg 1-3		
11							
12							
13							
14							
15							
16					Climbing Inspection		
17					Complete		
Damage Code		Corrective Action Code		Remark Code:			
MB: Missing Bolt		R: Repaired		G: Grounded Str		RS: Removed Lower Step Bolts	
B: Bent		RP: Replaced		BP: Beat Packout		NS: New Danger/Aerial/Number Signs	
C: Cracked		LF: Left as Found		GW: Applied Greywax		IP: Installed Package Per Specs	
TM: Thin Member				NB: New Bolts		FP: Flipped /Straightened Plates	
O: Other

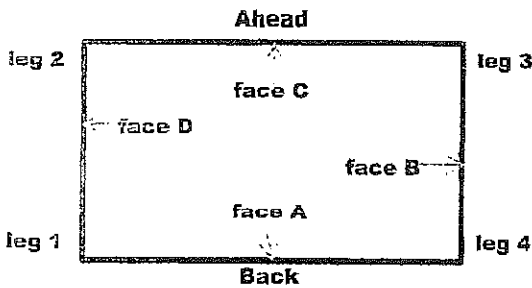
Structure No: 12

Groundline Inspection				
Severe Corrosion		Steel Measurements		
	Yes	No	Reading 1	Reading 2
Leg 1		✓		
Leg 2		✓		
Leg 3		✓		
Leg 4		✓	Good	VG
				Action Code
				P
				P
				P
				P

Step Bolt Clips Added:		✓ Yes		No		Quantity:	38
	Damage	Face	Member	Corrective Action		Remark	
1	P	Bd	10x2	R		BP - Gw - NB	
2	P	Bd	11x2	R			
3	P	A	219x2	R			
4	TM	ABcd	220x8	RP			
5							
6						Installed Grounds	
7						Leg 3-4	
8							
9							
10							
11							
12							
13							
14						Climbing Inspection	
15						Complete	
16							
17							
Damage Code		Corrective Action Code		Remark Code:			
MB: Missing Bolt		R: Repaired		G: Grounded Str		RS: Removed Lower Step Bolts	
B: Bent		RP: Replaced		BP: Beat Packout		NS: New Danger/Aerial/Number Signs	
C: Cracked		LF: Left as Found		GW: Applied Greywax		IP: Installed Package Per Specs	
TM: Thin Member				NB: New Bolts		FP: Flipped /Straightened Plates	
O: Other

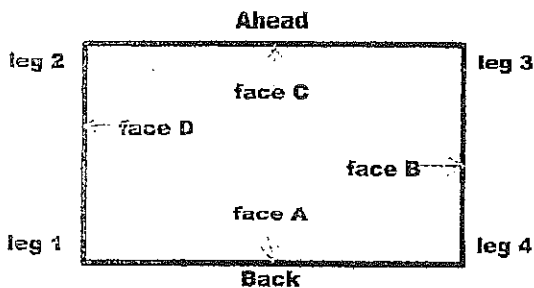
Structure No: 13

Groundline Inspection				
Severe Corrosion		Steel Measurements		
	Yes	No	Reading 1	Reading 2
Leg 1		✓	↓	↓
Leg 2		✓	↓	↓
Leg 3		✓	↓	↓
Leg 4		✓	Good	VG
				Action Code
				P
				P
				P
				P

Step Bolt Clips Added:		Yes		No		Quantity: 35	
	Damage	Face	Member	Corrective Action		Remark	
1	P	Bd	10x2	R		BP - Gw - NB	
2	P	Bd	11x2	R			
3	P	AC	219x4	R			
4							
5							
6							
7							
8							
9						Installed Grounds	
10						Leg 2-4	
11							
12							
13							
14							
15							
16							
17						Climbing Inspection Complete	
Damage Code		Corrective Action Code		Remark Code:			
MB: Missing Bolt		R: Repaired		G: Grounded Str		RS: Removed Lower Step Bolts	
B: Bent		RP: Replaced		BP: Beat Packout		NS: New Danger/Aerial/Number Signs	
C: Cracked		LF: Left as Found		GW: Applied Greywax		IP: Installed Package Per Specs	
TM: Thin Member				NB: New Bolts		FP: Flipped /Straightened Plates	
O: Other

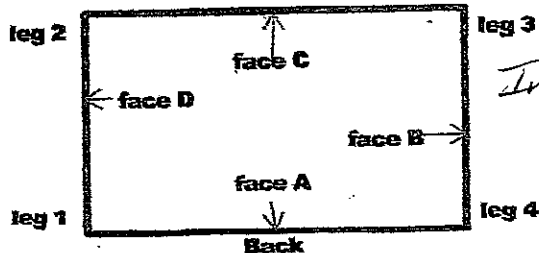
Severe Corrosion		Steel Measurements			
	Yes	No	Reading 1	Reading 2	Action Code
Leg 1	—	✓	VG	VG	P
Leg 2	—	✓	VG	VG	P
Leg 3	—	✓	VG	VG	P
Leg 4	—	✓	VG	VG	P

Step Bolt Clips Added:		Yes	No	Quantity: 43	
	Damage	Face	Member	Corrective Action	Remark
1	P	BD	10x2	BP-NB-GW	
2	P	BD	11x2	BP-NB-GW	
3	MB	C	42x1	R-NB-GW	
4	P	AC	213x2	BP-NB-GW	
5	C	BD	115Lx2	LF	
6	C	BD	115RX2	LF	
7	P	C	673x1	BP-NB-GW	
8	P	B	674x1	BP-NB-GW	
9	TM-B	ABCD	220x8	RP-BP-NB-GW	
10	O	AD	Leg 1	G	Rod - wire - Cadweld
11	O	CB	Leg 3	G	Rod - wire - Cadweld
12					
13					
14					
15					
16					
17

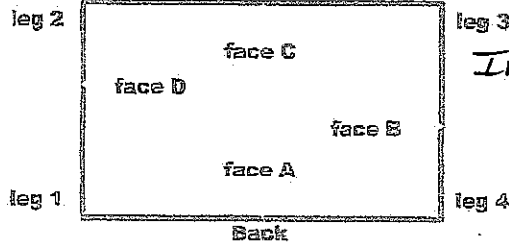
Groundline Inspection					
Severe Corrosion		Steel Measurements			
	Yes	No	Reading 1	Reading 2	Action Code
Leg 1		✓	VG	VG	P
Leg 2		✓	VG	VG	P
Leg 3		✓	VG	VG	P
Leg 4		✓	VG	VG	P

Step Bolt Clips Added: ✓ Yes		No		Quantity: 35	
Damage	Face	Member	Corrective Action	Remark	
P	BD	10x2	BP-NB-GW		
P	BD	11x2	BP-NB-GW		
C	BD	115LX1	LF		
C	BD	115RX1	LF		
P	AC	213X2	BP-NB-GW		
P	A	594X1	BP-NB-GW		
O	AD	Leg 1	G	Rod - WIRE - Cackwield	
O	CB	Leg 3	G	Rod - WIRE - Cackwield	
Damage Code		Corrective Action Code		Remark Code:	
MB: Missing Bolt		R: Repaired		G: Grounded Str	RS: Removed Lower Step Bolts
B: Bent		RP: Replaced		BP: Beat Packout	NS: New Danger/Aerial/Number Signs
C: Cracked		LF: Left as Found		GW: Applied Greywax	IP: Installed Package Per Specs
TM: Thin Member				NB: New Bolts	FP: Flipped /Straightened Plates
O: Other

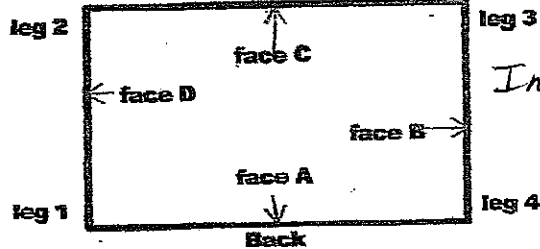
Structure No: 16

Groundline Inspection				
Severe Corrosion		Steel Measurements		
	Yes	No	Reading 1	Reading 2
Leg 1		✓	VG	VG
Leg 2		✓	VG	VG
Leg 3		✓	VG	VG
Leg 4		✓	VG	VG

Step Bolt Clips Added: ✓ Yes		No		Quantity: 48	
	Damage	Face	Member	Corrective Action	Remark
1	P	BD	10x2	BP-NB-GW	
2	P	BD	11x2	BP-NB-GW	
3	C	BD	115Lx2	LF	Ladder
4	C	BD	115Rx2	LF	Ladder
5	P	AC	213x2	BP-NB-GW	
6	TM-B	ABCD	220X9	RP-BP-NB-GW	
7	P	A	8151X1	BP-NB-GW	
8	P	B	8291X1	BP-NB-GW	
9	P	A	704X1	BP-NB-GW	
10	P	BD	707X4	BP-NB-GW	
11	O	AB	Leg 2	G	ground rod - wire - Cadweld
12	O	CD	Leg 4	G	ground rod - wire - Cadweld
13	O	ABCD	High Voltage Signs	X4 NS	
14	C	A	805X1	RP-BP-NB-GW	
15					
16					
17					
Damage Code		Corrective Action Code		Remark Code:	
MB: Missing Bolt		R: Repaired		G: Grounded Str	RS: Removed Lower Step Bolts
B: Bent		RP: Replaced		BP: Beat Packout	NS: New Danger/Aerial/Number Signs
C: Cracked		LF: Left as Found		GW: Applied Greywax	IP: Installed Package Per Specs
TM: Thin Member				NB: New Bolts	FP: Flipped /Straightened Plates
O: Other

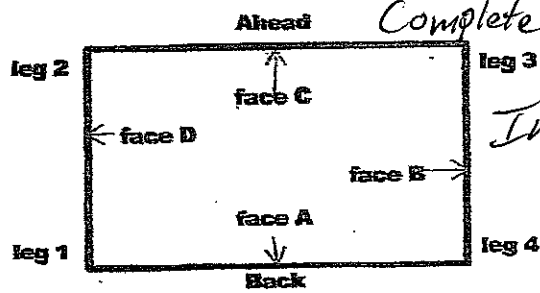
Line Number: 579  
 Structure No: 21  
 Structure Type: SLT+25'LE  
 Back Substation: SEPTA  
 Ahead Substation: YADKIN

Groundline Inspection				
Severe Corrosion		Steel Measurements		Action Code
Yes	No	Reading 1	Reading 2	
Leg 1	<input checked="" type="checkbox"/>	VG	VG	P
Leg 2	<input checked="" type="checkbox"/>	VG	VG	P
Leg 3	<input checked="" type="checkbox"/>	VG	VG	P
Leg 4	<input checked="" type="checkbox"/>	VG	VG	P

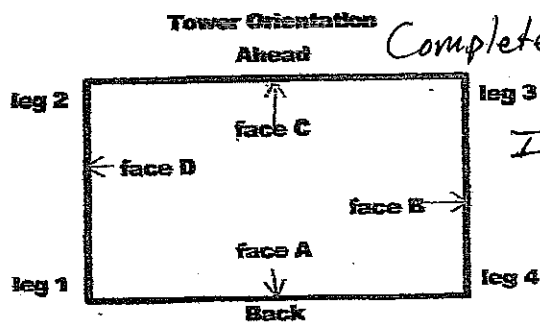
Line Number: 579  
 Structure No: 35  
 Structure Type: SLT+40'LE  
 Back Substation: SEPTA  
 Ahead Substation: YADKIN

Groundline Inspection				
Severe Corrosion		Steel Measurements		
	Yes	No	Reading 1	Reading 2
Leg 1		✓	VG	VG
Leg 2		✓	VG	VG
Leg 3		✓	VG	VG
Leg 4		✓	VG	VG

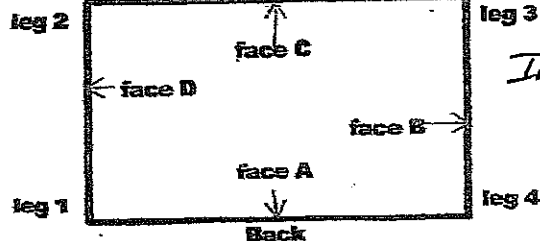
Groundline Inspection				
Severe Corrosion		Steel Measurements		
	Yes	No	Reading 1	Reading 2
Leg 1	✓	—	0.23400	0.24150
Leg 2	—	✓	VG	VG
Leg 3	✓	—	0.19670	0.24615
Leg 4	—	✓	VG	VG

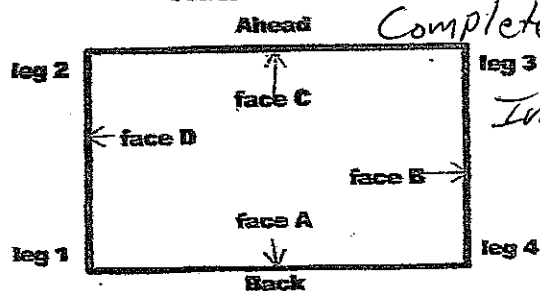
Line Number: 579  
 Structure No: 40  
 Structure Type: SLT+40'LE  
 Back Substation: SEPTA  
 Ahead Substation: YADKIN

Groundline Inspection					
Severe Corrosion		Steel Measurements			
	Yes	No	Reading 1	Reading 2	Action Code
Leg 1	—	✓	VG	VG	P
Leg 2	—	✓	VG	VG	P
Leg 3	—	✓	VG	VG	P
Leg 4	—	✓	VG	VG	P

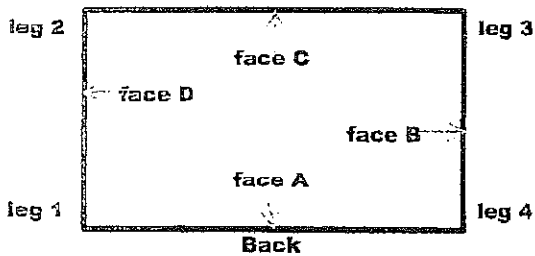
Structure No: 46

Severe Corrosion		Steel Measurements			
	Yes	No	Reading 1	Reading 2	Action Code
Leg 1	_____	✓	↓	↓	P
Leg 2	_____	✓	↓	↓	P
Leg 3	_____	✓	↓	↓	P
Leg 4	_____	✓	Good	VG	P

Damage	Face	Member	Corrective Action	Remark
1	P	Bd	10x2	R	BP - NB - GW
2	P	Bd	11x2	R	
3	P	AC	213x2	R	
4	Tm	ABcd	220x2	RP	
5					
6					
7					Installed Grounds
8					LEG 1-3
9					
10					
11					
12					
13					
14					
15					
16					Climbing Inspection
17					Complete

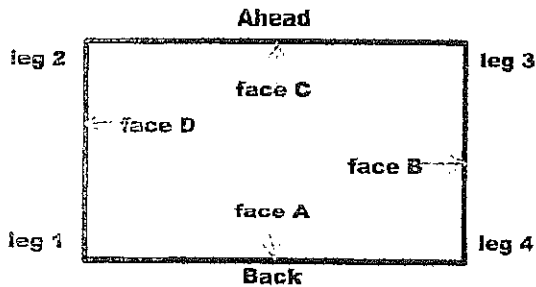
Structure No: 48

Groundline Inspection					
Severe Corrosion		Steel Measurements			
	Yes	No	Reading 1	Reading 2	Action Code
Leg 1		✓	↓	↓	P
Leg 2		✓	↓	↓	P
Leg 3		✓	↓	↓	P
Leg 4		✓	Good	VG	P

Foundation Inspection		
Date:	<u>03-24-22</u>	
Foreman:	<u>Alley Rundgren</u>	
See spec book for explanation of foundation codes	Find Code	Action Code
		LF
		LF
		LF
	3	FR

Step Bolt Clips Added:		✓	Yes	No	Quantity: 41
	Damage	Face	Member	Corrective Action	Remark
1	P	Bd	10x2	R	BP - NB - GW
2	P	Bd	11x2	R	
3	P	AC	213x2	R	
4	TM	ABcd	220x8	RP	
5					
6					
7					Installed Grounds LEg 1-3
8					
9					
10					
11					
12					
13					
14					
15					
16					Climbing Inspection Complete
17					
Damage Code		Corrective Action Code		Remark Code:	
MB: Missing Bolt		R: Repaired		G: Grounded Str	RS: Removed Lower Step Bolts
B: Bent		RP: Replaced		BP: Beat Packout	NS: New Danger/Aerial/Number Signs
C: Cracked		LF: Left as Found		GW: Applied Greywax	IP: Installed Package Per Specs
TM: Thin Member				NB: New Bolts	FP: Flipped /Straightened Plates
O: Other

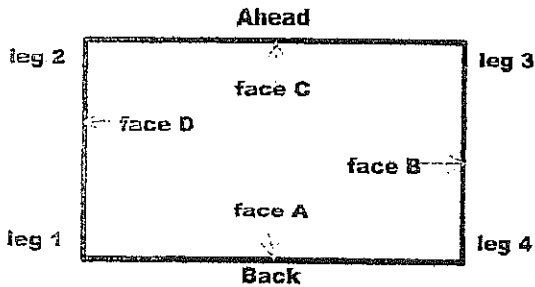
Structure No: 49

Groundline Inspection					
Severe Corrosion		Steel Measurements			
	Yes	No	Reading 1	Reading 2	Action Code
Leg 1		✓			P
Leg 2		✓			P
Leg 3		✓			P
Leg 4		✓	Good	VG	P

Step Bolt Clips Added:		<u>✓</u> Yes	<u>      </u> No	Quantity: <u>41</u>	
	Damage	Face	Member	Corrective Action	Remark
1	P	Bd	10x2	R	BP - NB - GW
2	P	Bd	11x2	R	
3	P	Ac	213x2	R	
4	TM	ABcd	220x8	RP	
5					Installed Grounds leg 1-3
6					
7					
8					
9					
10					
11					
12					
13					
14					
15					
16					Climbing Inspection Complete
17					
Damage Code		Corrective Action Code		Remark Code:	
MB: Missing Bolt		R: Repaired		G: Grounded Str	RS: Removed Lower Step Bolts
B: Bent		RP: Replaced		BP: Beat Packout	NS: New Danger/Aerial/Number Signs
C: Cracked		LF: Left as Found		GW: Applied Greywax	IP: Installed Package Per Specs
TM: Thin Member				NB: New Bolts	FP: Flipped /Straightened Plates
O: Other

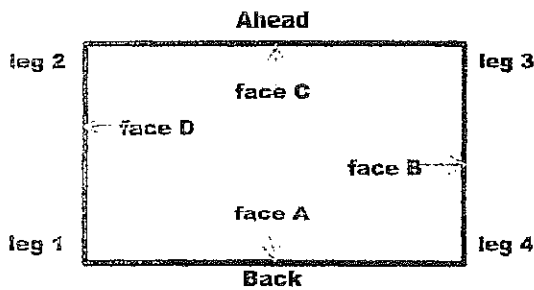
Structure No: 52

Groundline Inspection				
Severe Corrosion		Steel Measurements		Action Code
	Yes No	Reading 1	Reading 2	
Leg 1	<input checked="" type="checkbox"/>			P
Leg 2	<input checked="" type="checkbox"/>			P
Leg 3	<input checked="" type="checkbox"/>			P
Leg 4	<input checked="" type="checkbox"/>	Good	VG	P

Step Bolt Clips Added:		<input checked="" type="checkbox"/> Yes	<input type="checkbox"/> No	Quantity: 41	
	Damage	Face	Member	Corrective Action	Remark
1	P	Bd	10x2	P	BP - NA - GW
2	P	Bd	11x2	P	
3	P	AC	213x2	P	
4	Tm	ABcd	220x8	RP	
5					
6					INSTALLED GROUNDS
7					LEG 1-3 REATTACHED
8					GROUND LEG 4
9					
10					
11					
12					
13					
14					
15					
16					CLIMBING INSPECTION
17					COMPLETE
Damage Code		Corrective Action Code		Remark Code:	
MB: Missing Bolt		R: Repaired		G: Grounded Str	RS: Removed Lower Step Bolts
B: Bent		RP: Replaced		BP: Beat Packout	NS: New Danger/Aerial/Number Signs
C: Cracked		LF: Left as Found		GW: Applied Greywax	IP: Installed Package Per Specs
TM: Thin Member				NB: New Bolts	FP: Flipped /Straightened Plates
O: Other

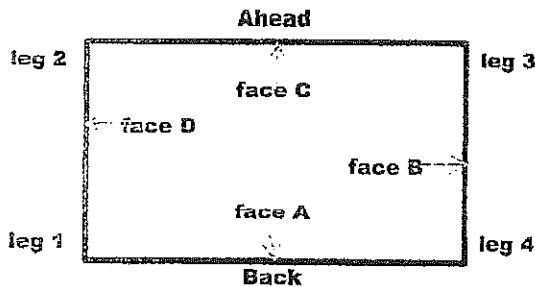
Structure No: 53

Groundline Inspection					
Severe Corrosion		Steel Measurements			
	Yes	No	Reading 1	Reading 2	Action Code
Leg 1		✓			P
Leg 2		✓			P
Leg 3		✓			P
Leg 4		✓	Good	VG	P

Step Bolt Clips Added:		<input checked="" type="checkbox"/> Yes <input type="checkbox"/> No		Quantity: <u>47</u>	
	Damage	Face	Member	Corrective Action	Remark
1	P	Bd	10x2	R	BP - NB - GW
2	P	Bd	11x2	R	
3	TM	ABcd	220x16	RP	
4	P	AC	213x2	R	
5	P	AC	754x2	R	
6	P	Bd	757x3	R	
7					
8					INSULATOR BROKE B FACE INSIDE STRING
9					
10					
11					
12					Grounds Installed leg 1-3
13					
14					Climbing Inspection complete
15					
16					
17					
Damage Code		Corrective Action Code		Remark Code:	
MB: Missing Bolt		R: Repaired		G: Grounded Str	RS: Removed Lower Step Bolts
B: Bent		RP: Replaced		BP: Beat Packout	NS: New Danger/Aerial/Number Signs
C: Cracked		LF: Left as Found		GW: Applied Greywax	IP: Installed Package Per Specs
TM: Thin Member				NB: New Bolts	FP: Flipped /Straightened Plates
O: Other

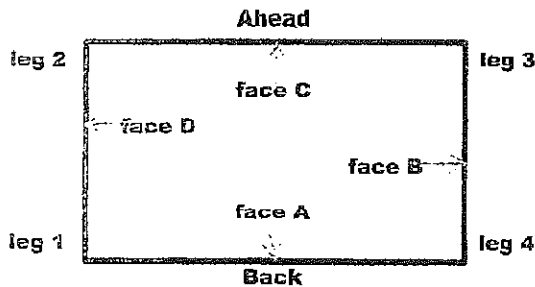
Structure No: 55

Groundline Inspection					
Severe Corrosion		Steel Measurements			
	Yes	No	Reading 1	Reading 2	Action Code
Leg 1	<input type="checkbox"/>	<input checked="" type="checkbox"/>			P
Leg 2	<input type="checkbox"/>	<input checked="" type="checkbox"/>			P
Leg 3	<input type="checkbox"/>	<input checked="" type="checkbox"/>			P
Leg 4	<input type="checkbox"/>	<input checked="" type="checkbox"/>	Good	VG	P

Step Bolt Clips Added:		✓ Yes		No		Quantity: 32	
	Damage	Face	Member	Corrective Action		Remark	
1	P	Bd	10x2	R		BP - NB - GW	
2	P	Bd	11x2	R			
3	P	AC	213x2	R			
4	Tm	ABcd	220x8	RP			
5							
6						Installed Grounds	
7						1Eg 1-3	
8							
9							
10							
11							
12							
13							
14							
15						Climbing Inspection	
16						Complete	
17							
Damage Code		Corrective Action Code		Remark Code:			
MB: Missing Bolt		R: Repaired		G: Grounded Str		RS: Removed Lower Step Bolts	
B: Bent		RP: Replaced		BP: Beat Packout		NS: New Danger/Aerial/Number Signs	
C: Cracked		LF: Left as Found		GW: Applied Greywax		IP: Installed Package Per Specs	
TM: Thin Member				NB: New Bolts		FP: Flipped /Straightened Plates	
O: Other

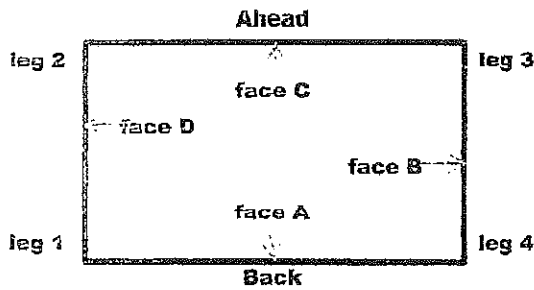
Structure No: 56

Groundline Inspection				
Severe Corrosion		Steel Measurements		Action Code
	Yes No	Reading 1	Reading 2	
Leg 1	<input checked="" type="checkbox"/>			P
Leg 2	<input checked="" type="checkbox"/>			P
Leg 3	<input checked="" type="checkbox"/>			P
Leg 4	<input checked="" type="checkbox"/>	Good	VG	P

Step Bolt Clips Added:		<input checked="" type="checkbox"/> Yes		<input type="checkbox"/> No		Quantity: _____
	Damage	Face	Member	Corrective Action	Remark	
1	P	Bd	10x2	R	BP - NB - GW	
2	P	Bd	11x2	R		
3	P	AC	213x2	R		
4	TM	ABcd	220x8	RP		
5						
6						
7					Installed Grounds LEg 1-3	
8						
9						
10						
11						
12						
13						
14						
15						
16					Climbing Inspection Complete	
17						
Damage Code		Corrective Action Code		Remark Code:		
MB: Missing Bolt		R: Repaired		G: Grounded Str		RS: Removed Lower Step Bolts
B: Bent		RP: Replaced		BP: Beat Packout		NS: New Danger/Aerial/Number Signs
C: Cracked		LF: Left as Found		GW: Applied Greywax		IP: Installed Package Per Specs
TM: Thin Member				NB: New Bolts		FP: Flipped /Straightened Plates
O: Other

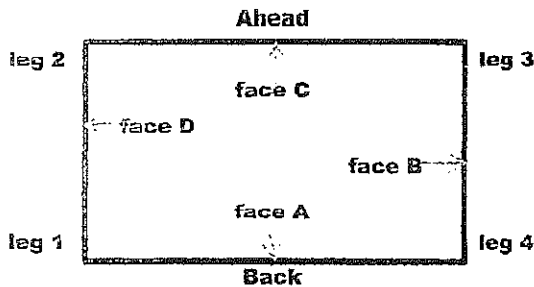
Structure No: 57

Groundline Inspection				
Severe Corrosion		Steel Measurements		
	Yes	No	Reading 1	Reading 2
Leg 1		✓		
Leg 2		✓		
Leg 3		✓		
Leg 4		✓	Good	VG

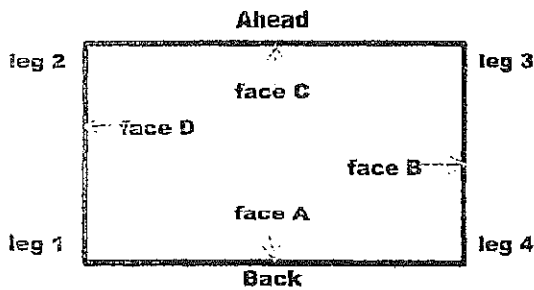
Structure No: 58

Groundline Inspection				
Severe Corrosion		Steel Measurements		
	Yes	No	Reading 1	Reading 2
Leg 1		✓		
Leg 2		✓		
Leg 3		✓		
Leg 4		✓	Good	VG

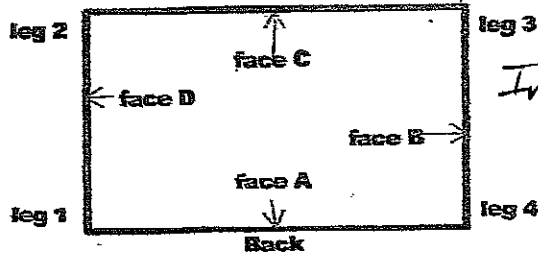
<div style="display: flex; justify-content: space-between;"> <span>Leg 1</span> <span>Back</span> <span>Leg 4</span> </div>						<b>Foundation Inspection</b>		
<b>Groundline Inspection</b>						<b>Date:</b> _____		
<b>Severe Corrosion</b>		<b>Steel Measurements</b>				<b>Foreman:</b> _____		
	Yes	No	Reading 1	Reading 2	Action Code	See spec book for explanation of foundation codes	Fnd Code	Action Code
Leg 1	—	✓	VG	VG	P			LF
Leg 2	—	✓	VG	VG	P			LF
Leg 3	—	✓	VG	VG	P			EF
Leg 4	—	✓	VG	VG	P			LF

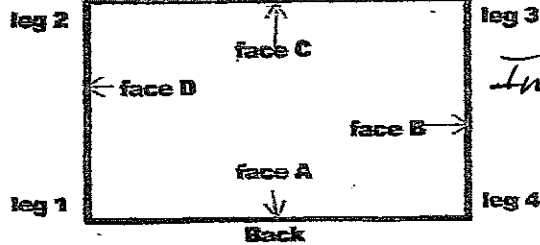
Groundline Inspection					
Severe Corrosion		Steel Measurements			
	Yes	No	Reading 1	Reading 2	Action Code
Leg 1		✓	VG	VG	P
Leg 2		✓	VG	VG	P
Leg 3		✓	VG	VG	P
Leg 4		✓	VG	VG	P

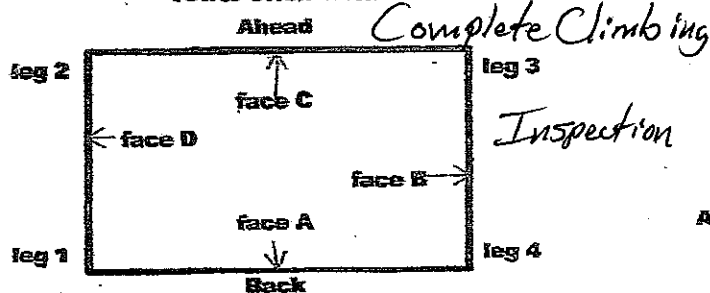
Line Number: 579  
 Structure No: 102  
 Structure Type: SHA+35' LE  
 Back Substation: SEPTA  
 Ahead Substation: NADKIN

Groundline Inspection				
Severe Corrosion		Steel Measurements		Action Code
Yes	No	Reading 1	Reading 2	
Leg 1	<input checked="" type="checkbox"/>	VG	VG	P
Leg 2	<input checked="" type="checkbox"/>	VG	VG	P
Leg 3	<input checked="" type="checkbox"/>	VG	VG	P
Leg 4	<input checked="" type="checkbox"/>	VG	VG	P

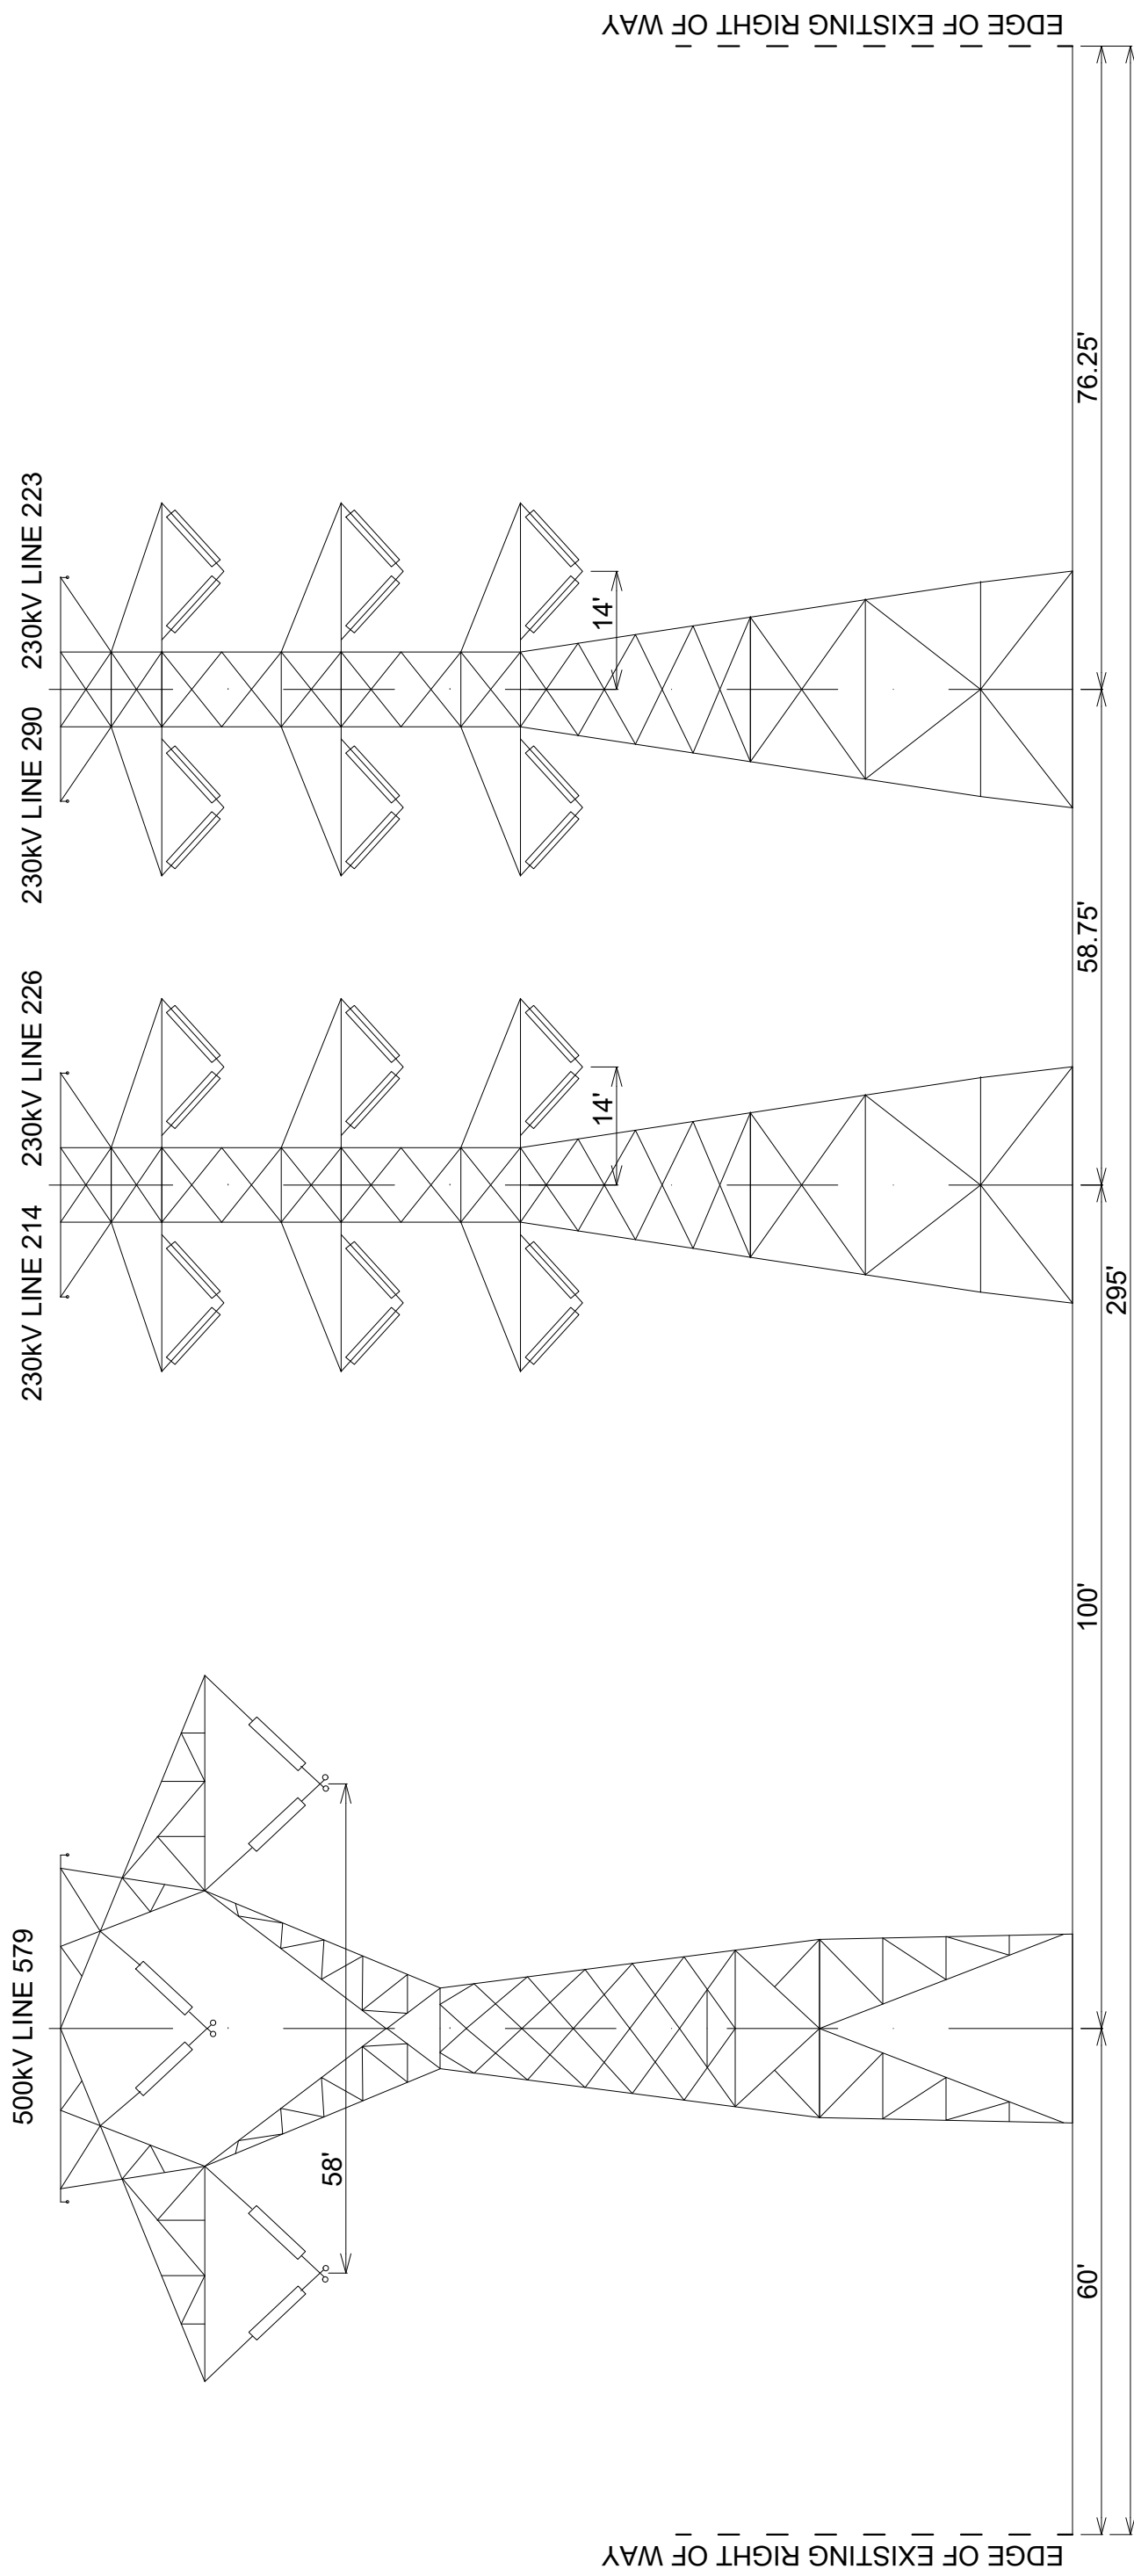
ORIGINAL	REVISION	DRAWING NO.
DRAWN	GKF			ATTACHMENT II.A.5.a.i
CHECKED	RAJ			
APPROVED	RAJ			
DATE	4/14/25

## TYPICAL EXISTING RIGHT OF WAY LOOKING TOWARDS YADKIN SUBSTATION

1. THIS CROSS SECTION IS APPLICABLE FROM EXISTING STRUCTURE 579/1 TO 579/60.

Response: See Attachment II.A.5.a.i-j.i (existing) and II.A.5.a.ii-j.ii (proposed).

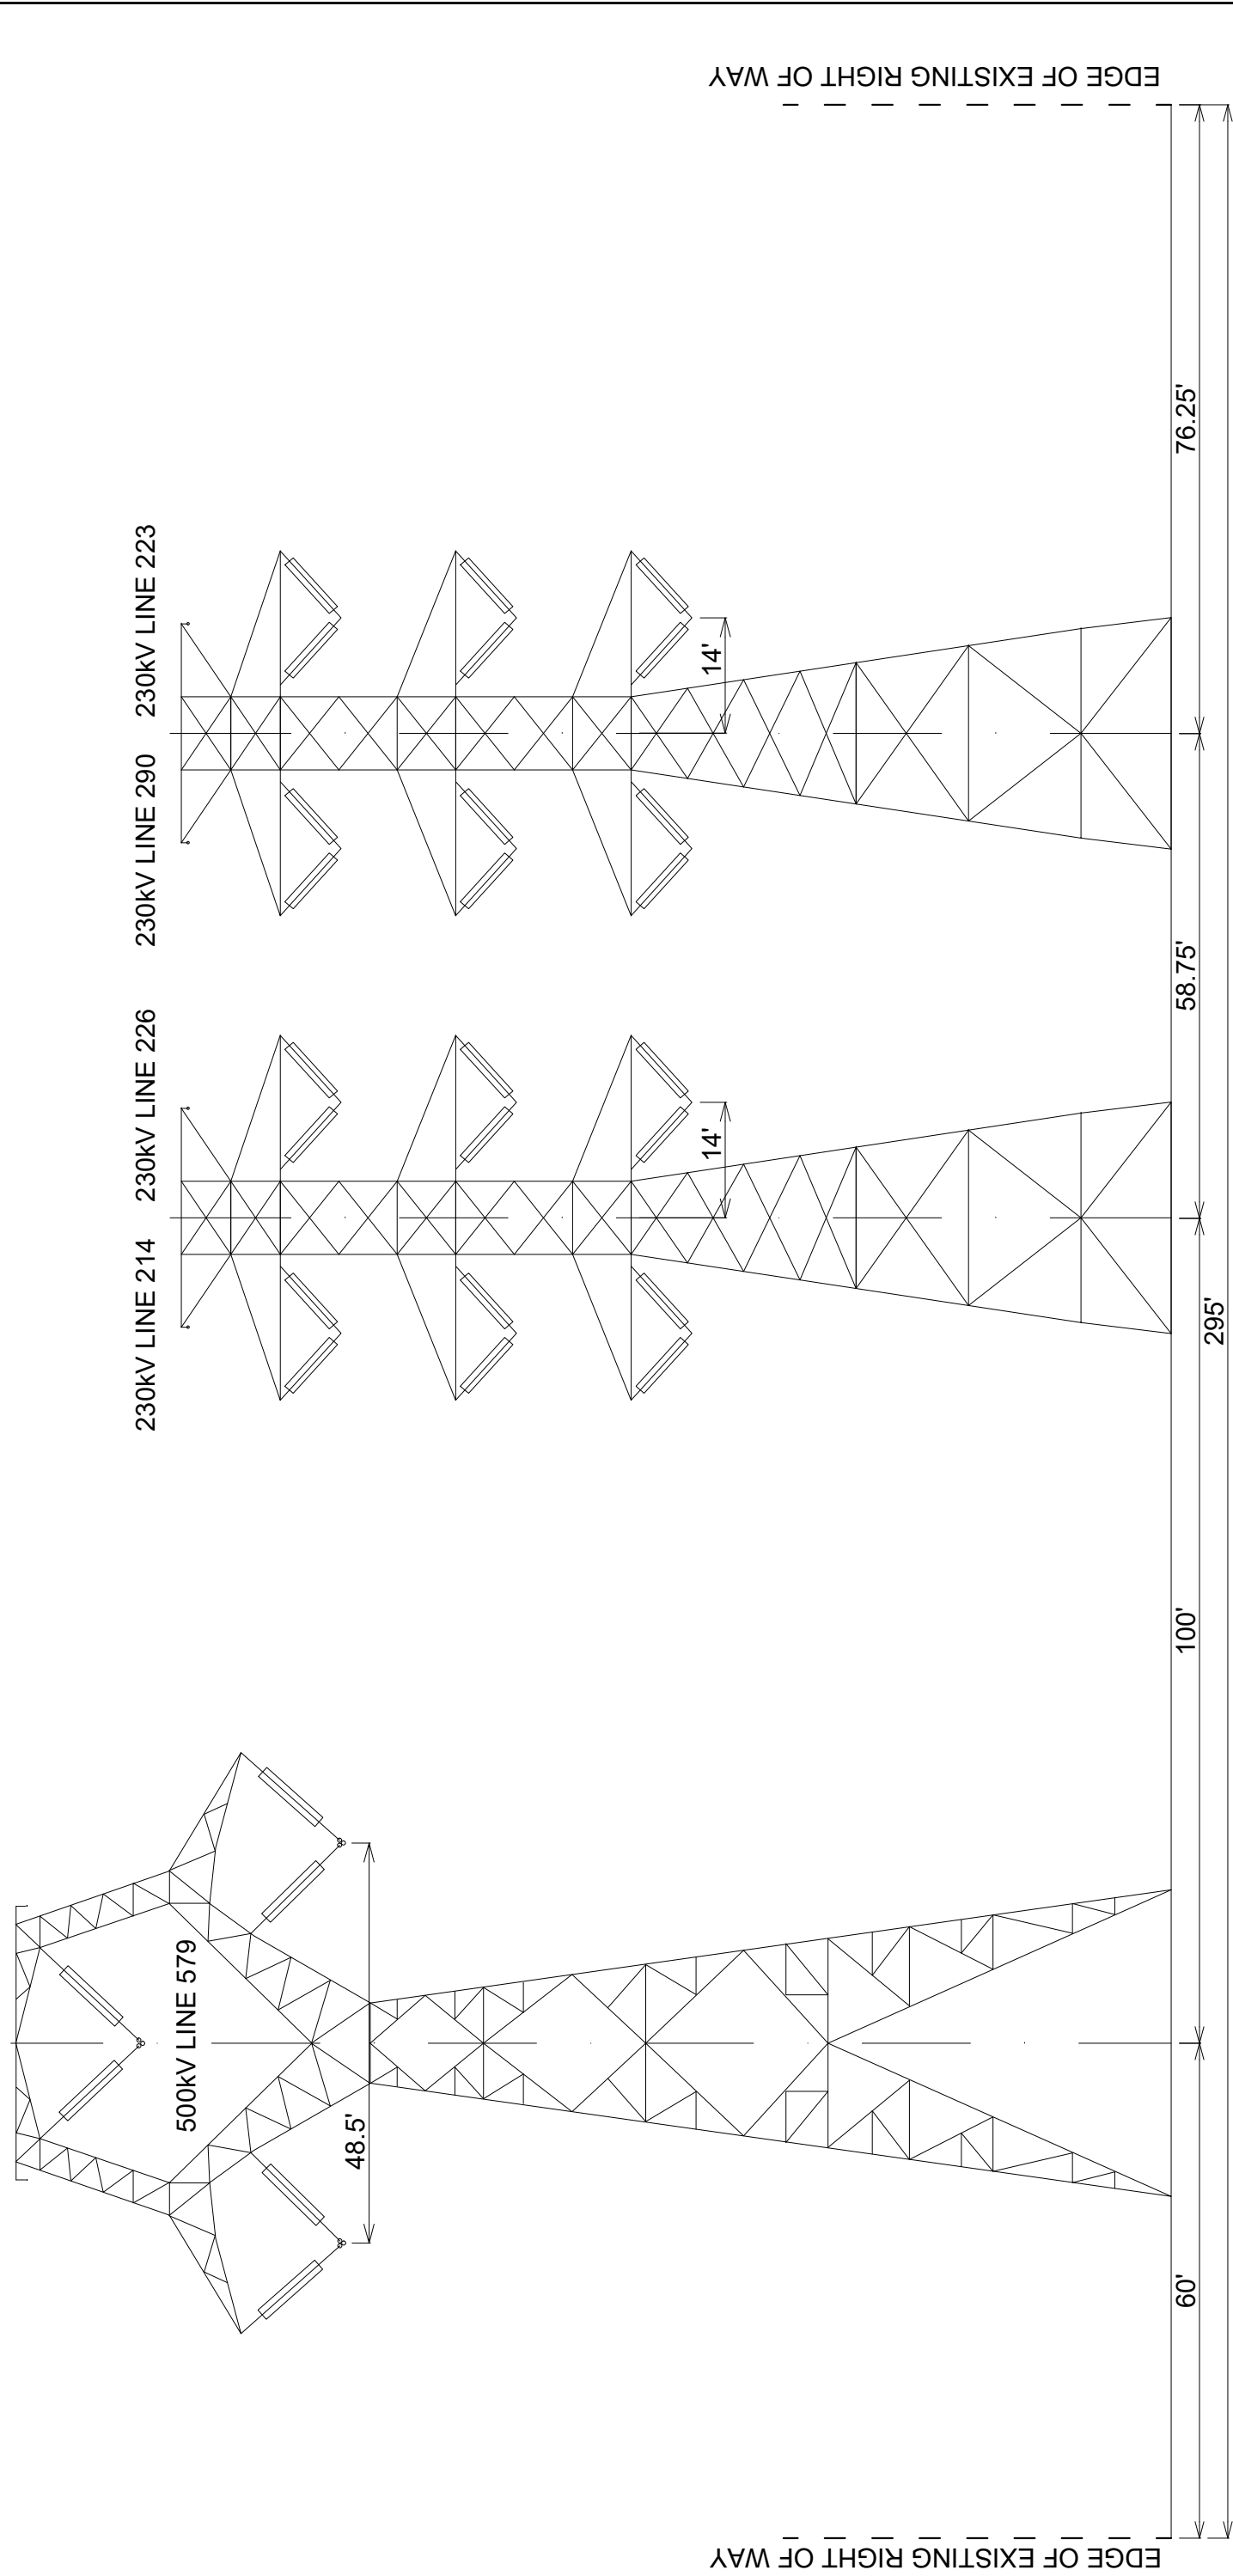
Dominion Energy 5000 Dominion Blvd Glen Allen, VA 23060	
ORIGINAL	REVISION	DRAWING NO.	
DRAWN	GKF	ATTACHMENT II.A.5.a.ii	
CHECKED	RAJ		
APPROVED	RAJ		
DATE	4/14/25

TYPICAL PROPOSED RIGHT OF WAY LOOKING TOWARDS YADKIN SUBSTATION

1. THIS CROSS SECTION IS APPLICABLE FROM EXISTING STRUCTURE 579/1 TO 579/60.
2. INFORMATION CONTAINED ON DRAWING IS CONSIDERED PRELIMINARY IN NATURE AND SUBJECT TO CHANGE BASED ON FINAL DESIGN.
