*Application of Virginia Electric and Power Company for approval and certification  
of electric transmission facilities: 500 kV Septa-Yadkin Line #579 Rebuild and  
230 kV Suffolk-Thrasher Line #2110 Partial Rebuild*  
**Case No. PUR-2025-00104**

SEPTA-YADKIN 500 kV LINE #579  
REBUILD AND SUFFOLK-  
THRASHER 230 kV LINE #2110  
PARTIAL REBUILD

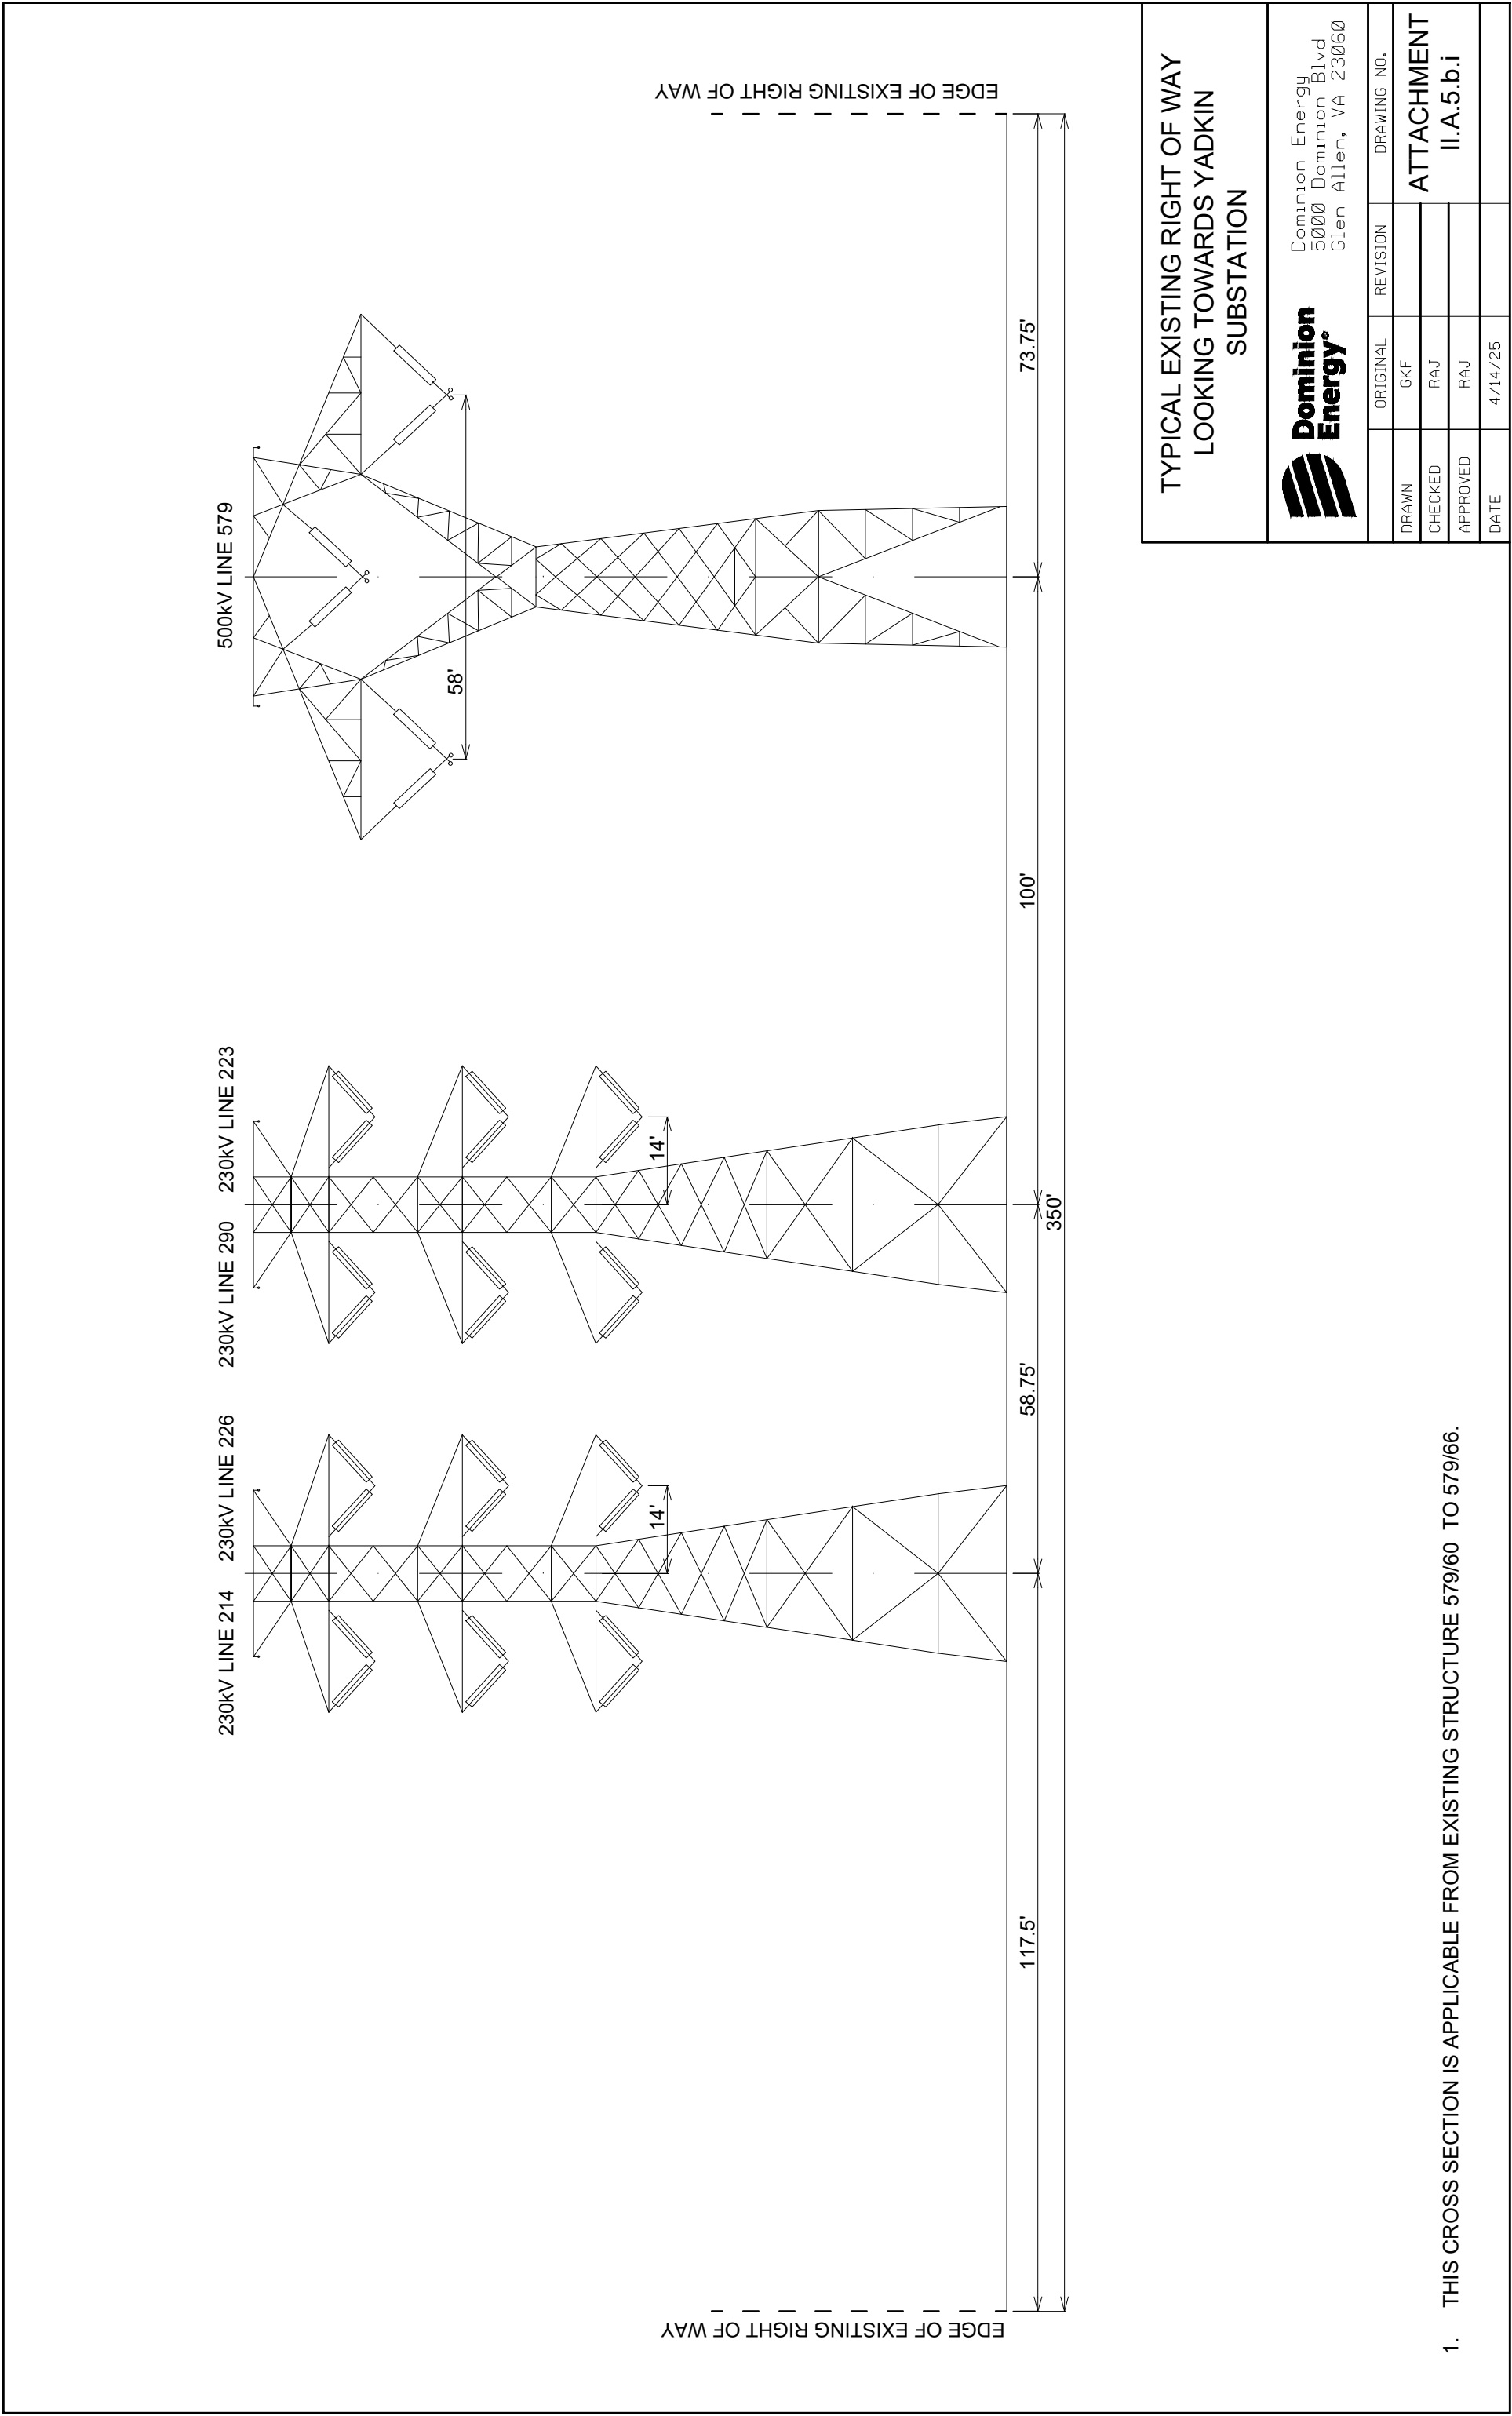
Dominion Energy 5000 Dominion Blvd Glen Allen, VA 23060	
ORIGINAL	REVISION	DRAWING NO.	
DRAWN	GKF	ATTACHMENT	
CHECKED	RAJ	II.A.5.b.i	
APPROVED	RAJ		
DATE	4/14/25

TYPICAL EXISTING RIGHT OF WAY LOOKING TOWARDS YADKIN SUBSTATION

1. THIS CROSS SECTION IS APPLICABLE FROM EXISTING STRUCTURE 579/60 TO 579/66.

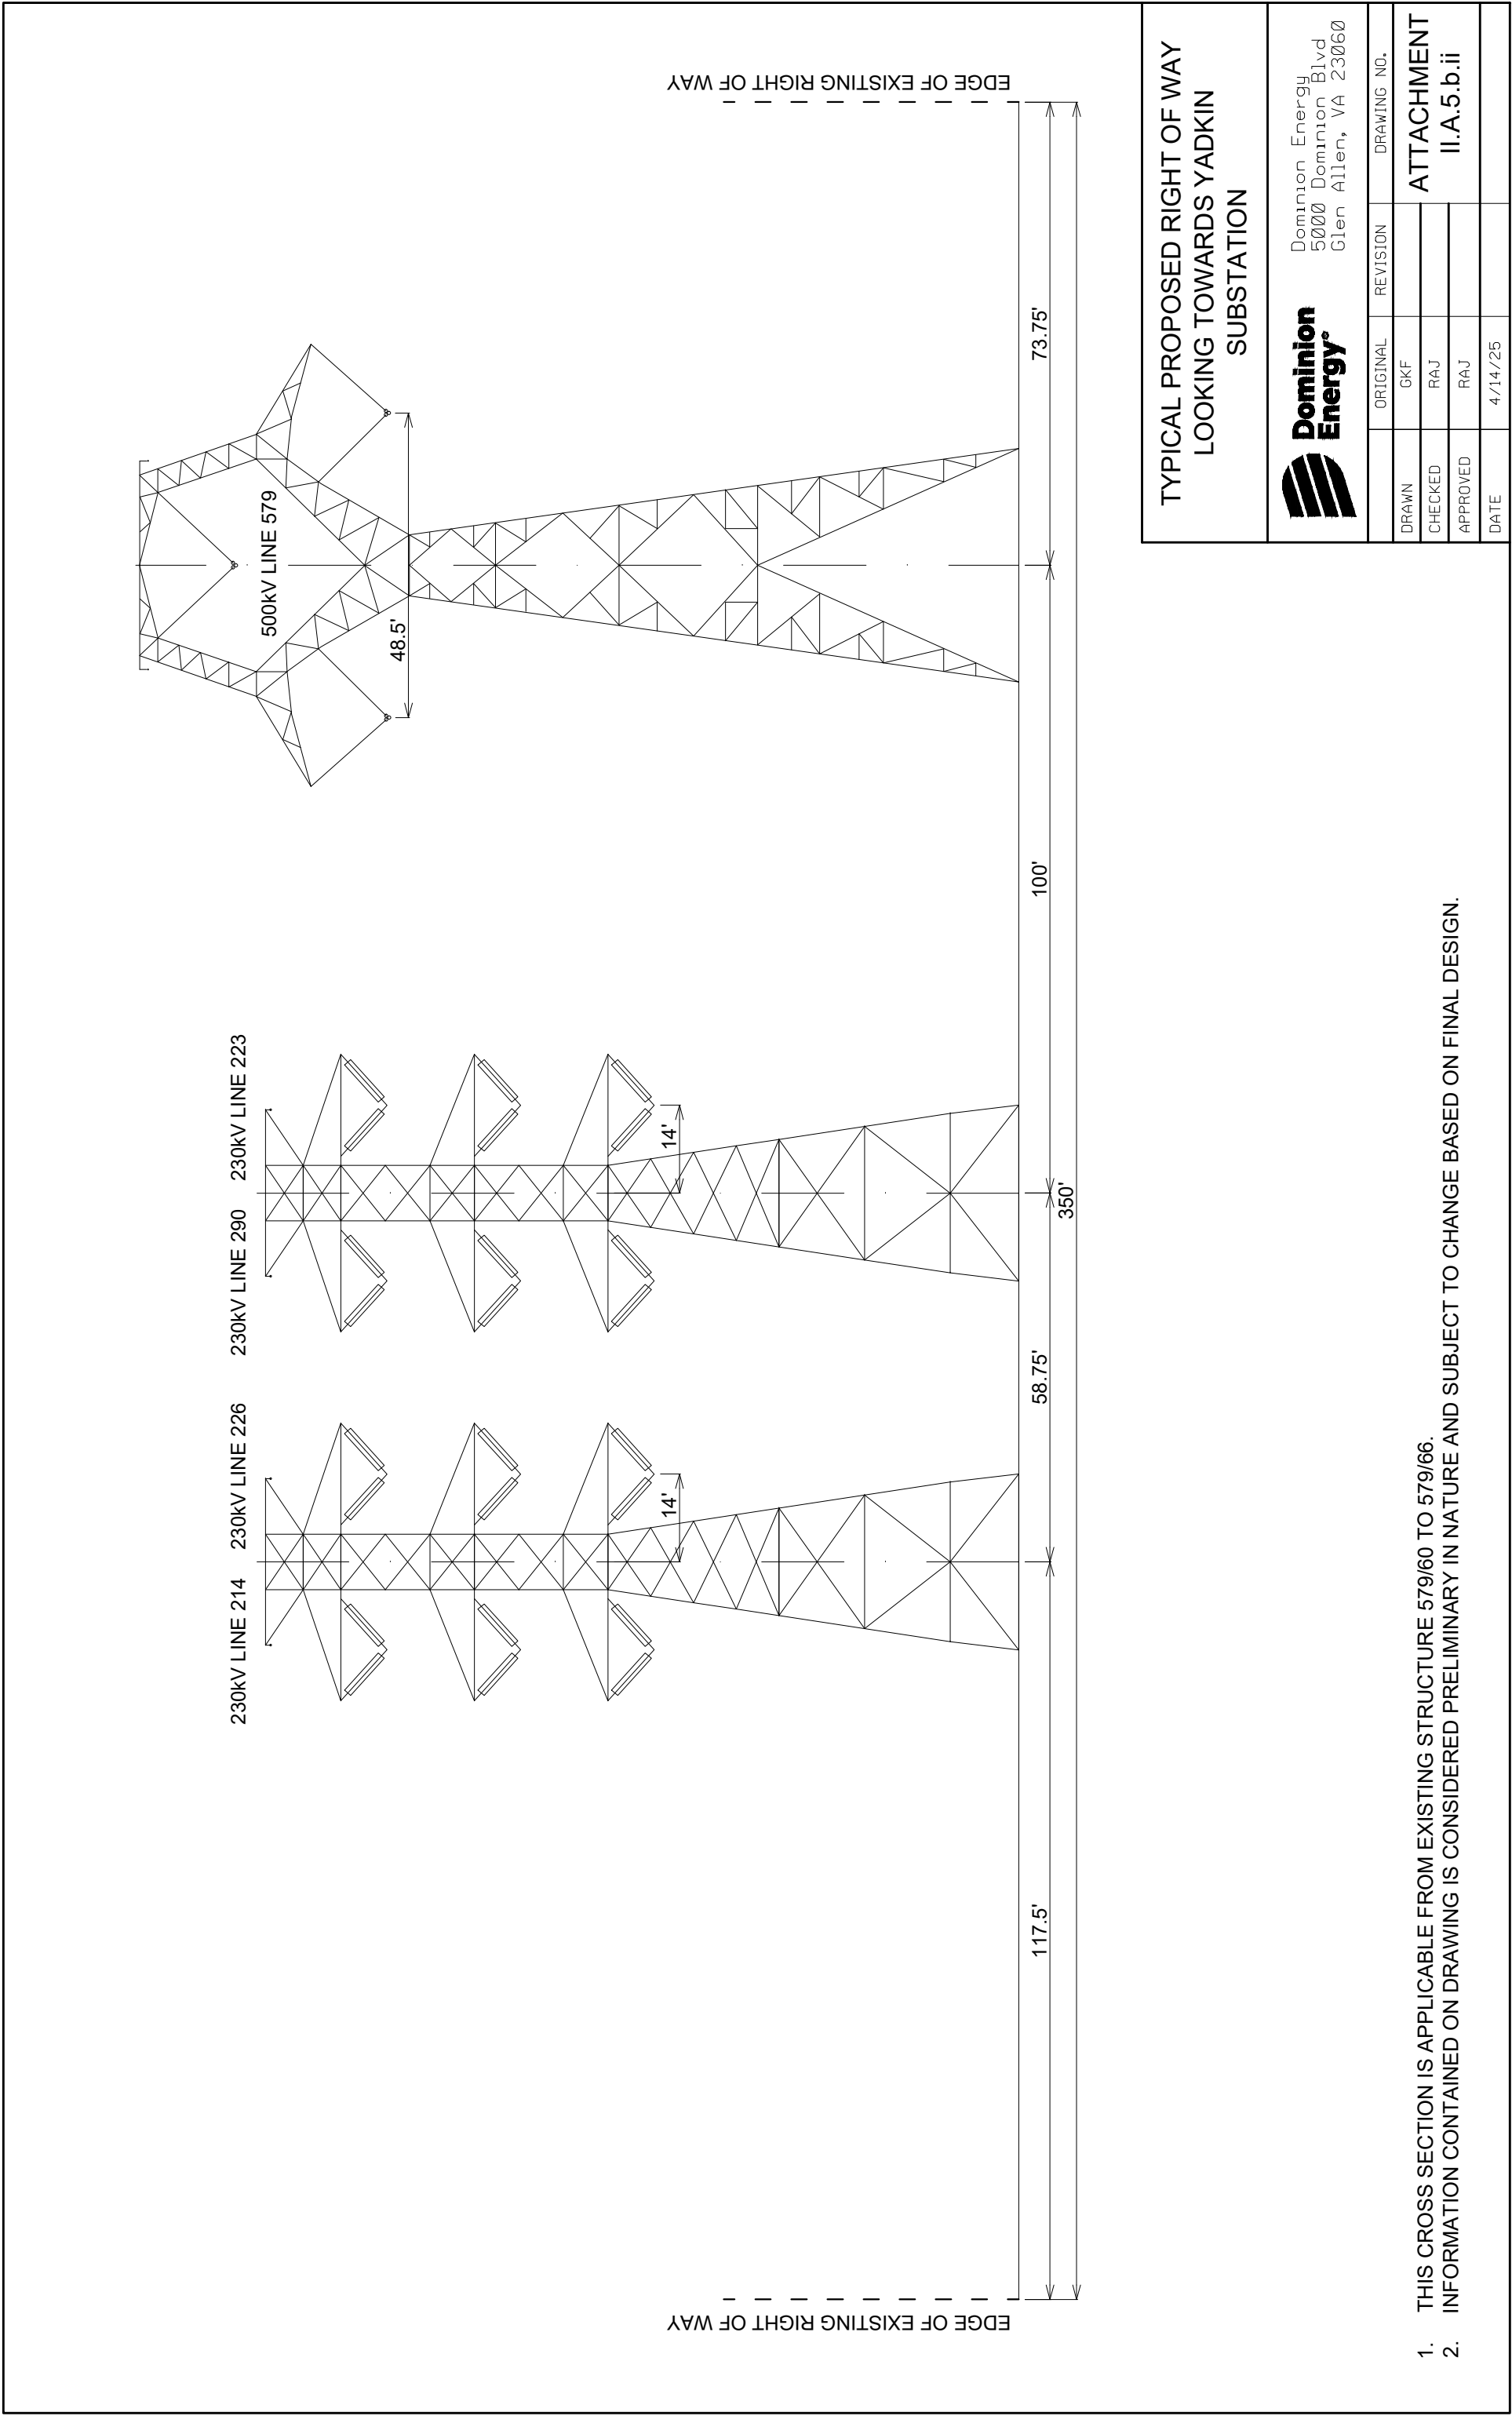
Dominion Energy 5000 Dominion Blvd Glen Allen, VA 23060	
	ORIGINAL	REVISION	DRAWING NO.
DRAWN	GKF		ATTACHMENT II.A.5.b.ii
CHECKED	RAJ		
APPROVED	RAJ		
DATE	4/14/25

TYPICAL PROPOSED RIGHT OF WAY LOOKING TOWARDS YADKIN SUBSTATION

1. THIS CROSS SECTION IS APPLICABLE FROM EXISTING STRUCTURE 579/60 TO 579/66.
2. INFORMATION CONTAINED ON DRAWING IS CONSIDERED PRELIMINARY IN NATURE AND SUBJECT TO CHANGE BASED ON FINAL DESIGN.

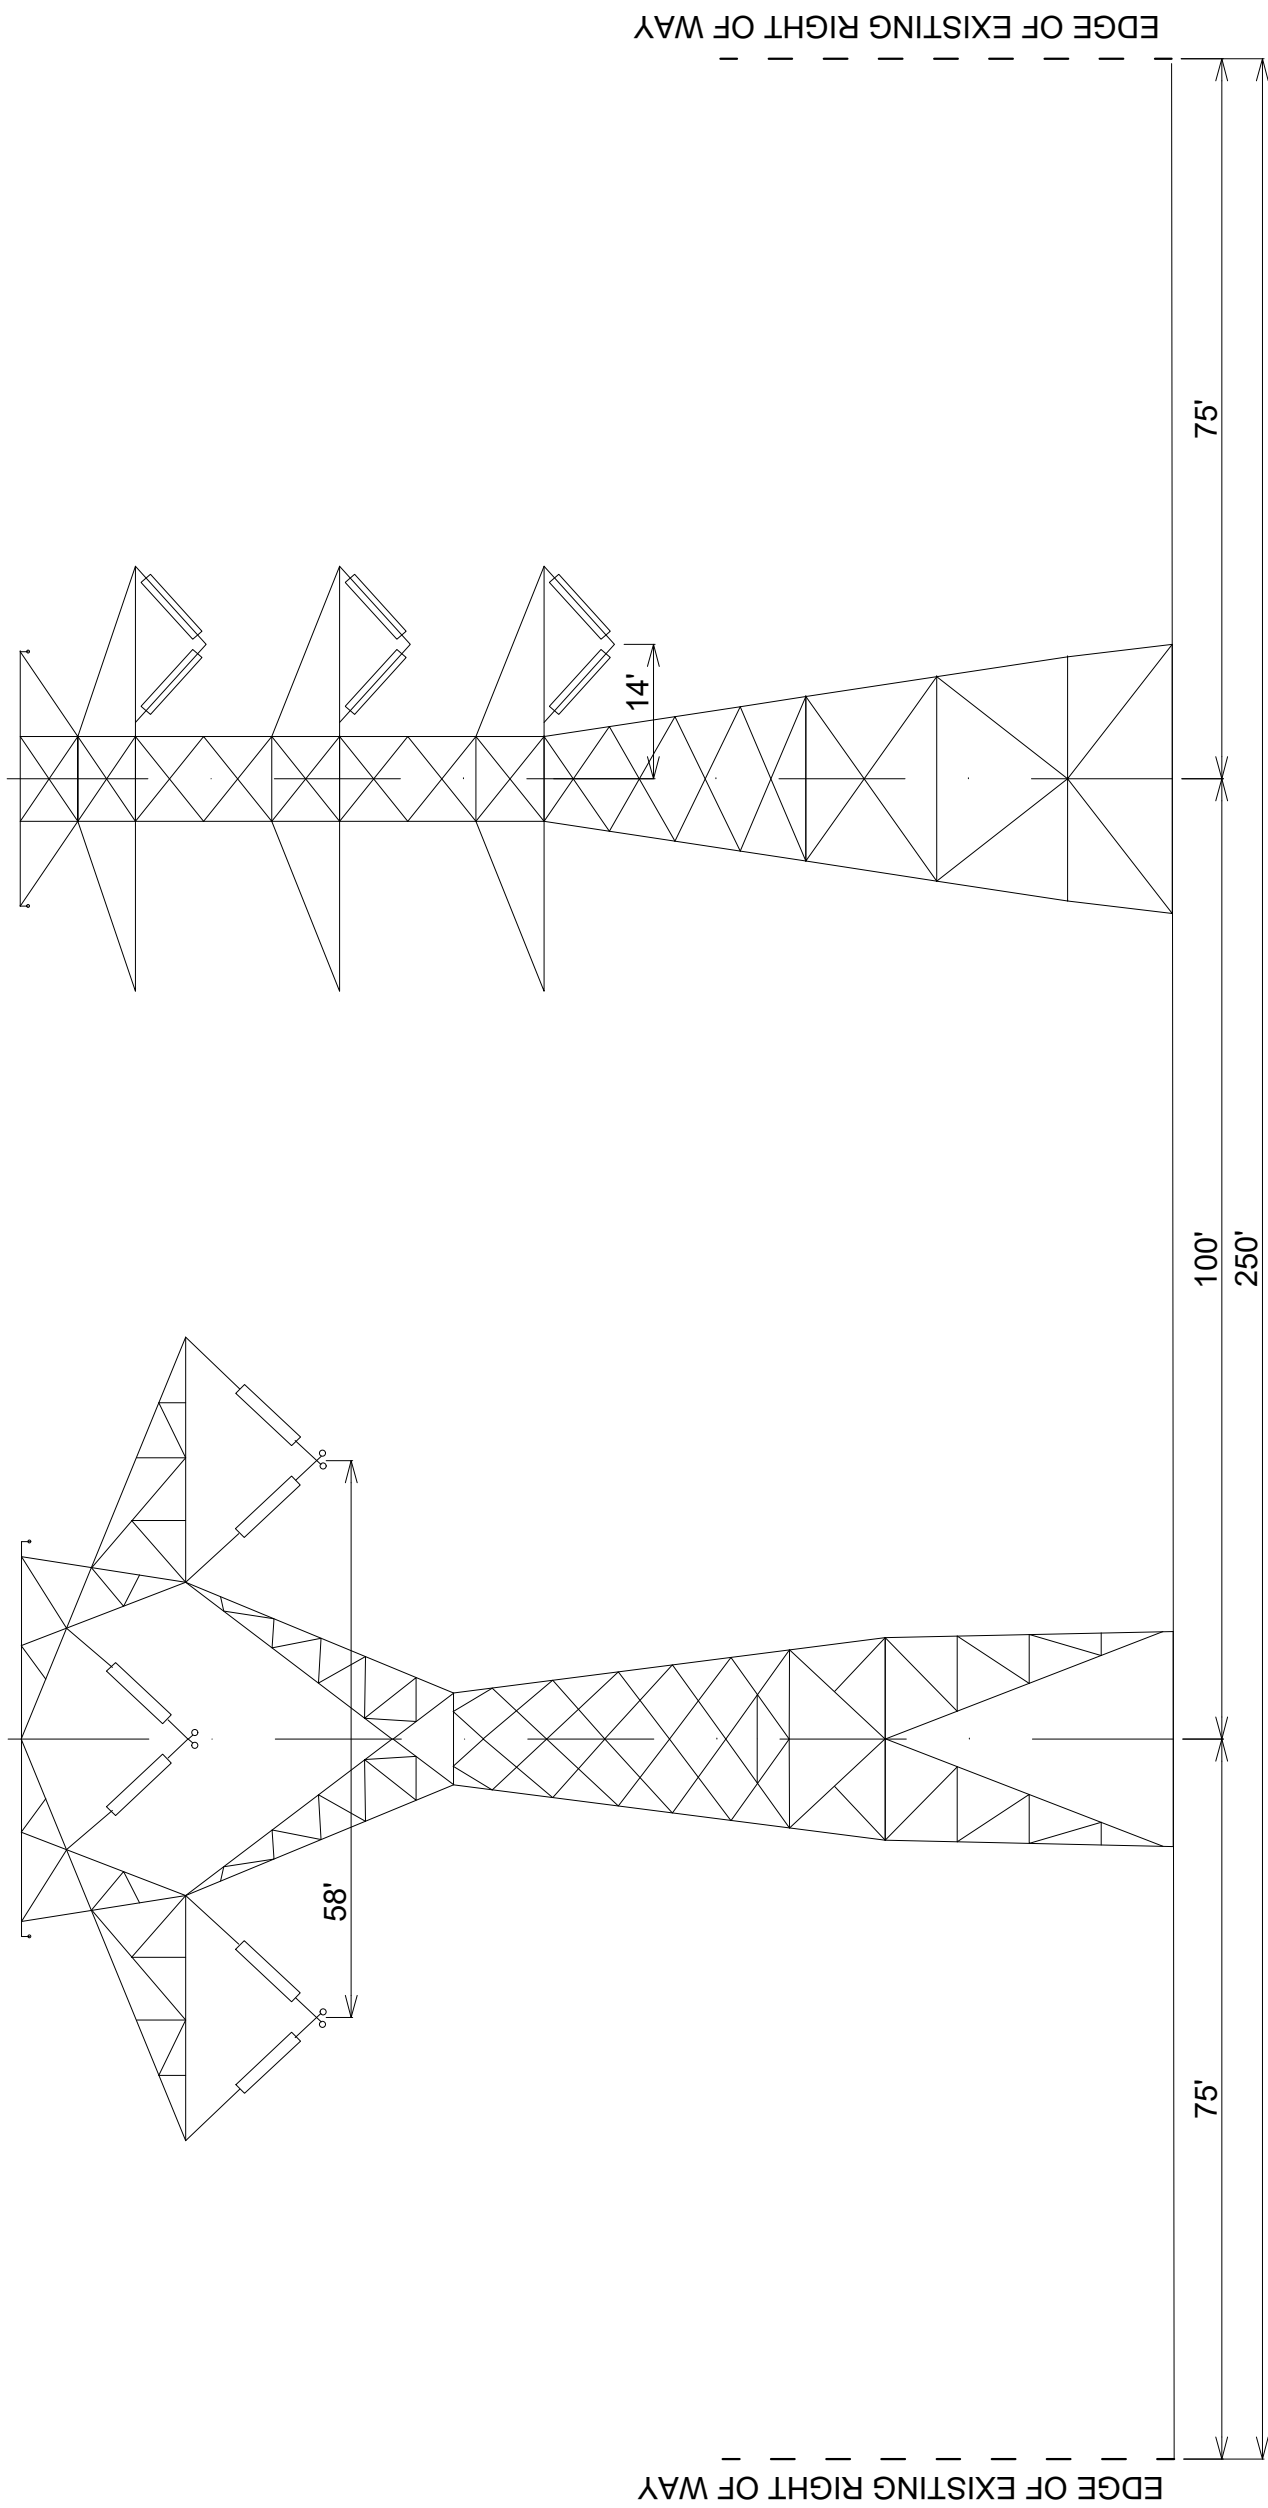
ORIGINAL	REVISION	DRAWING NO.
DRAWN	GKF		<b>ATTACHMENT II.A.5.c.i</b>
CHECKED	RAJ		
APPROVED	RAJ		
DATE	4/7/25

TYPICAL EXISTING RIGHT OF WAY  
LOOKING TOWARDS YADKIN  
SUBSTATION

1. THIS CROSS SECTION IS APPLICABLE FROM EXISTING STRUCTURE 579/66 TO 579/76 AND FROM 579/79 TO 579/94.

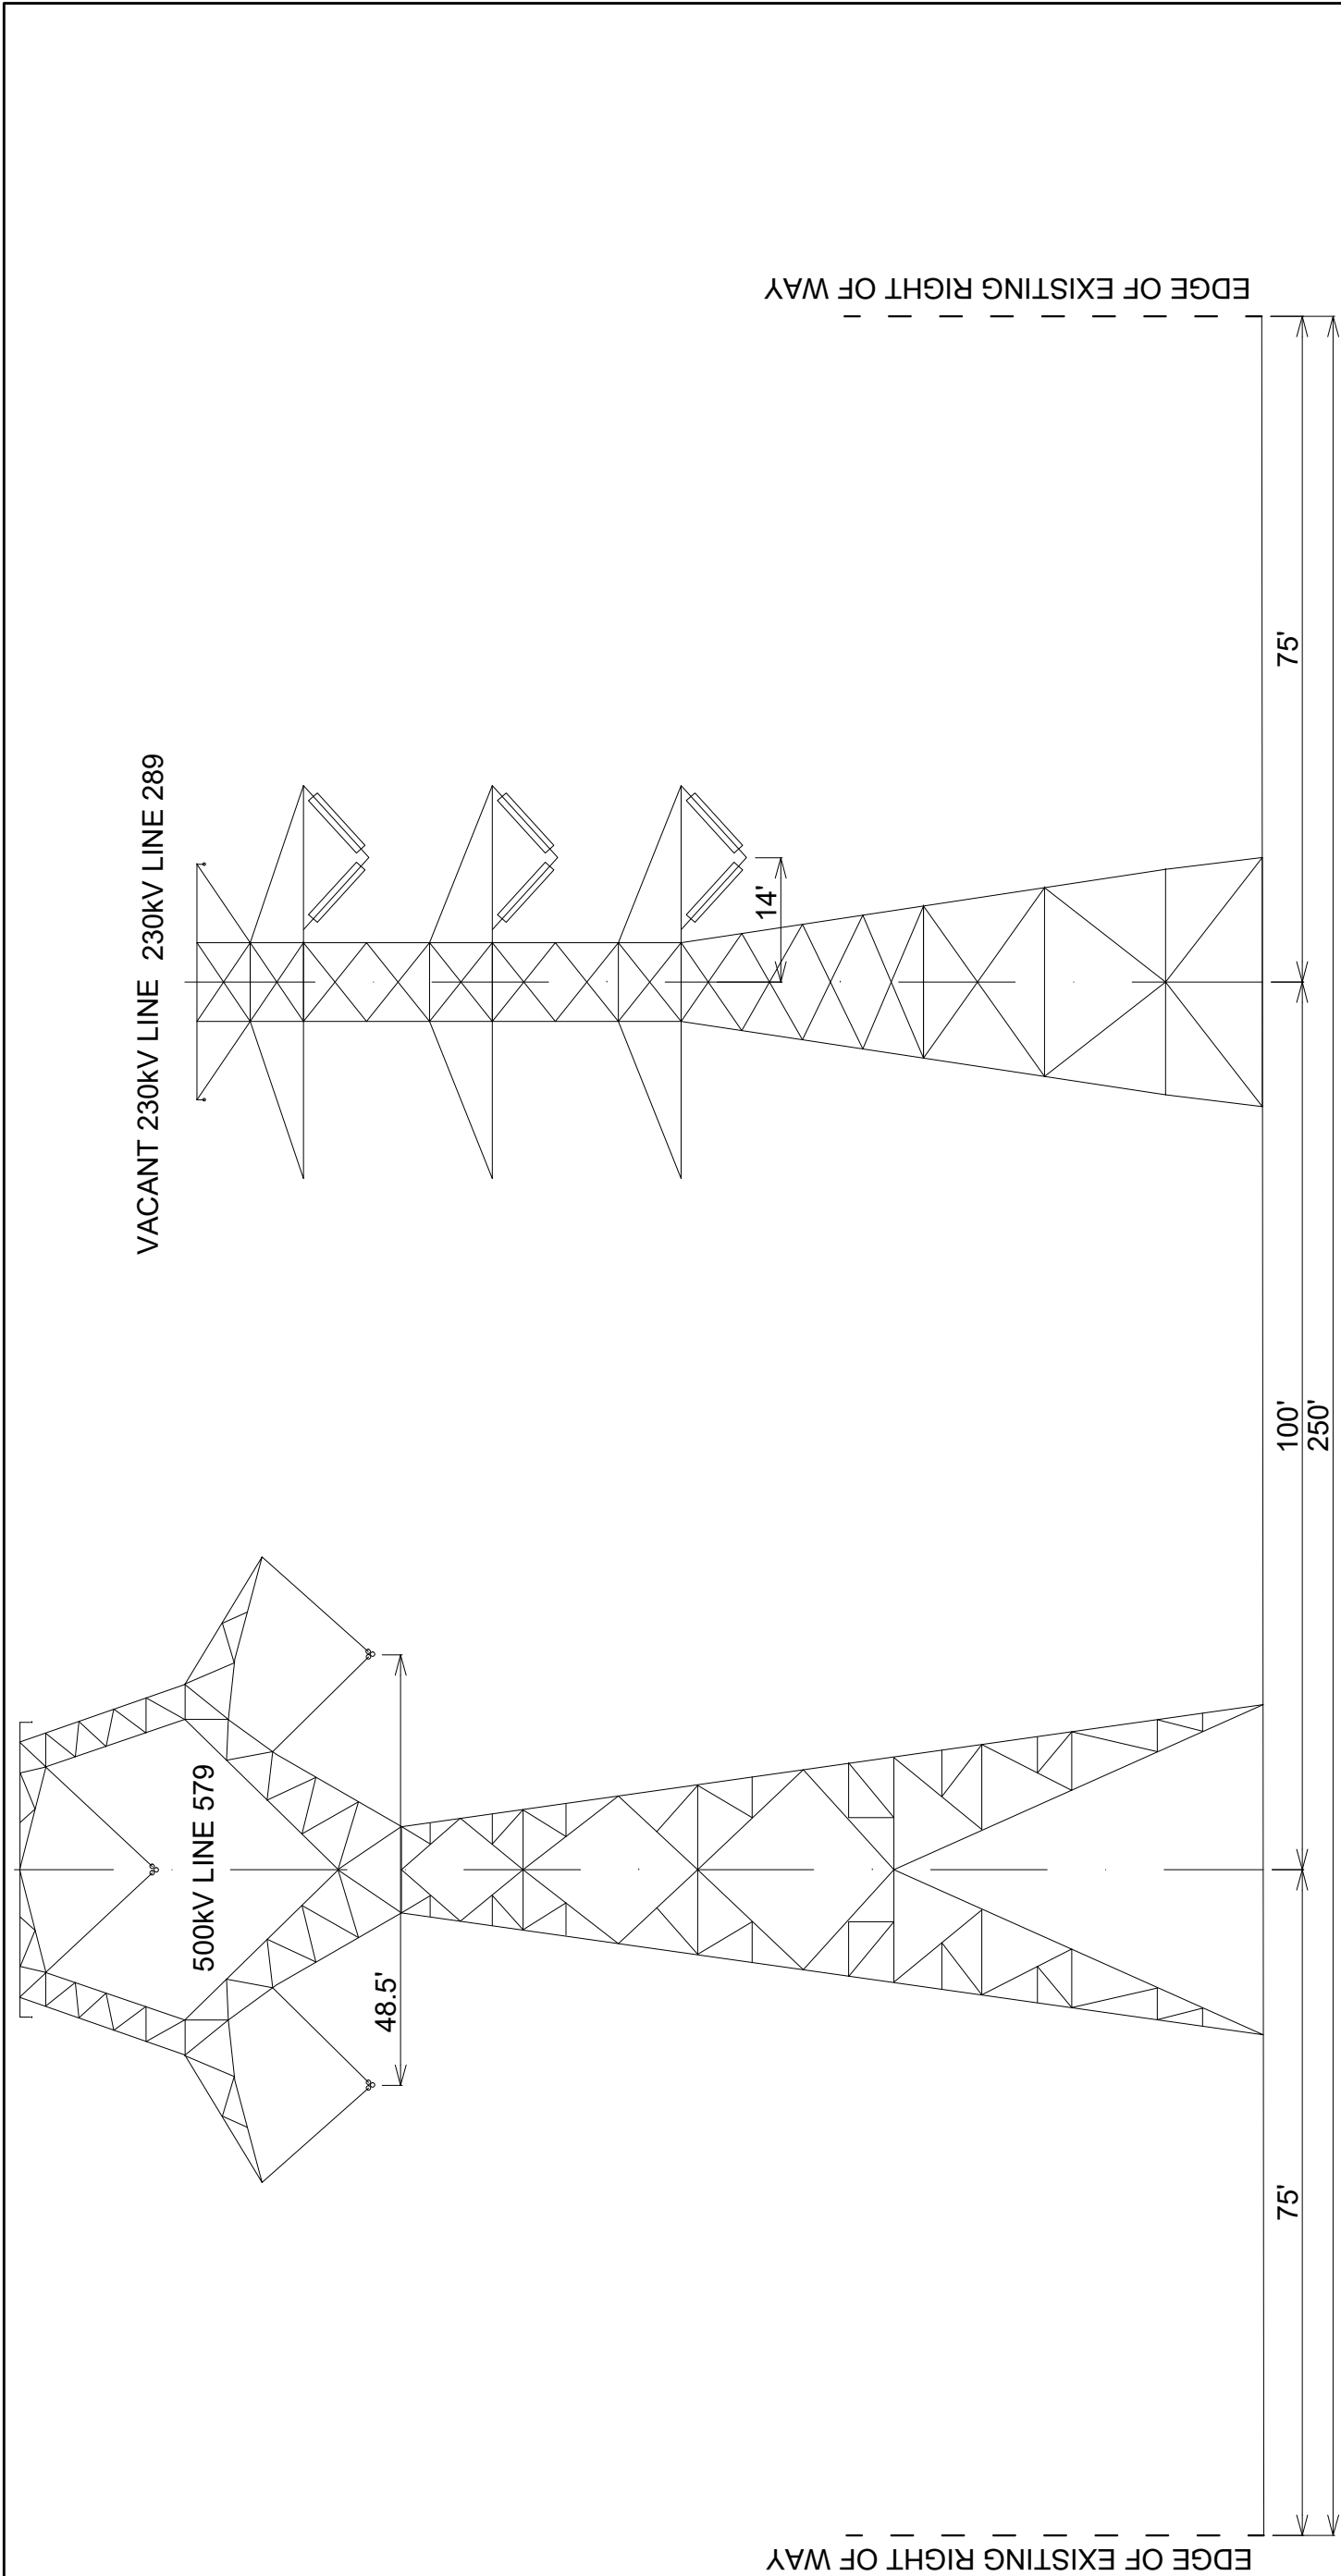
Dominion Energy 5000 Dominion Blvd Glen Allen, VA 23060	
ORIGINAL	REVISION	DRAWING NO.	
DRAWN	GKF	ATTACHMENT II.A.5.c.ii	
CHECKED	RAJ		
APPROVED	RAJ		
DATE	4/14/25

TYPICAL PROPOSED RIGHT OF WAY LOOKING TOWARDS YADKIN SUBSTATION

1. THIS CROSS SECTION IS APPLICABLE FROM EXISTING STRUCTURE 579/66 TO 579/76 AND FROM 579/79 TO 579/94.
2. INFORMATION CONTAINED ON DRAWING IS CONSIDERED PRELIMINARY IN NATURE AND SUBJECT TO CHANGE BASED ON FINAL DESIGN.

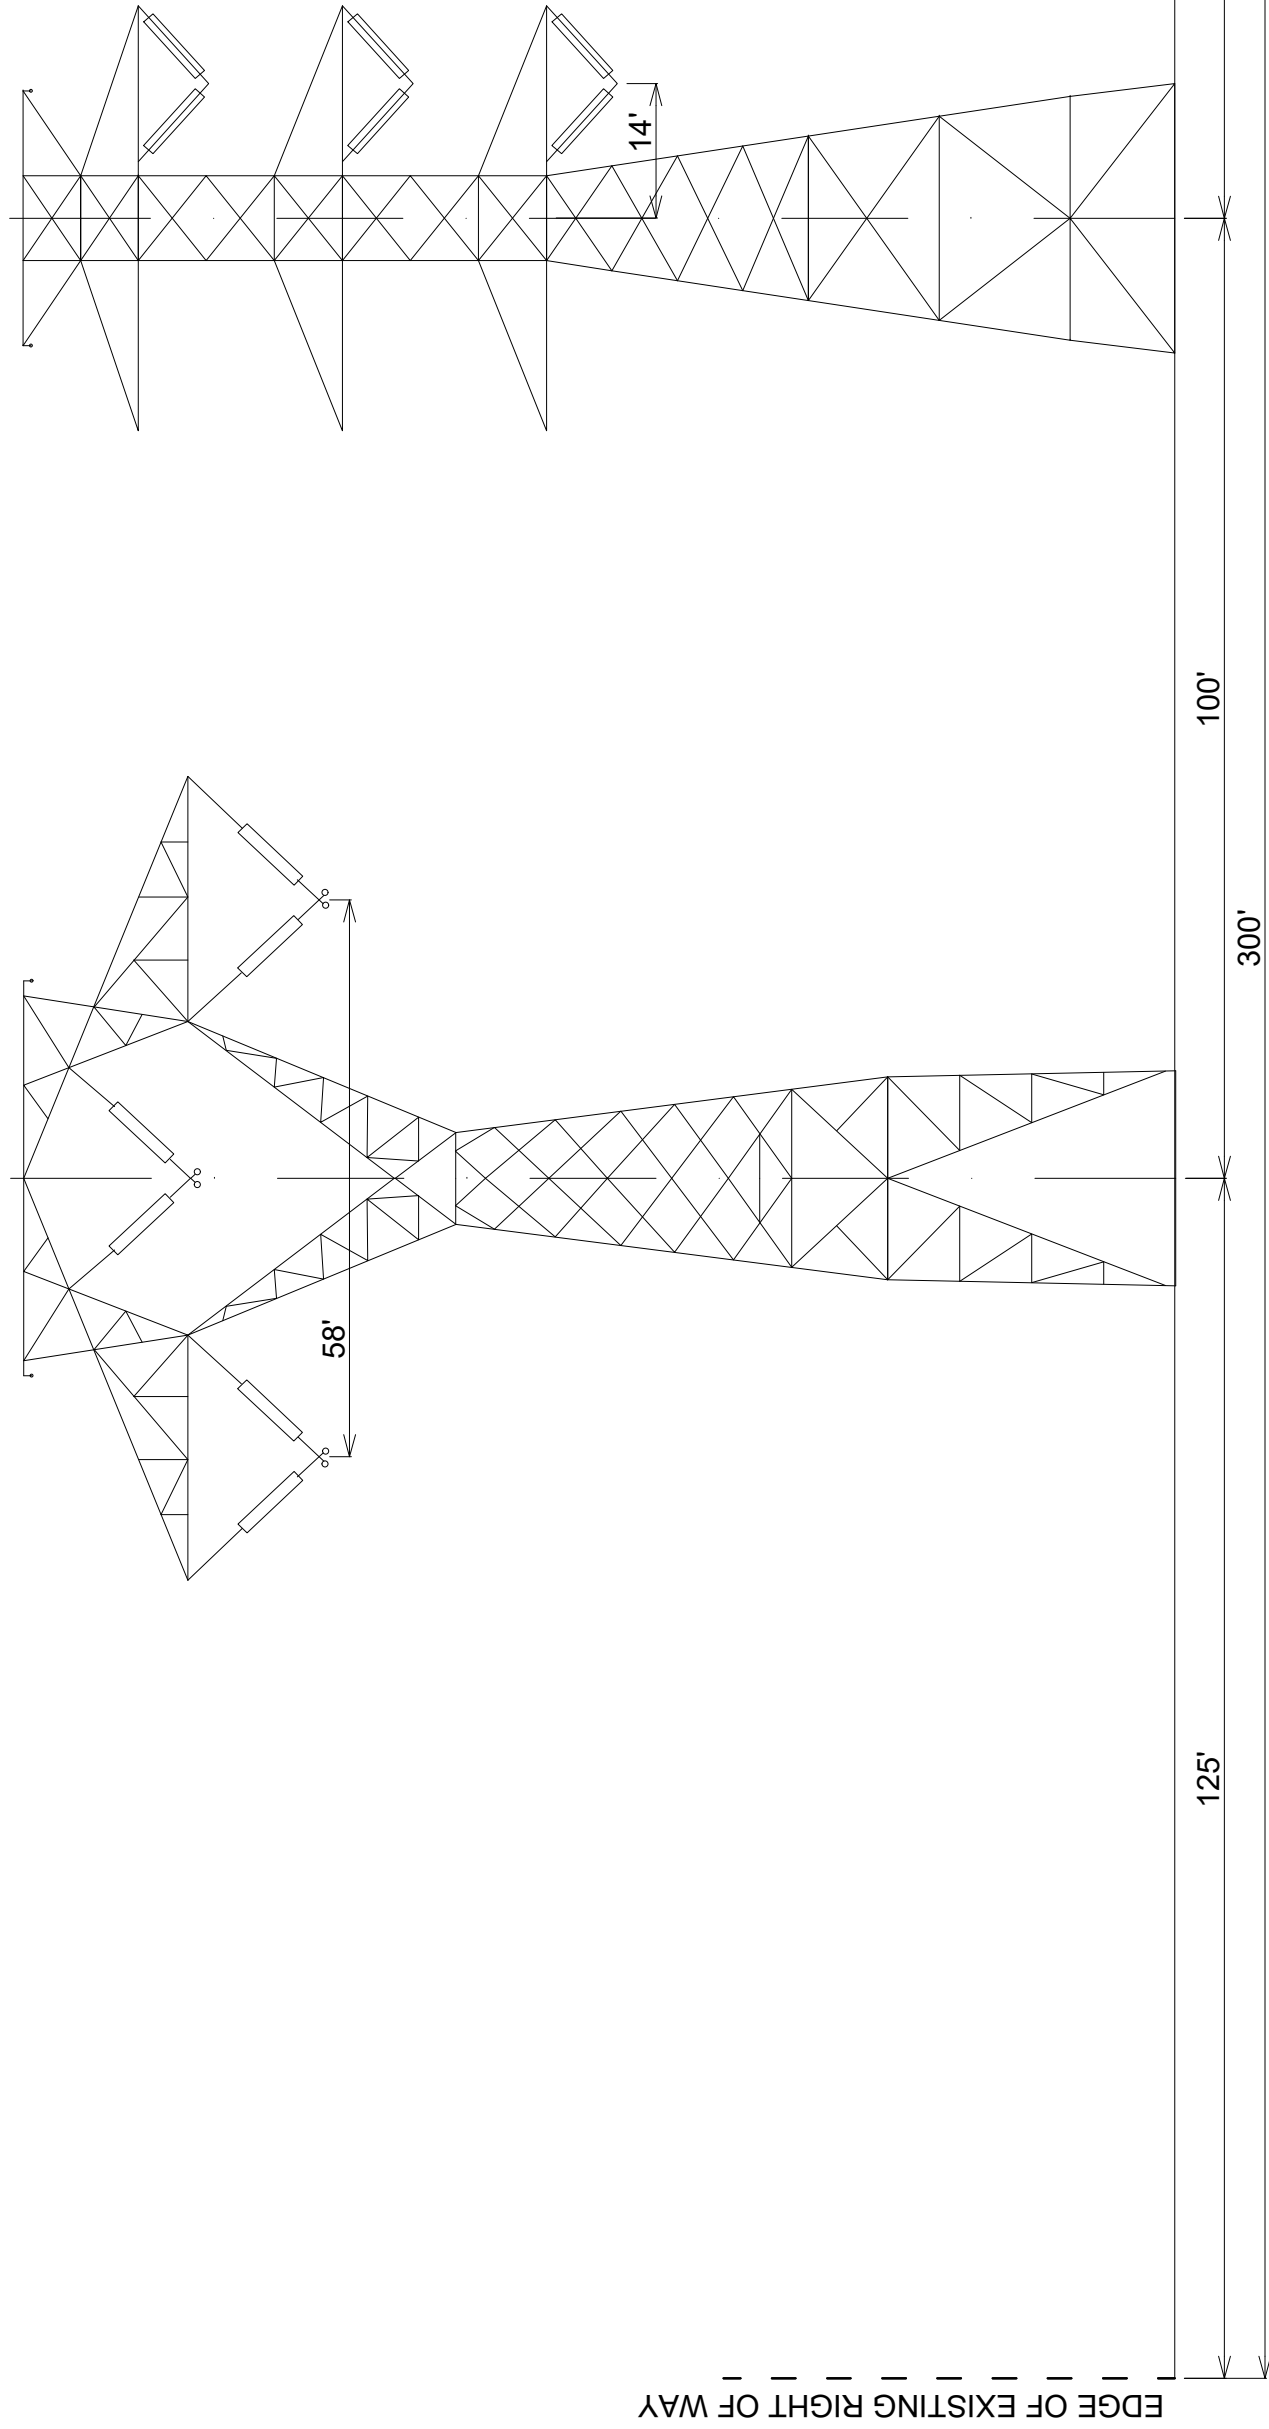
<b>Dominion Energy®</b>	Dominion Energy 5000 Dominion Blvd Glen Allen, VA 23060			
		ORIGINAL	REVISION	DRAWING NO.
	DRAWN	GKF		<b>ATTACHMENT</b> <b>II.A.5.d.i</b>
	CHECKED	RAJ		
APPROVED	RAJ			
DATE	4/14/25

## TYPICAL EXISTING RIGHT OF WAY LOOKING TOWARDS YADKIN SUBSTATION

1. THIS CROSS SECTION IS APPLICABLE FROM EXISTING STRUCTURE 579/76 TO 579/79.

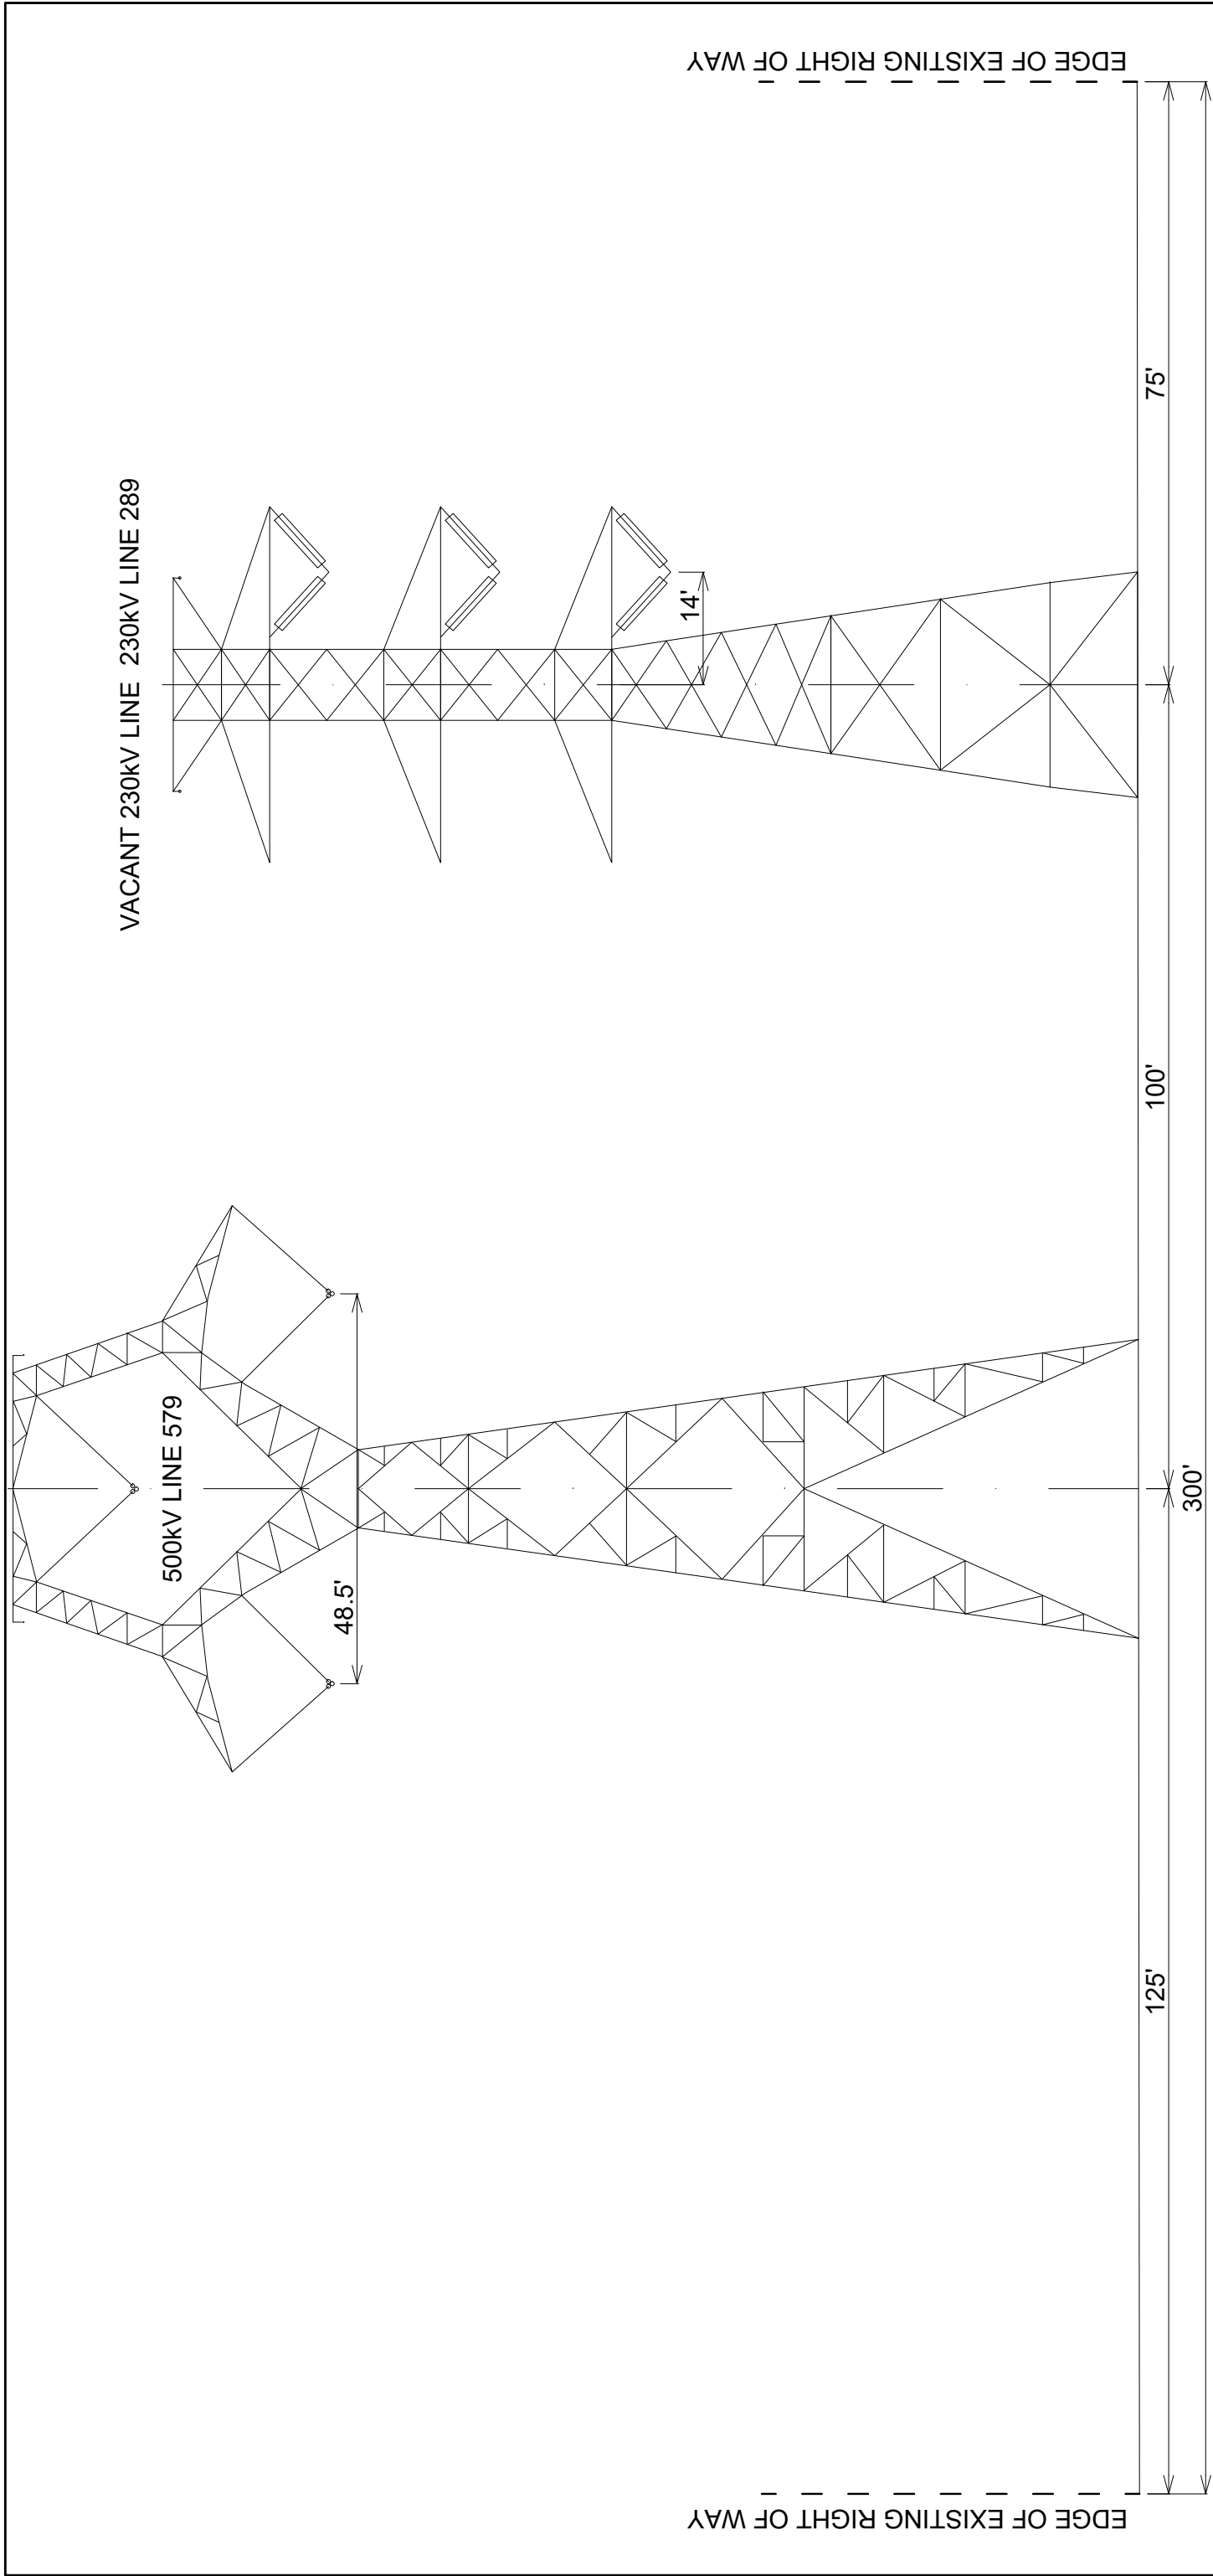
Dominion Energy 50000 Dominion Blvd Glen Allen, VA 23060	
	ORIGINAL	REVISION	DRAWING NO.
DRAWN	GKF		ATTACHMENT II.A.5.d.ii
CHECKED	RAJ		
APPROVED	RAJ		
DATE	4/14/25

TYPICAL PROPOSED RIGHT OF WAY LOOKING TOWARDS YADKIN SUBSTATION

1. THIS CROSS SECTION IS APPLICABLE FROM EXISTING STRUCTURE 579/76 TO 579/79.
2. INFORMATION CONTAINED ON DRAWING IS CONSIDERED PRELIMINARY IN NATURE AND SUBJECT TO CHANGE BASED ON FINAL DESIGN.
