*Application of Virginia Electric and Power Company for approval and certification  
of electric transmission facilities: 500 kV Septa-Yadkin Line #579 Rebuild and  
230 kV Suffolk-Thrasher Line #2110 Partial Rebuild*  
**Case No. PUR-2025-00104**

SEPTA-YADKIN 500 kV LINE #579  
REBUILD AND SUFFOLK-  
THRASHER 230 kV LINE #2110  
PARTIAL REBUILD

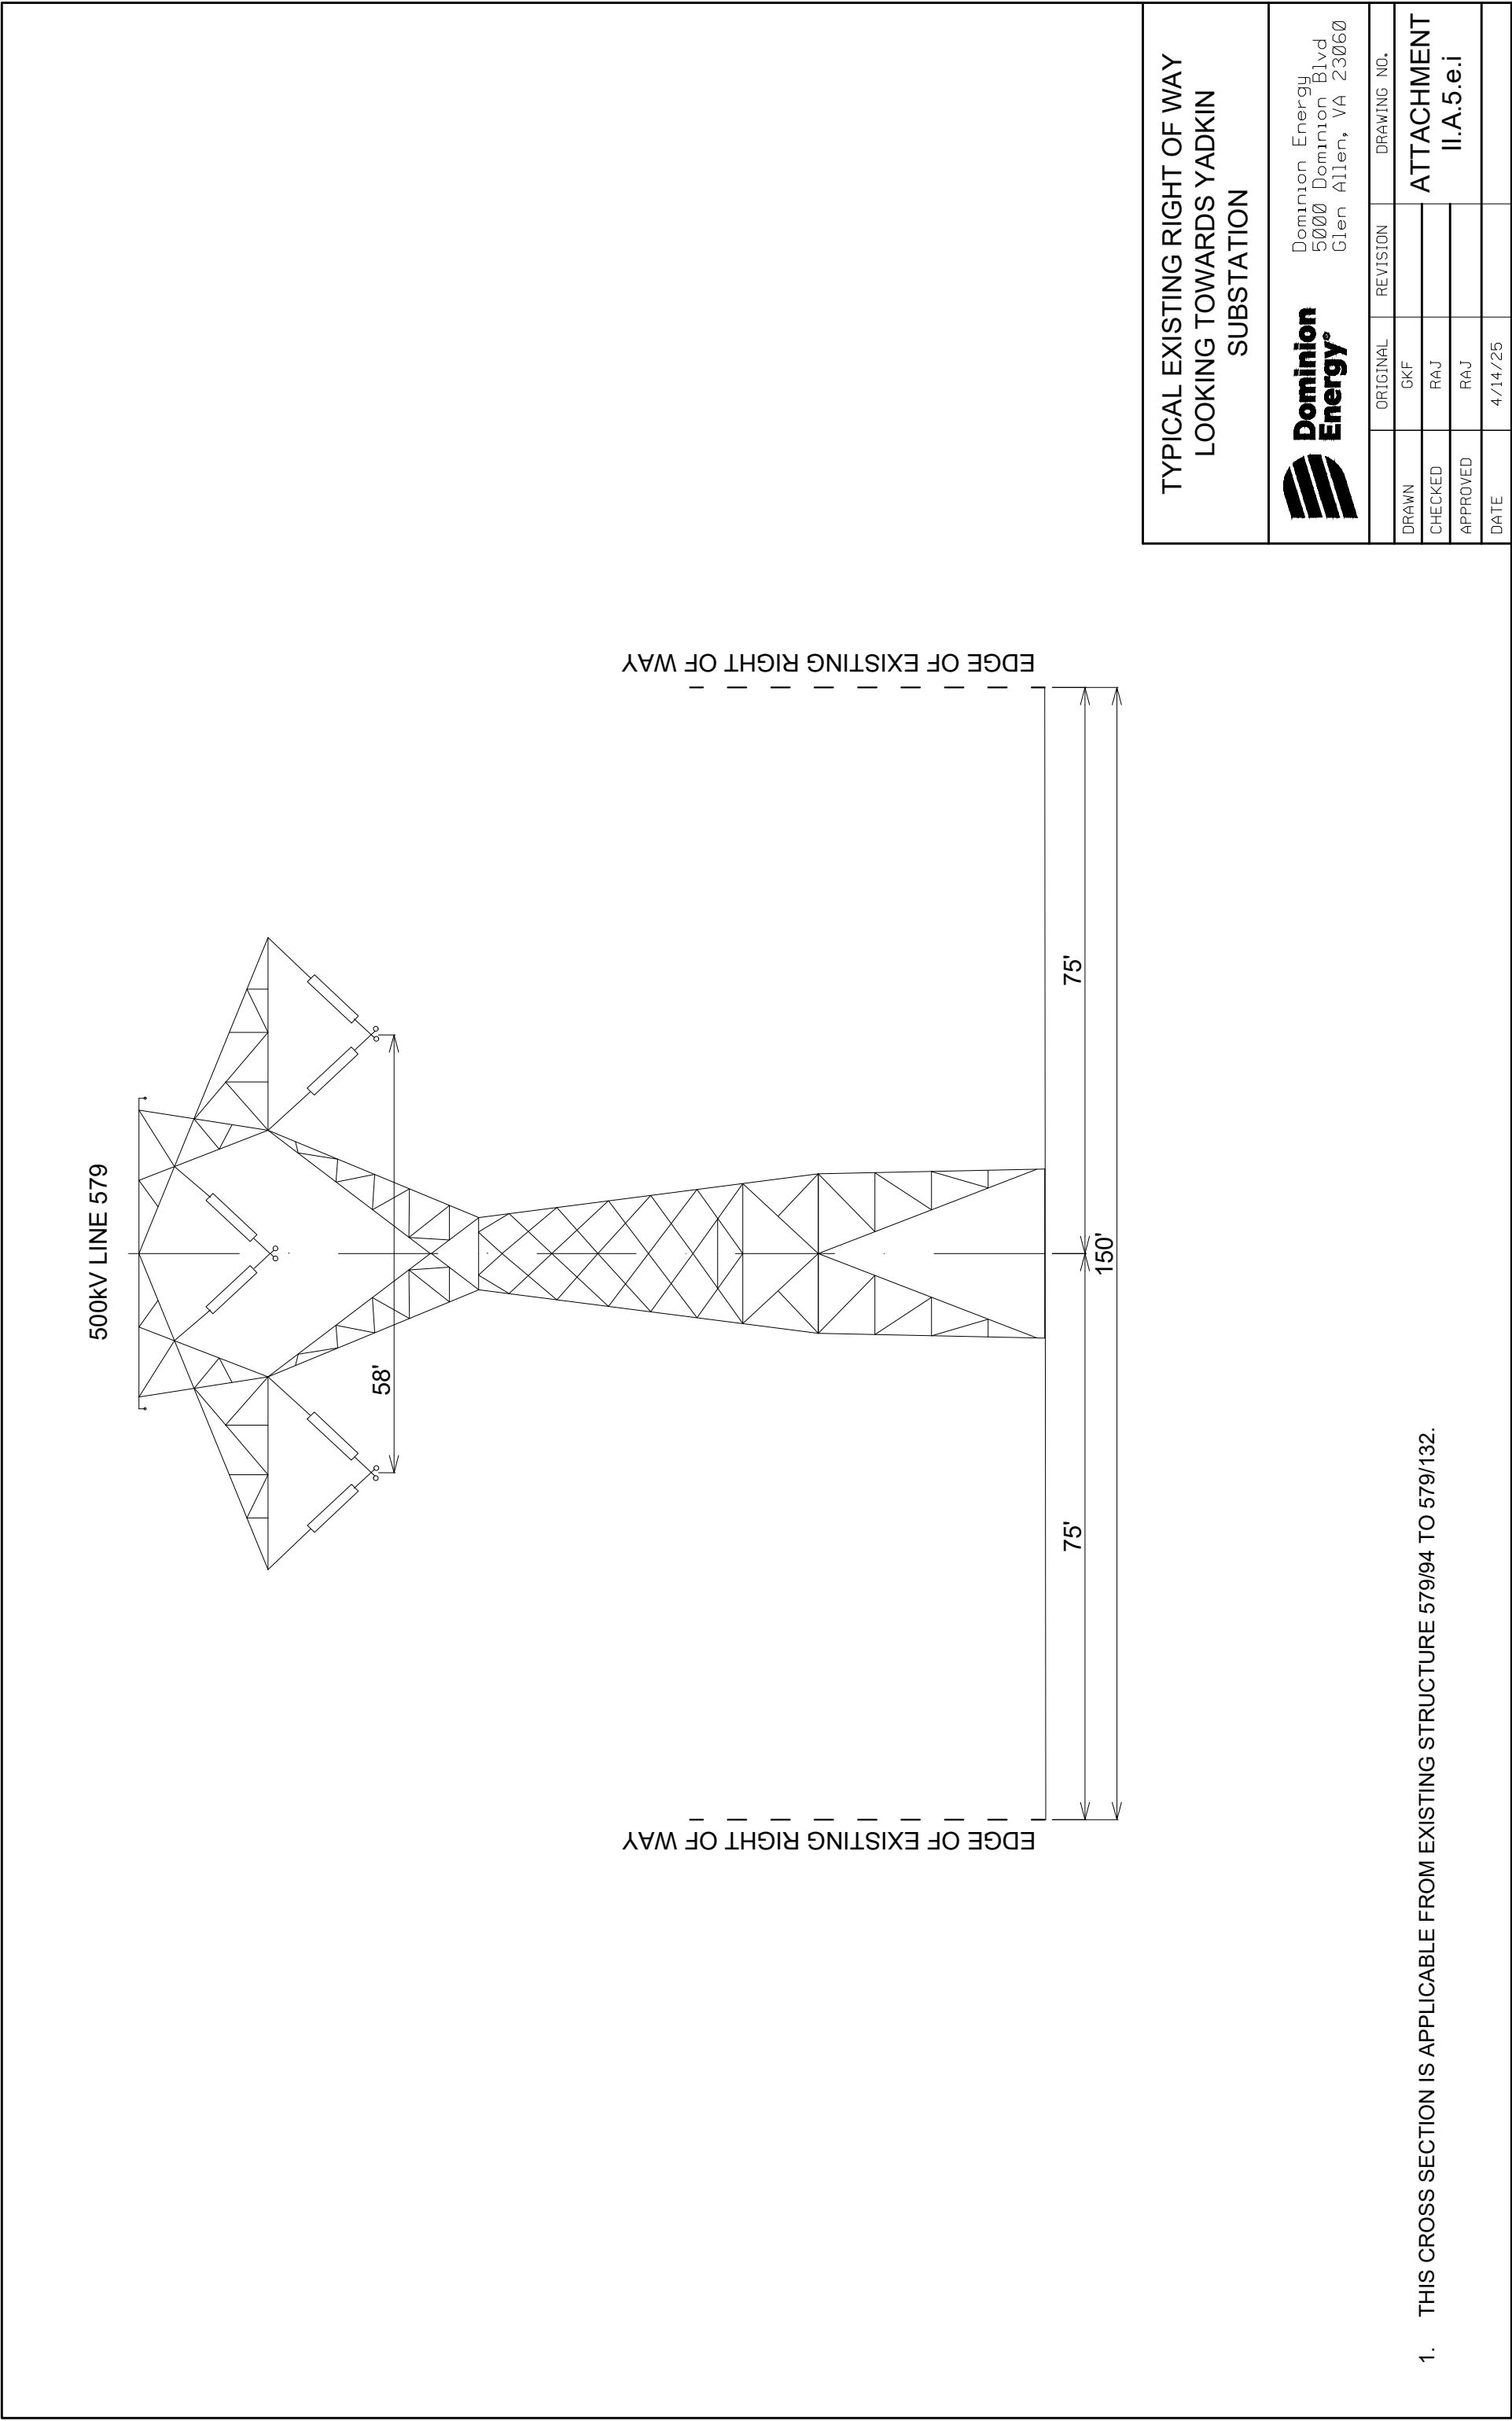
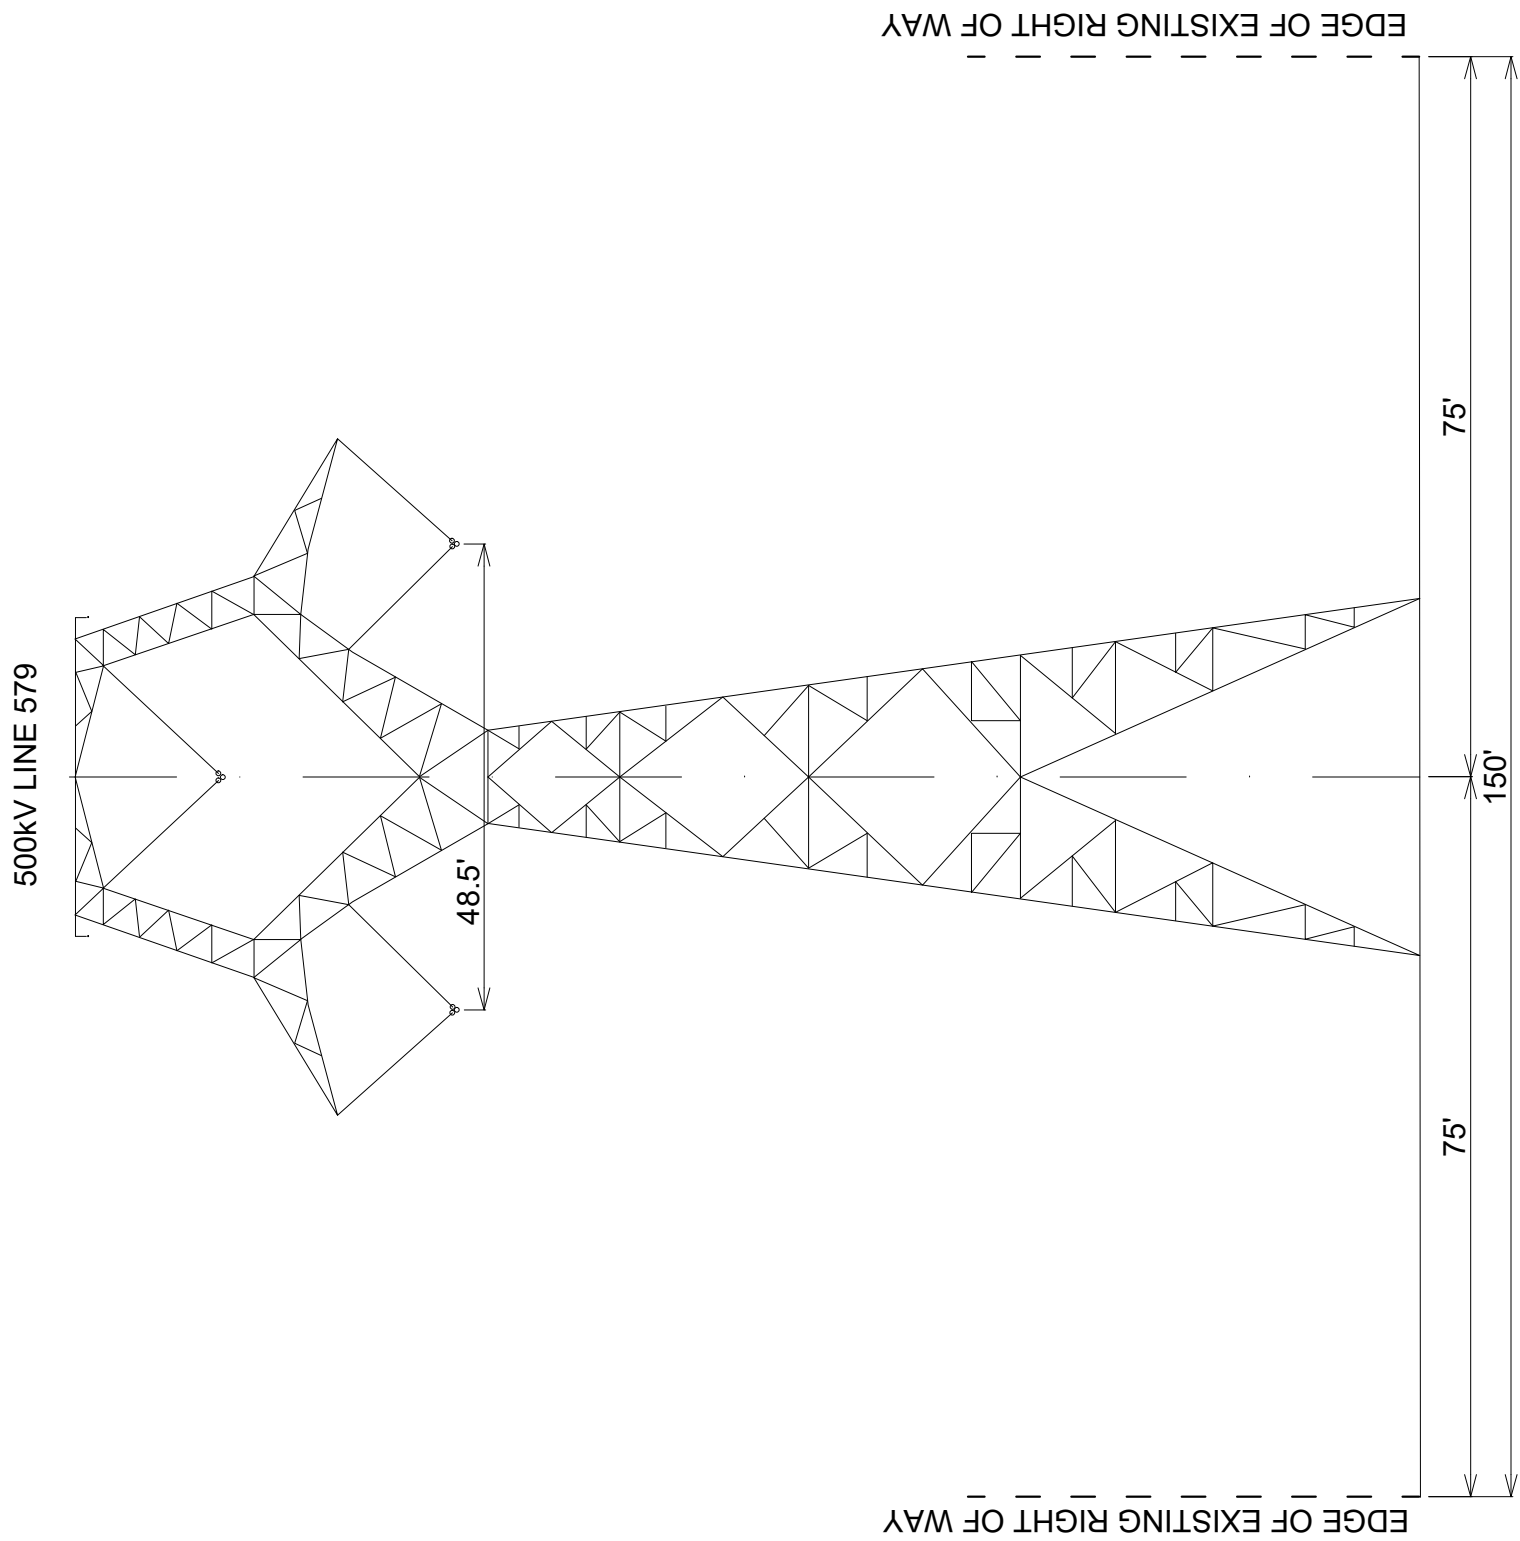
ORIGINAL	REVISION	<b>ATTACHMENT</b> <b>II.A.5.e.ii</b>
DRAWN	GKF		
CHECKED	RAJ		
APPROVED	RAJ		
DATE	4/14/25

1. THIS CROSS SECTION IS APPLICABLE FROM EXISTING STRUCTURE 579/94 TO 579/132.
2. INFORMATION CONTAINED ON DRAWING IS CONSIDERED PRELIMINARY IN NATURE AND SUBJECT TO CHANGE BASED ON FINAL DESIGN.

TYPICAL PROPOSED RIGHT OF WAY  
LOOKING TOWARDS YADKIN  
SUBSTATION

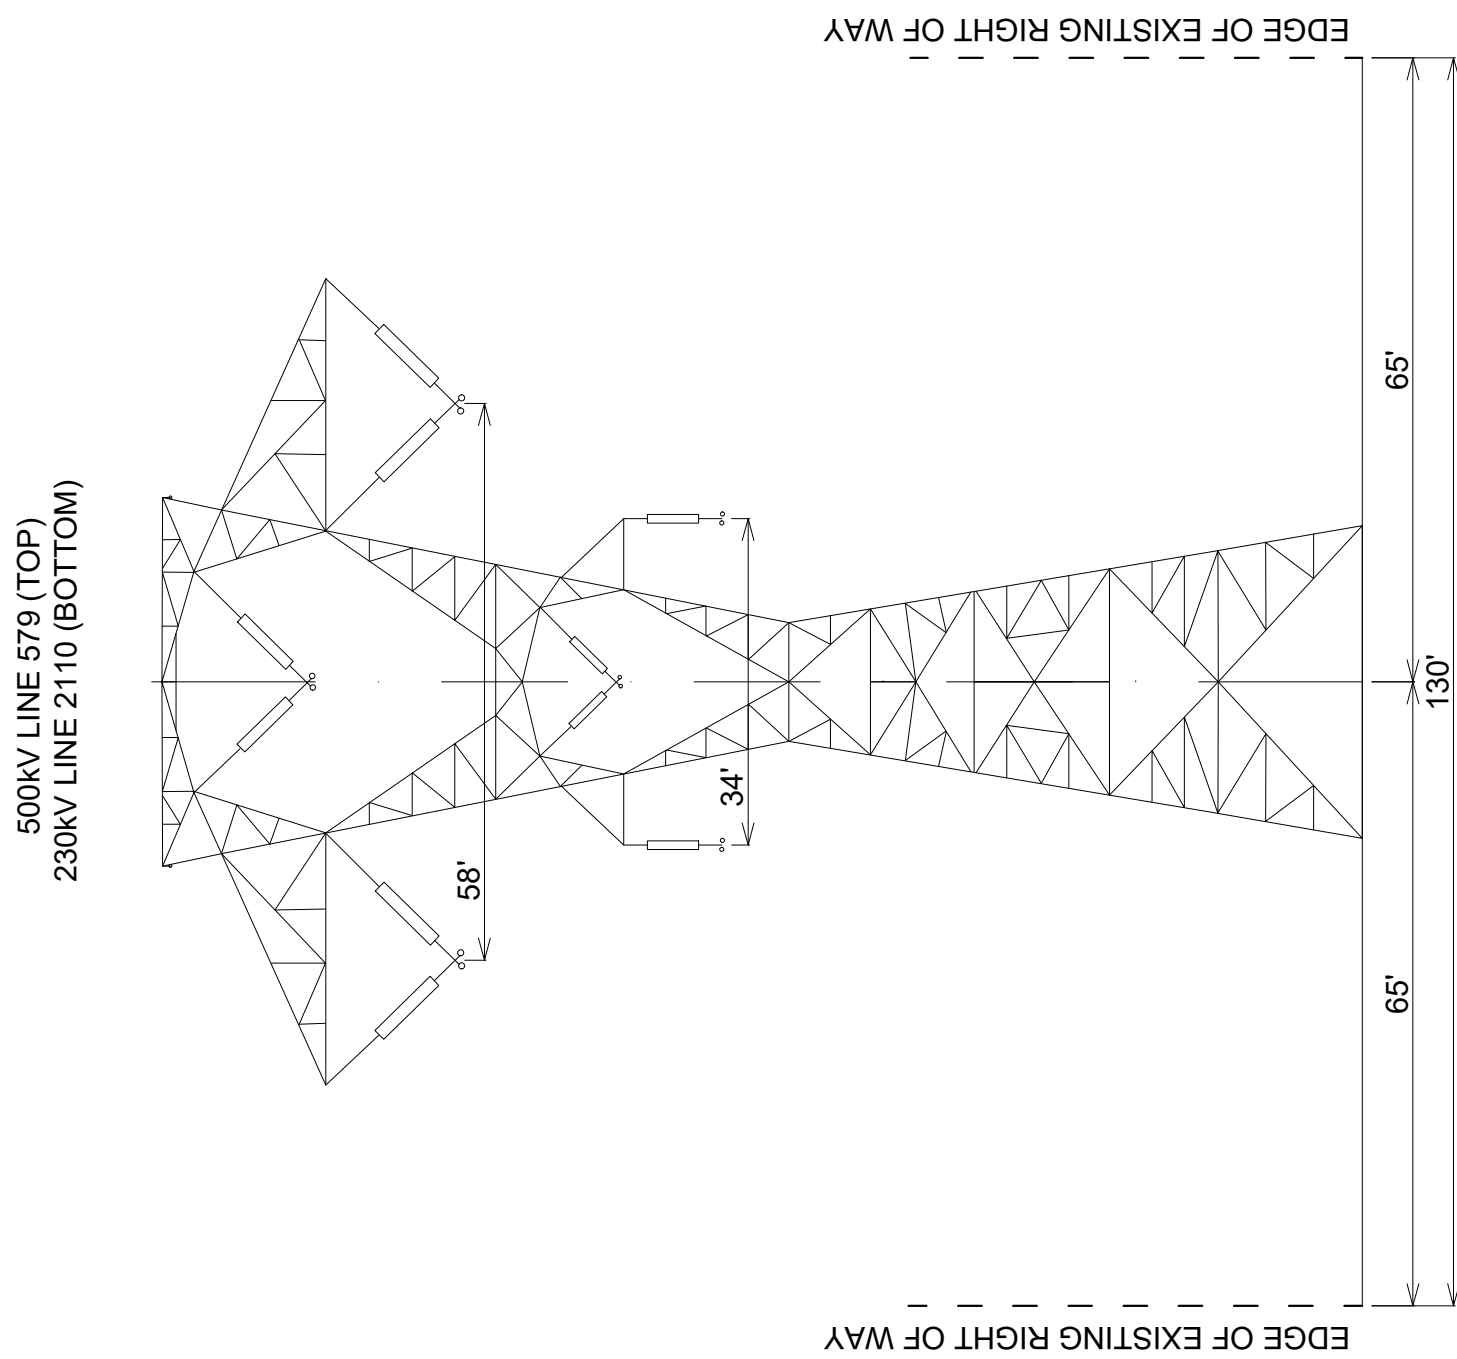
Dominion Energy 5000 Dominion Blvd Glen Allen, VA 23060		DRAWING NO.
DRAWN	GKF	ORIGINAL	REVISION	ATTACHMENT II.A.5.f.i
CHECKED	RAJ			
APPROVED	RAJ			
DATE	4/7/25

1. THIS CROSS SECTION IS APPLICABLE FROM EXISTING STRUCTURE 579/132 TO 579/134 AND FROM 579/158 TO 579/177.

TYPICAL EXISTING RIGHT OF WAY LOOKING TOWARDS YADKIN SUBSTATION

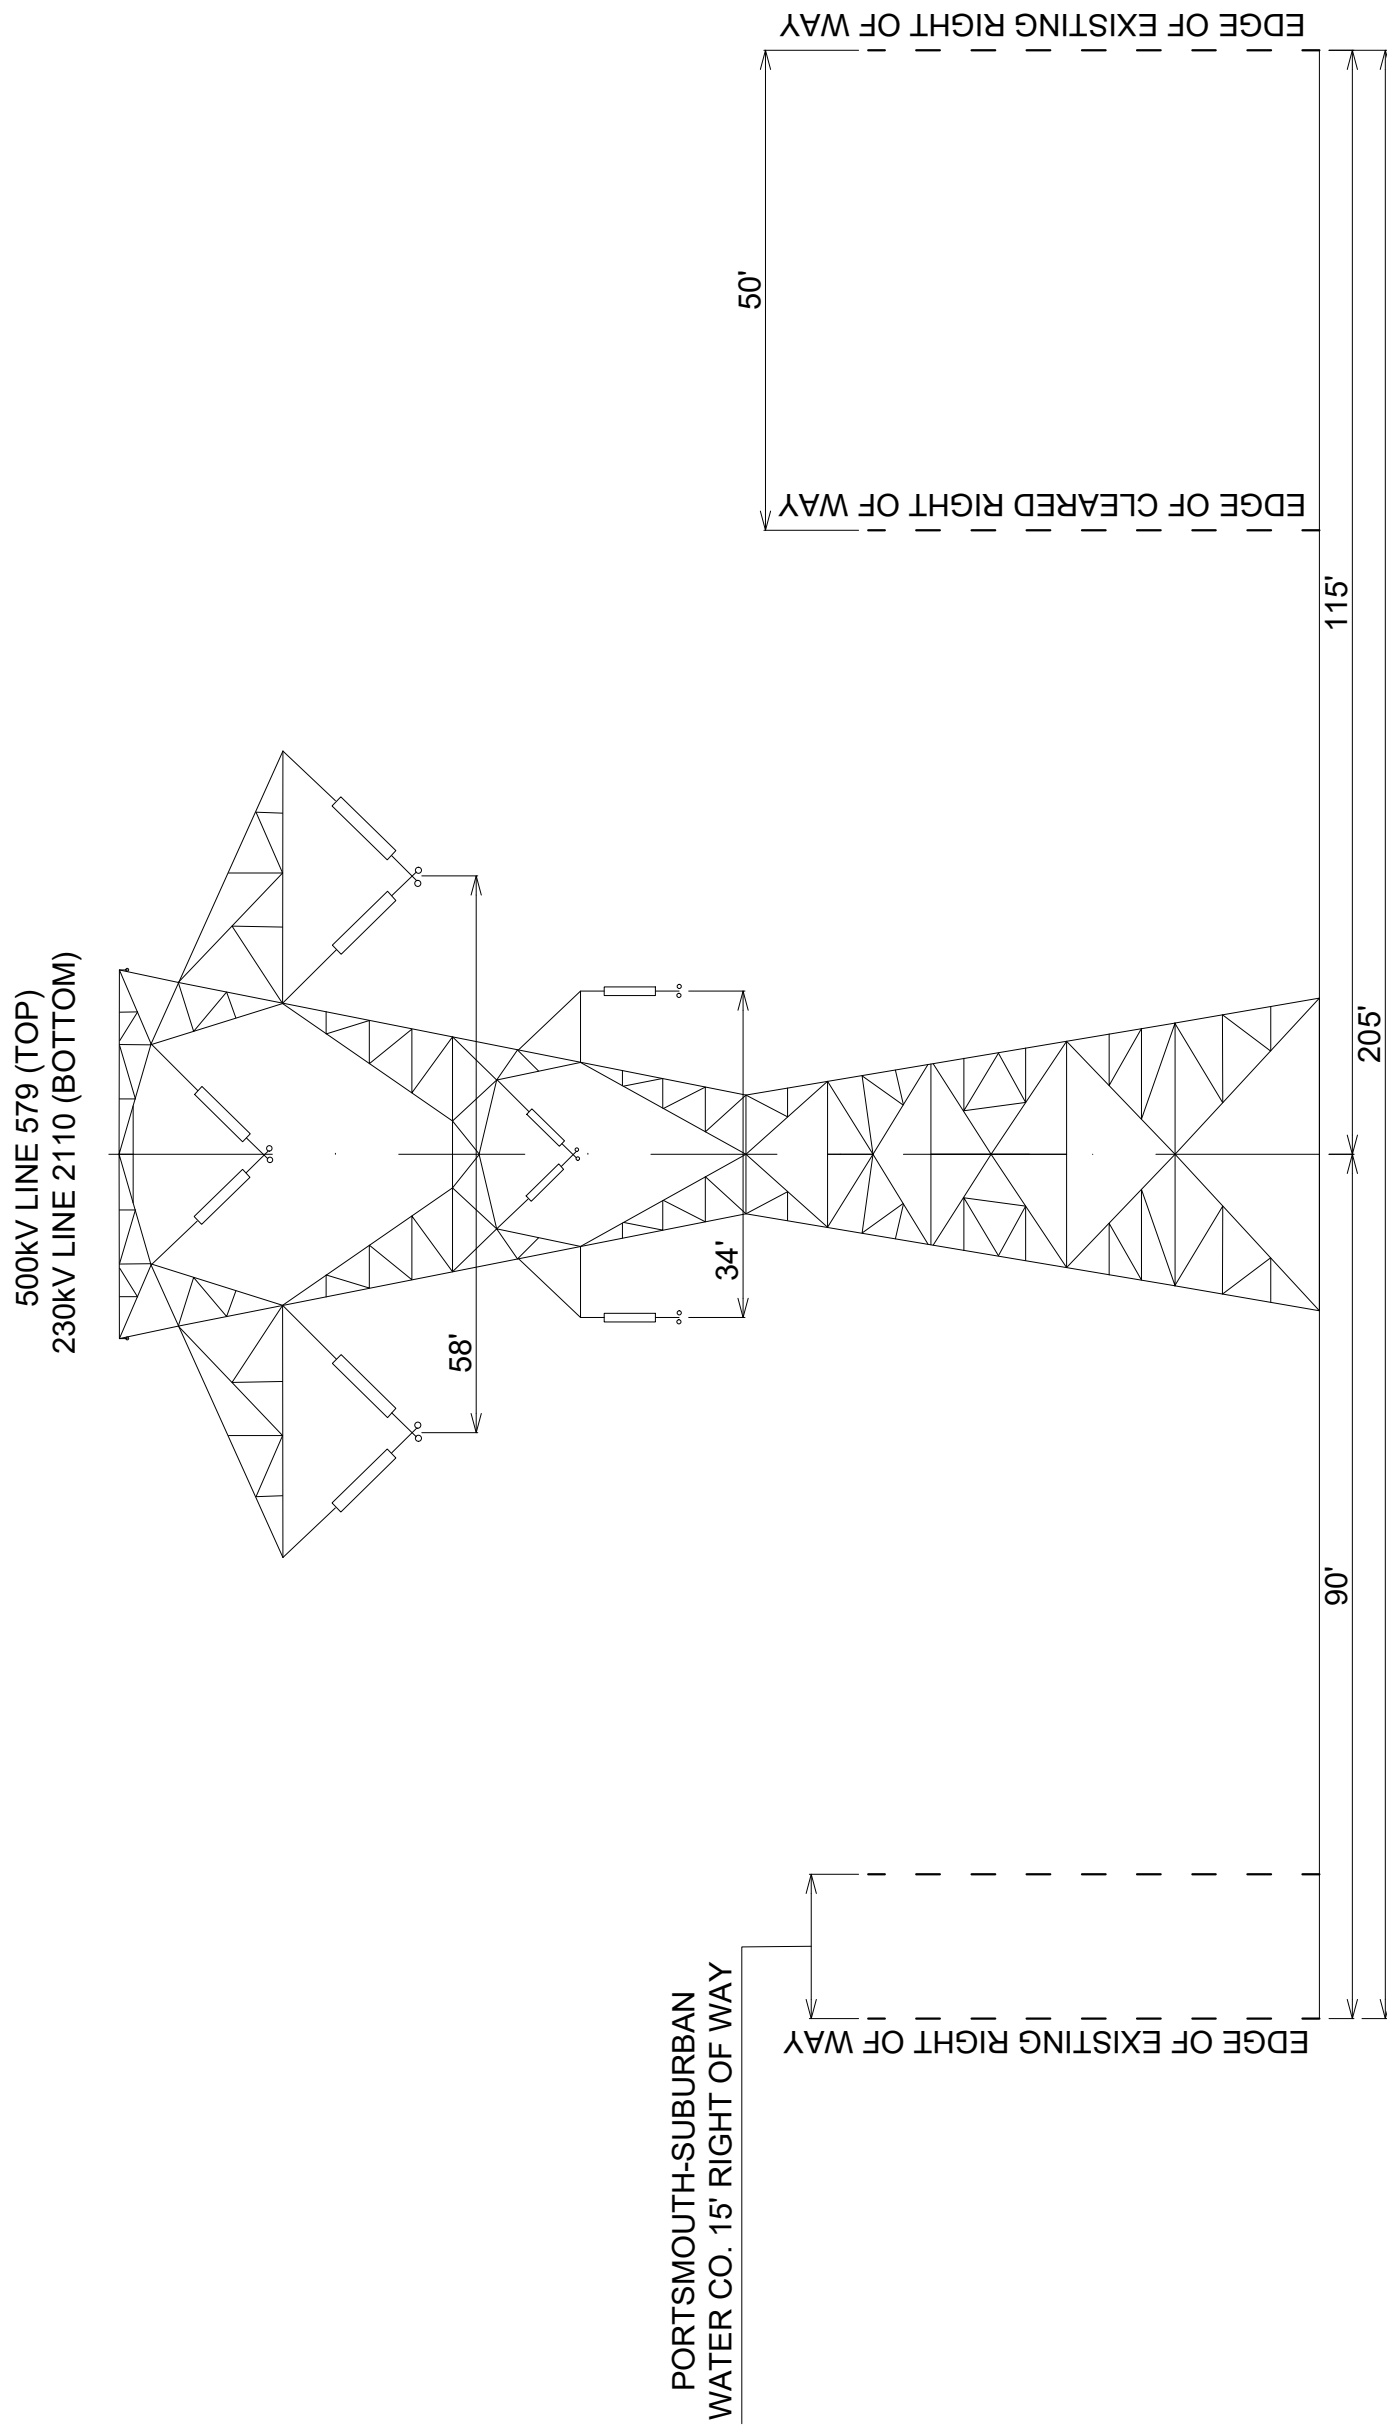
ORIGINAL	REVISION	DRAWING NO.
DRAWN		GKF		ATTACHMENT II.A.5.g.i
CHECKED		RAJ		
APPROVED		RAJ		
DATE		4/14/25

TYPICAL EXISTING RIGHT OF WAY  
LOOKING TOWARDS YADKIN  
SUBSTATION

1. THIS CROSS SECTION IS APPLICABLE FROM EXISTING STRUCTURE 579'134 TO 579'144.

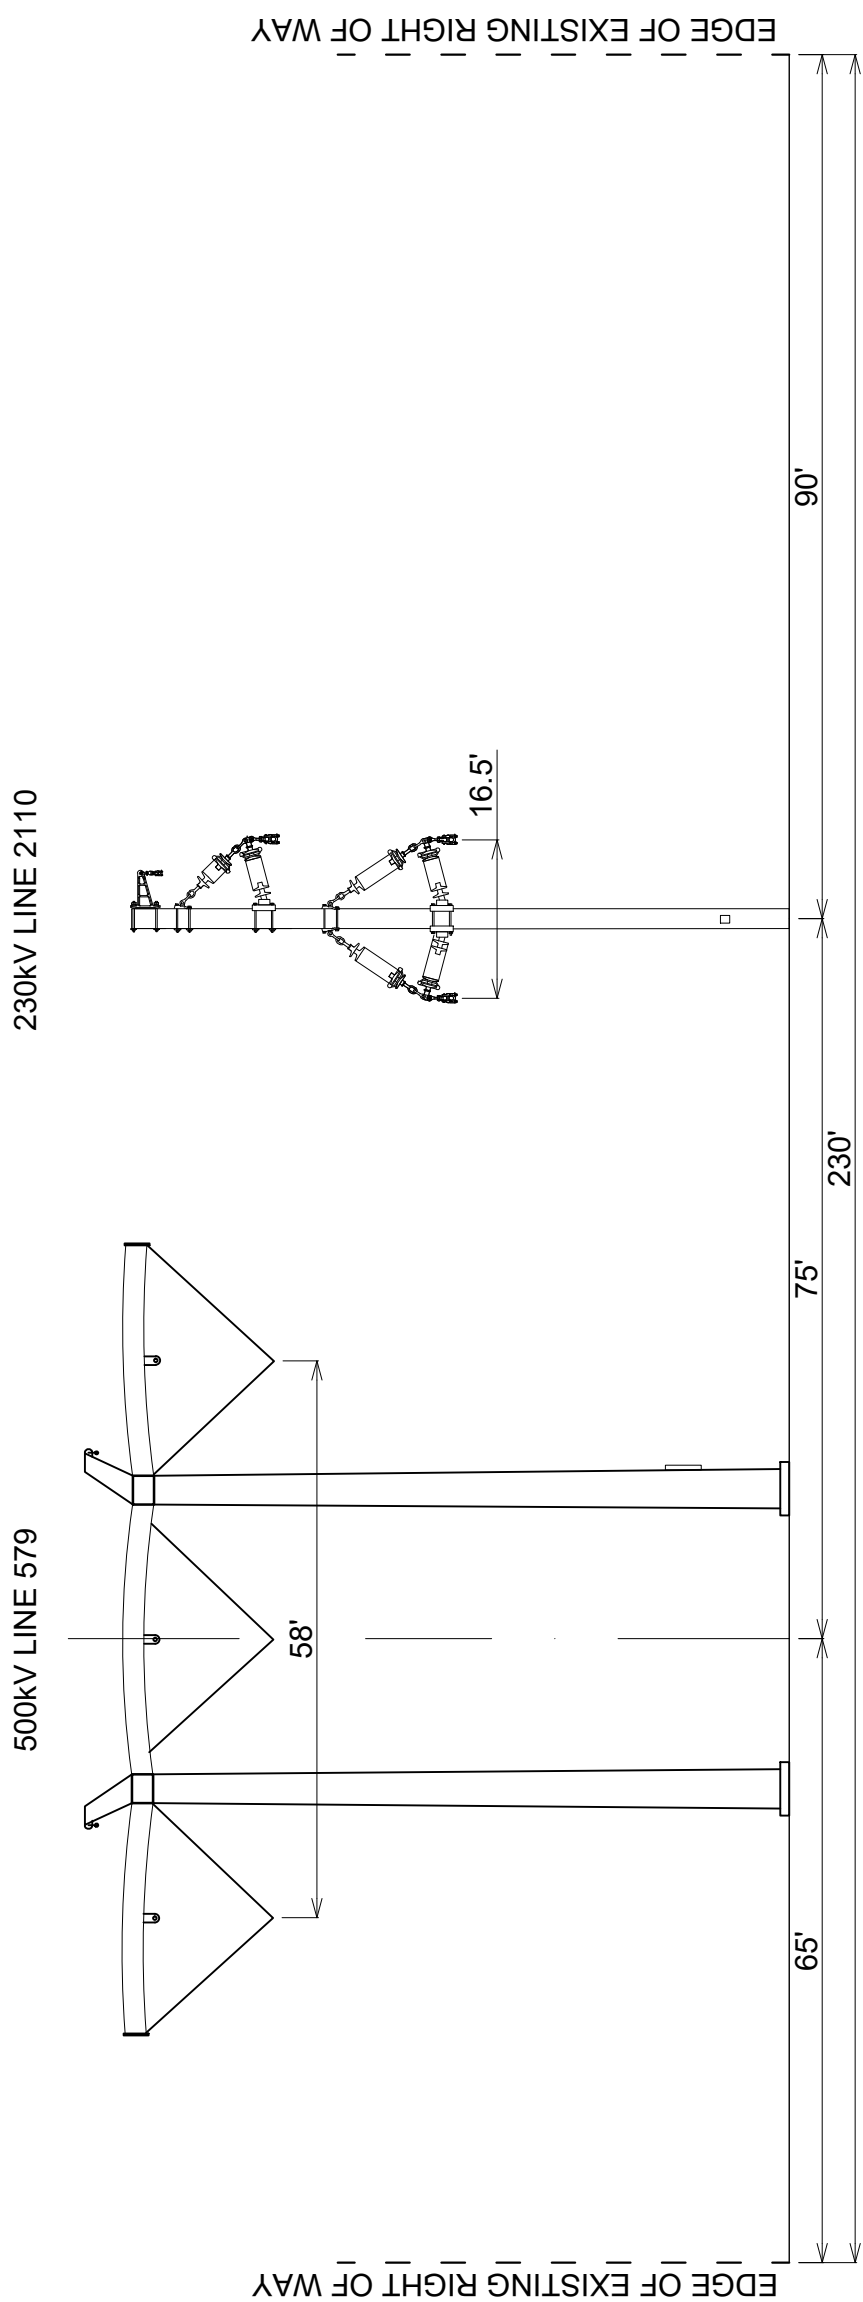
ORIGINAL	REVISION	DRAWING NO.
DRAWN	GKF		ATTACHMENT II.A.5.i.i
CHECKED	RAJ		
APPROVED	RAJ		
DATE	4/14/25

## TYPICAL EXISTING RIGHT OF WAY LOOKING TOWARDS YADKIN SUBSTATION

1. THIS CROSS SECTION IS APPLICABLE FROM EXISTING STRUCTURE 579/147 TO 579/153.

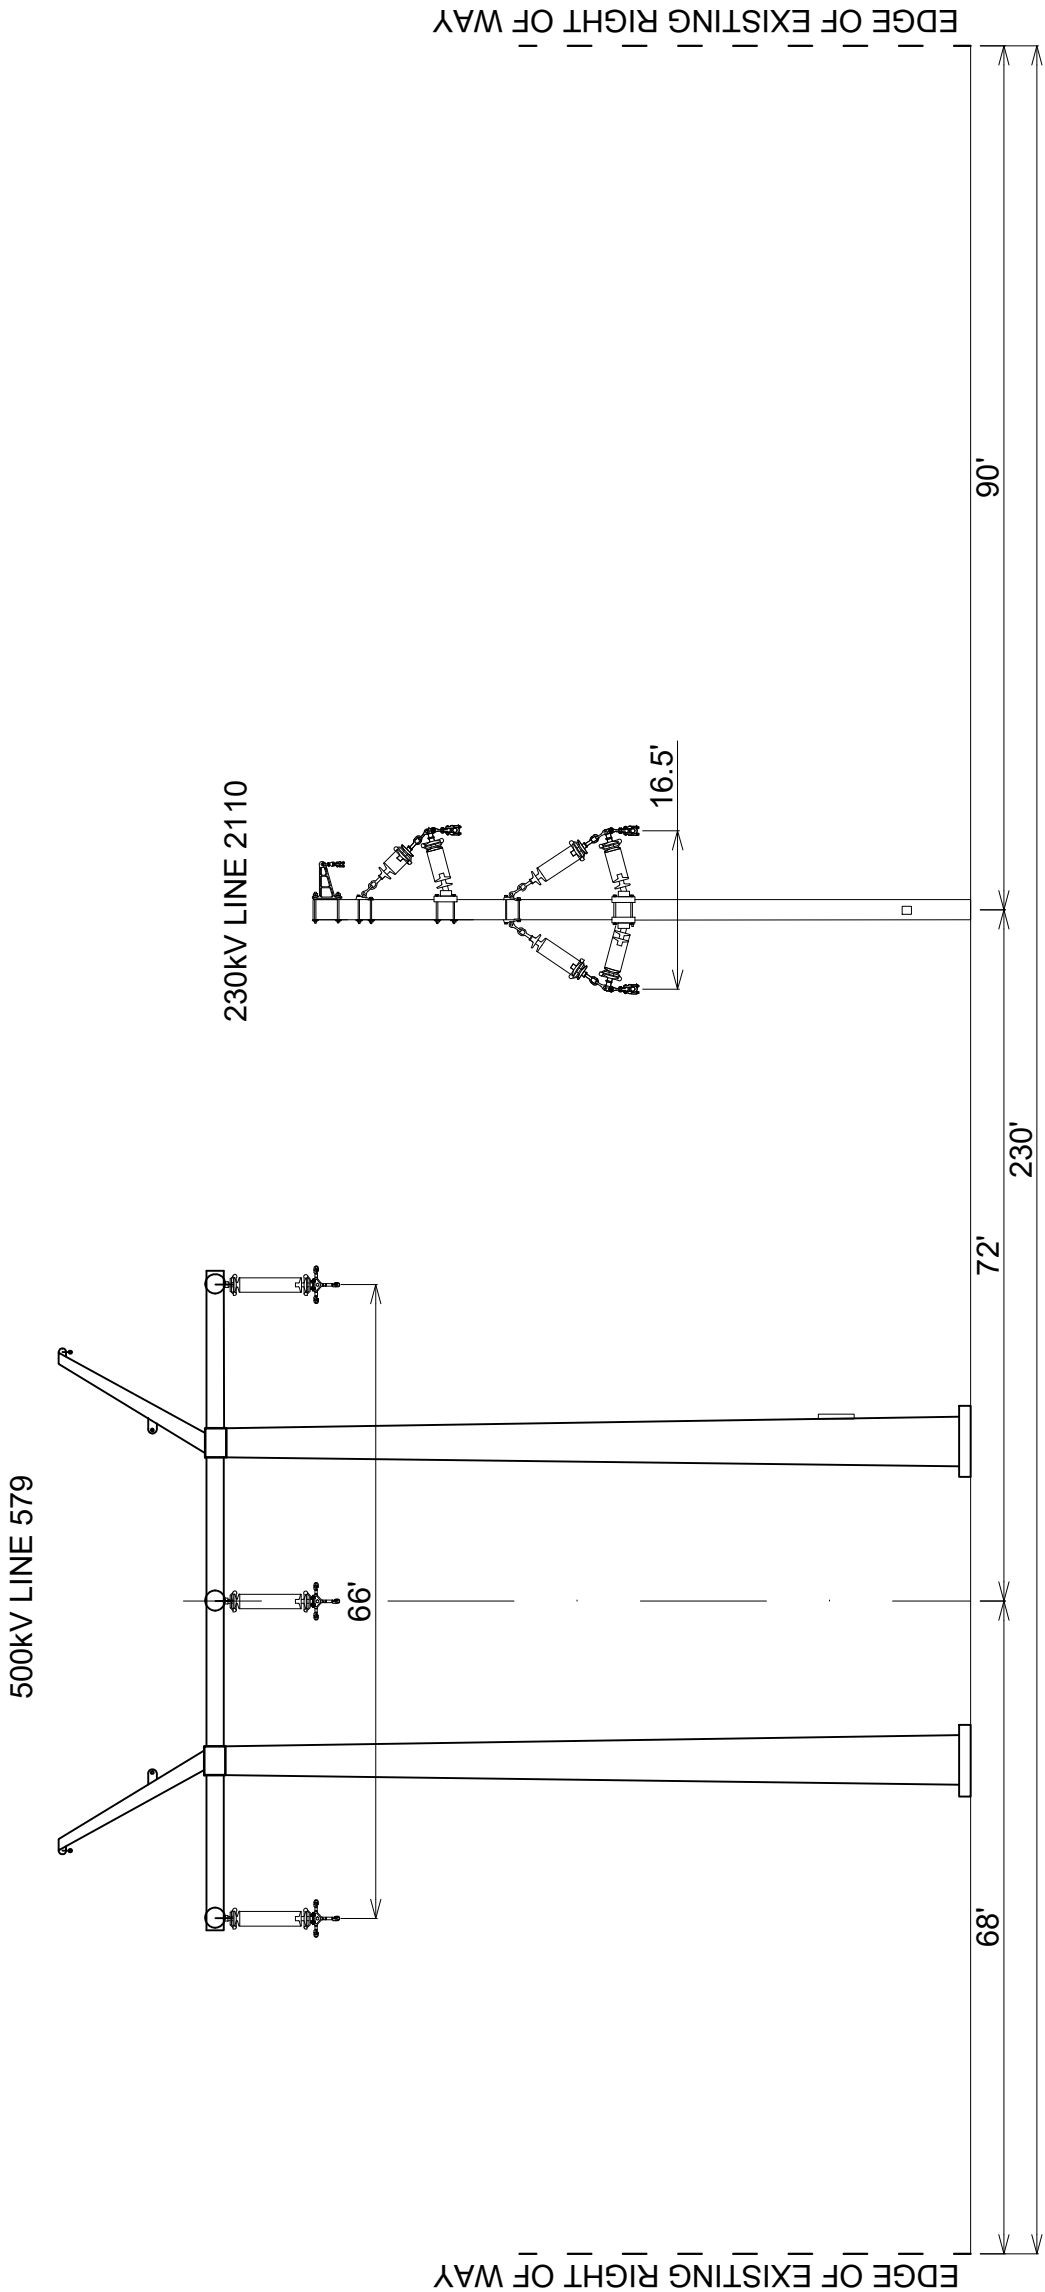
Dominion Energy 50000 Dominion Blvd Glen Allen, VA 23060		REVISION	DRAWING NO.
DRAWN	GKF		ATTACHMENT II.A.5.i.ii
CHECKED	RAJ		
APPROVED	RAJ		
DATE	4/14/25

TYPICAL PROPOSED RIGHT OF WAY LOOKING TOWARDS YADKIN SUBSTATION

1. THIS CROSS SECTION IS APPLICABLE FROM EXISTING STRUCTURE 579/147 TO 579/153.
2. INFORMATION CONTAINED ON DRAWING IS CONSIDERED PRELIMINARY IN NATURE AND SUBJECT TO CHANGE BASED ON FINAL DESIGN.

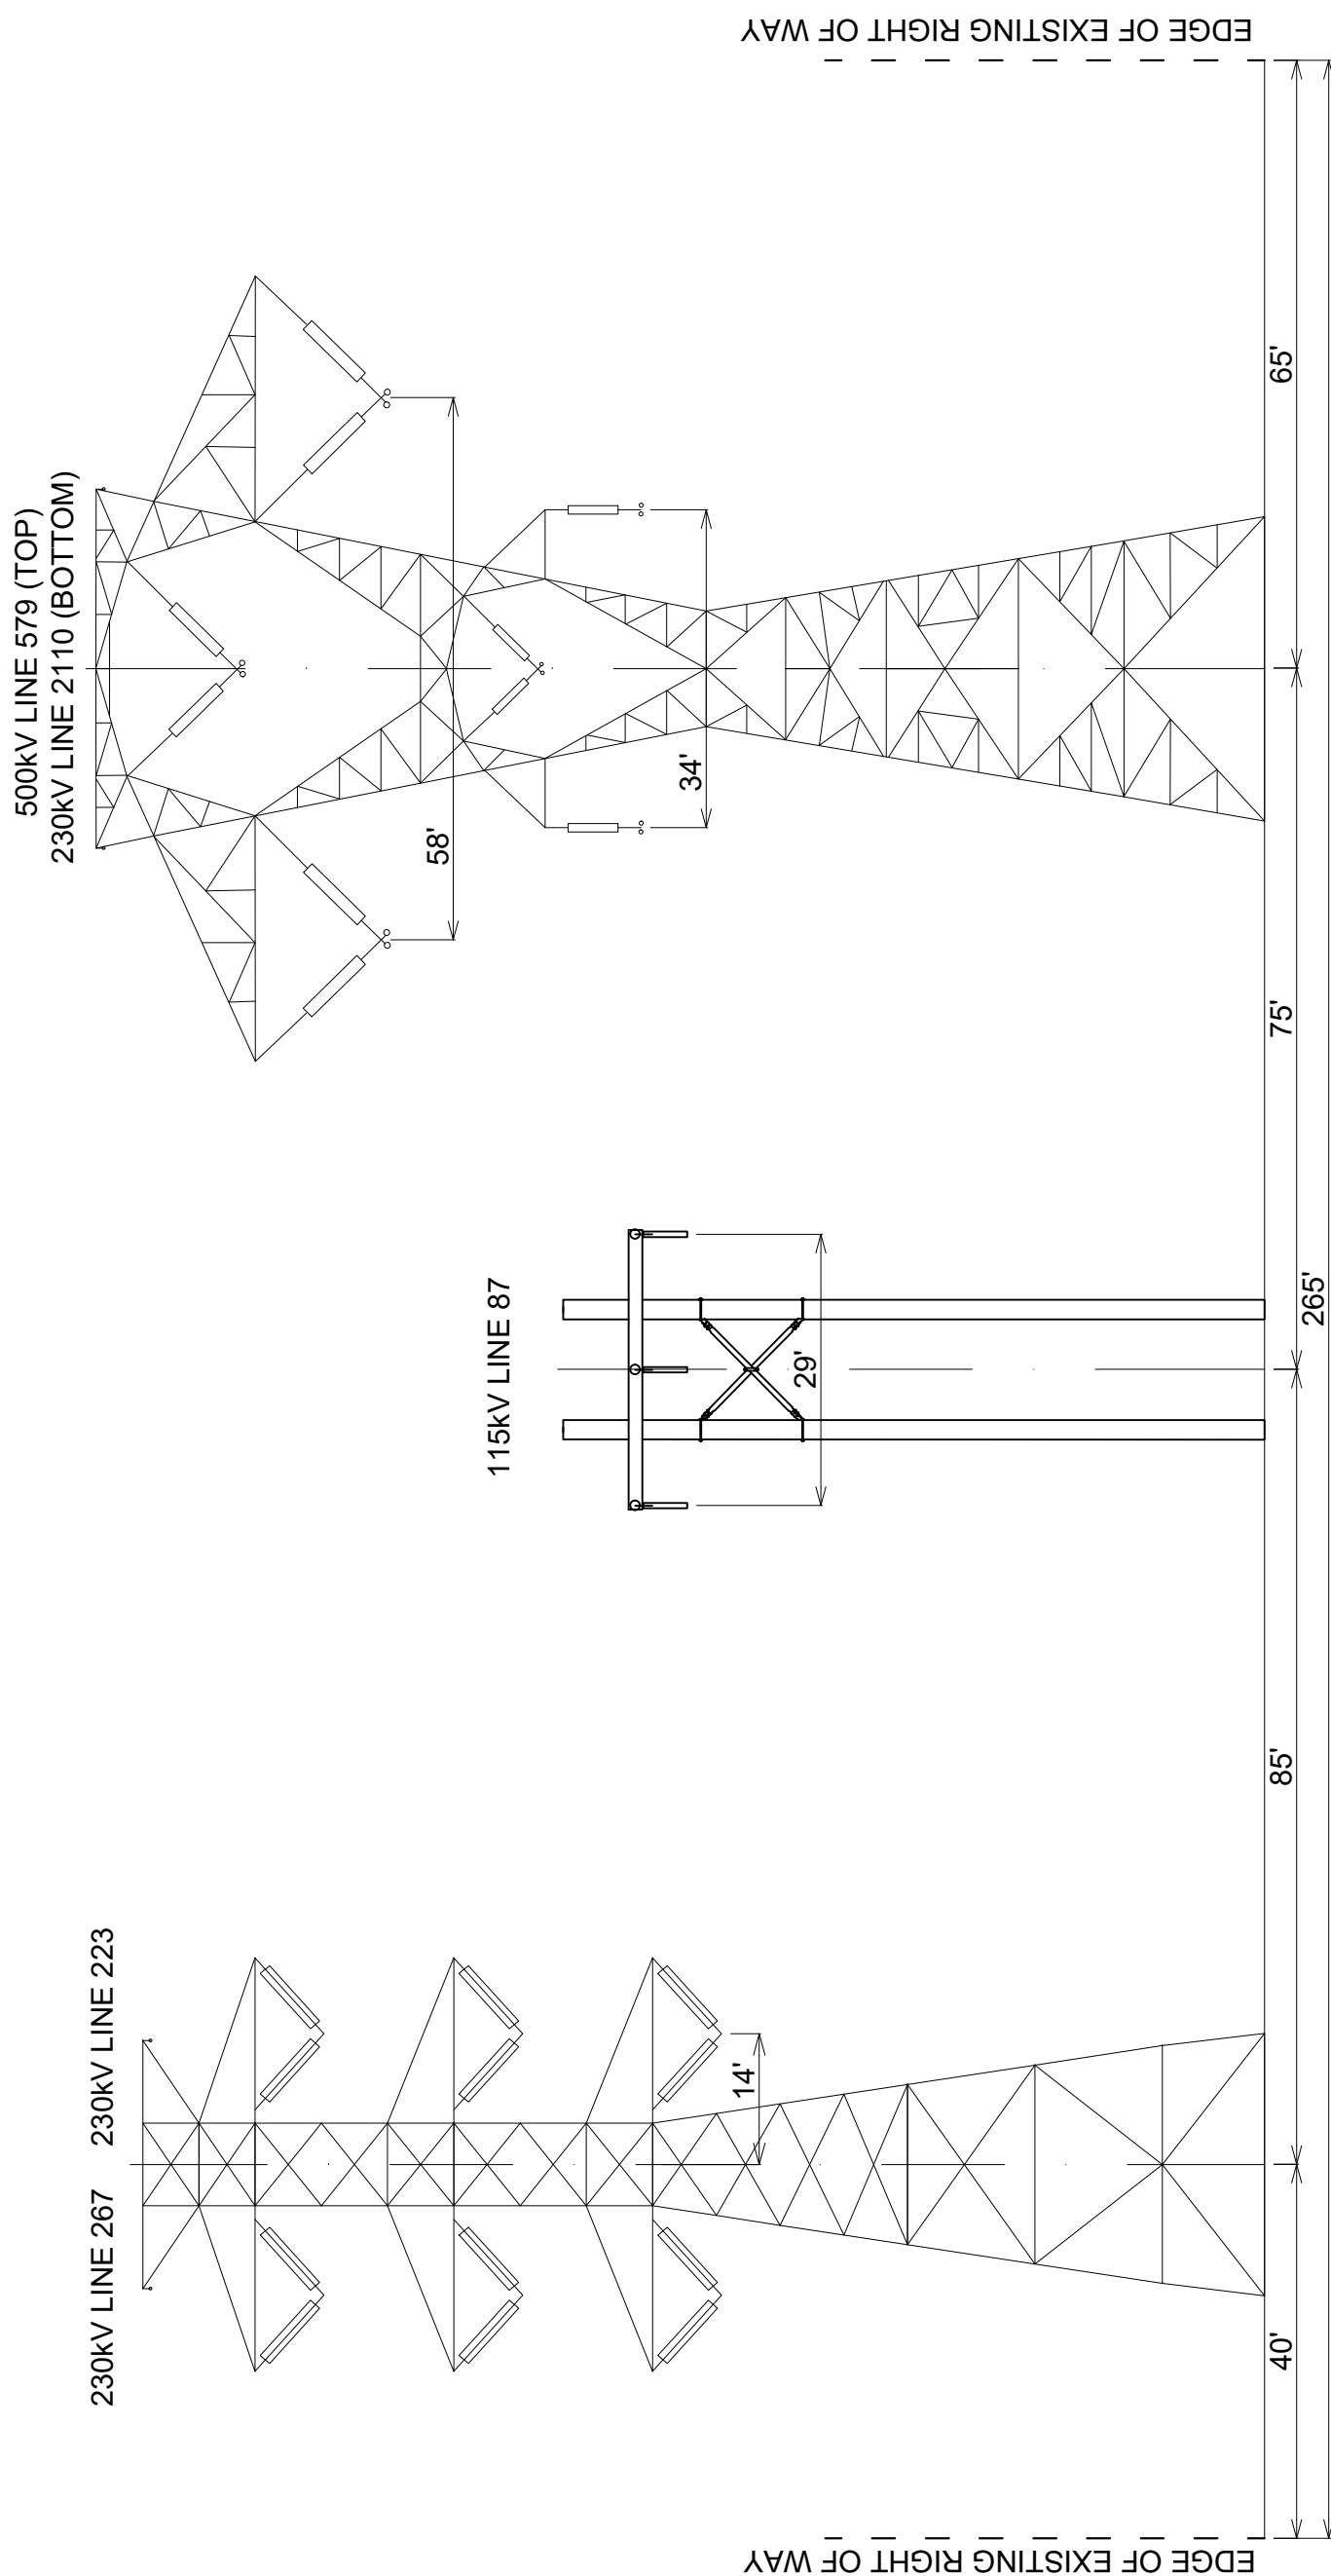
ORIGINAL	REVISION	DRAWING NO.
DRAWN		GKF		ATTACHMENT II.A.5.j.i
CHECKED		RAJ		
APPROVED		RAJ		
DATE		4/14/25

TYPICAL EXISTING RIGHT OF WAY  
LOOKING TOWARDS YADKIN  
SUBSTATION

1. THIS CROSS SECTION IS APPLICABLE FROM EXISTING STRUCTURE 579/177 TO 579/184.

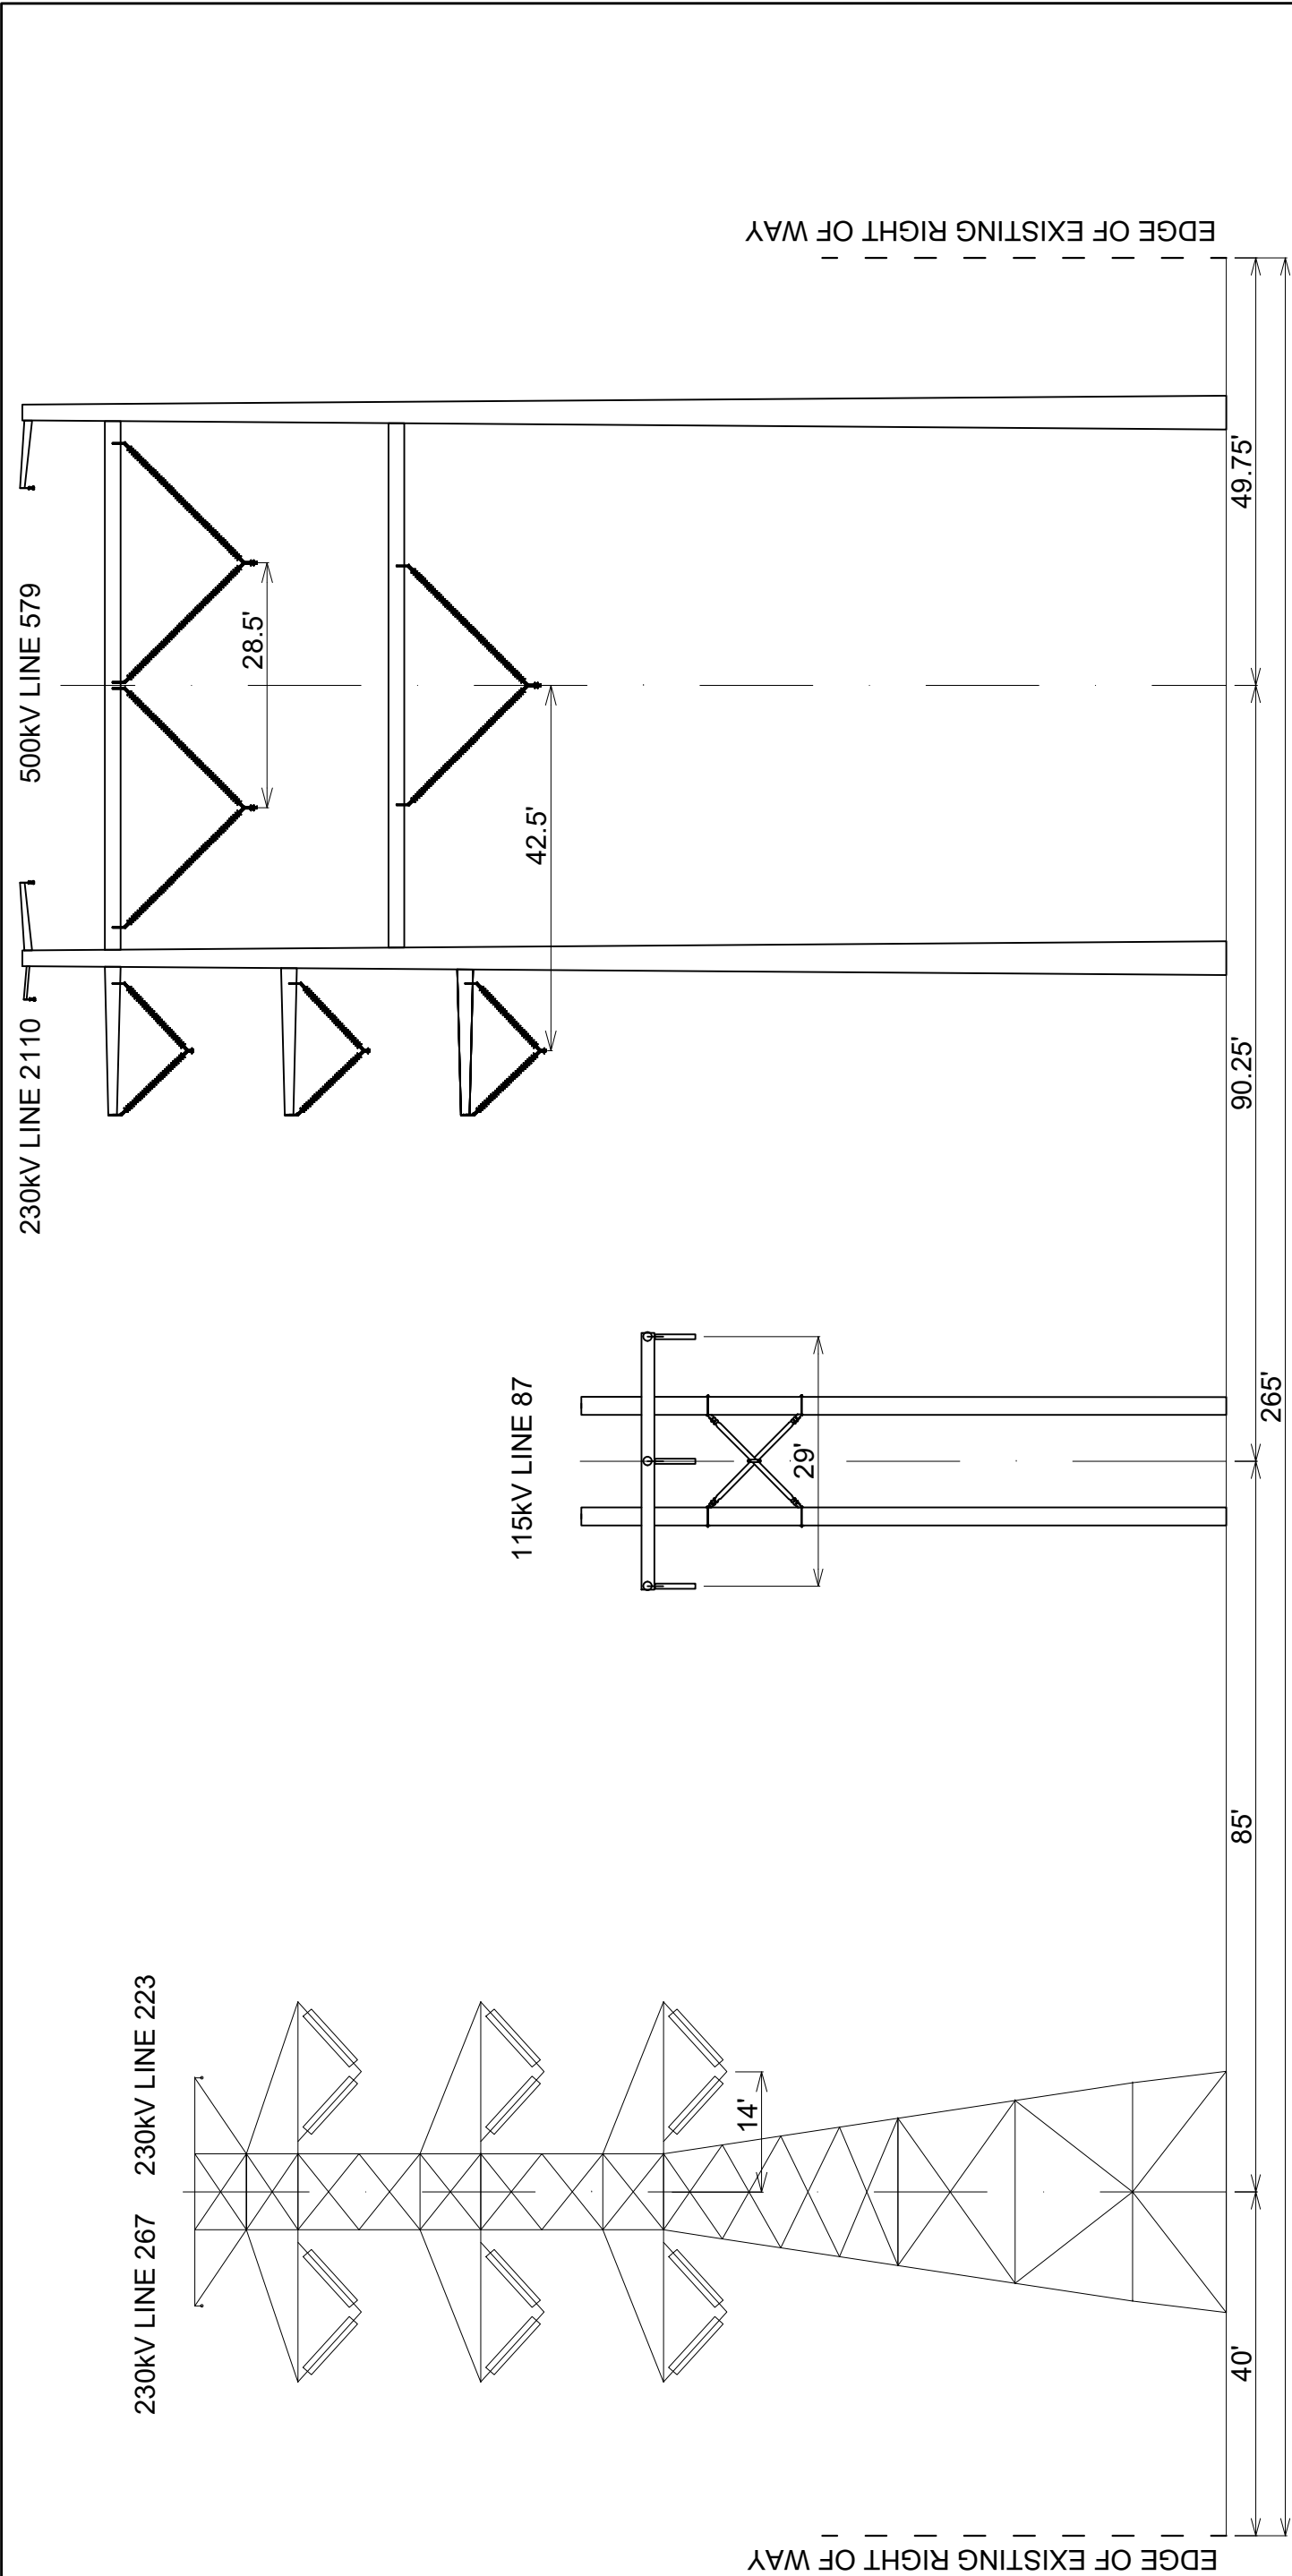
TYPICAL PROPOSED RIGHT OF WAY LOOKING TOWARDS YADKIN SUBSTATION
