*Application of Virginia Electric and Power Company for approval and certification  
of electric transmission facilities: 500 kV Septa-Yadkin Line #579 Rebuild and  
230 kV Suffolk-Thrasher Line #2110 Partial Rebuild*  
**Case No. PUR-2025-00104**

SEPTA-YADKIN 500 kV LINE #579  
REBUILD AND SUFFOLK-  
THRASHER 230 kV LINE #2110  
PARTIAL REBUILD

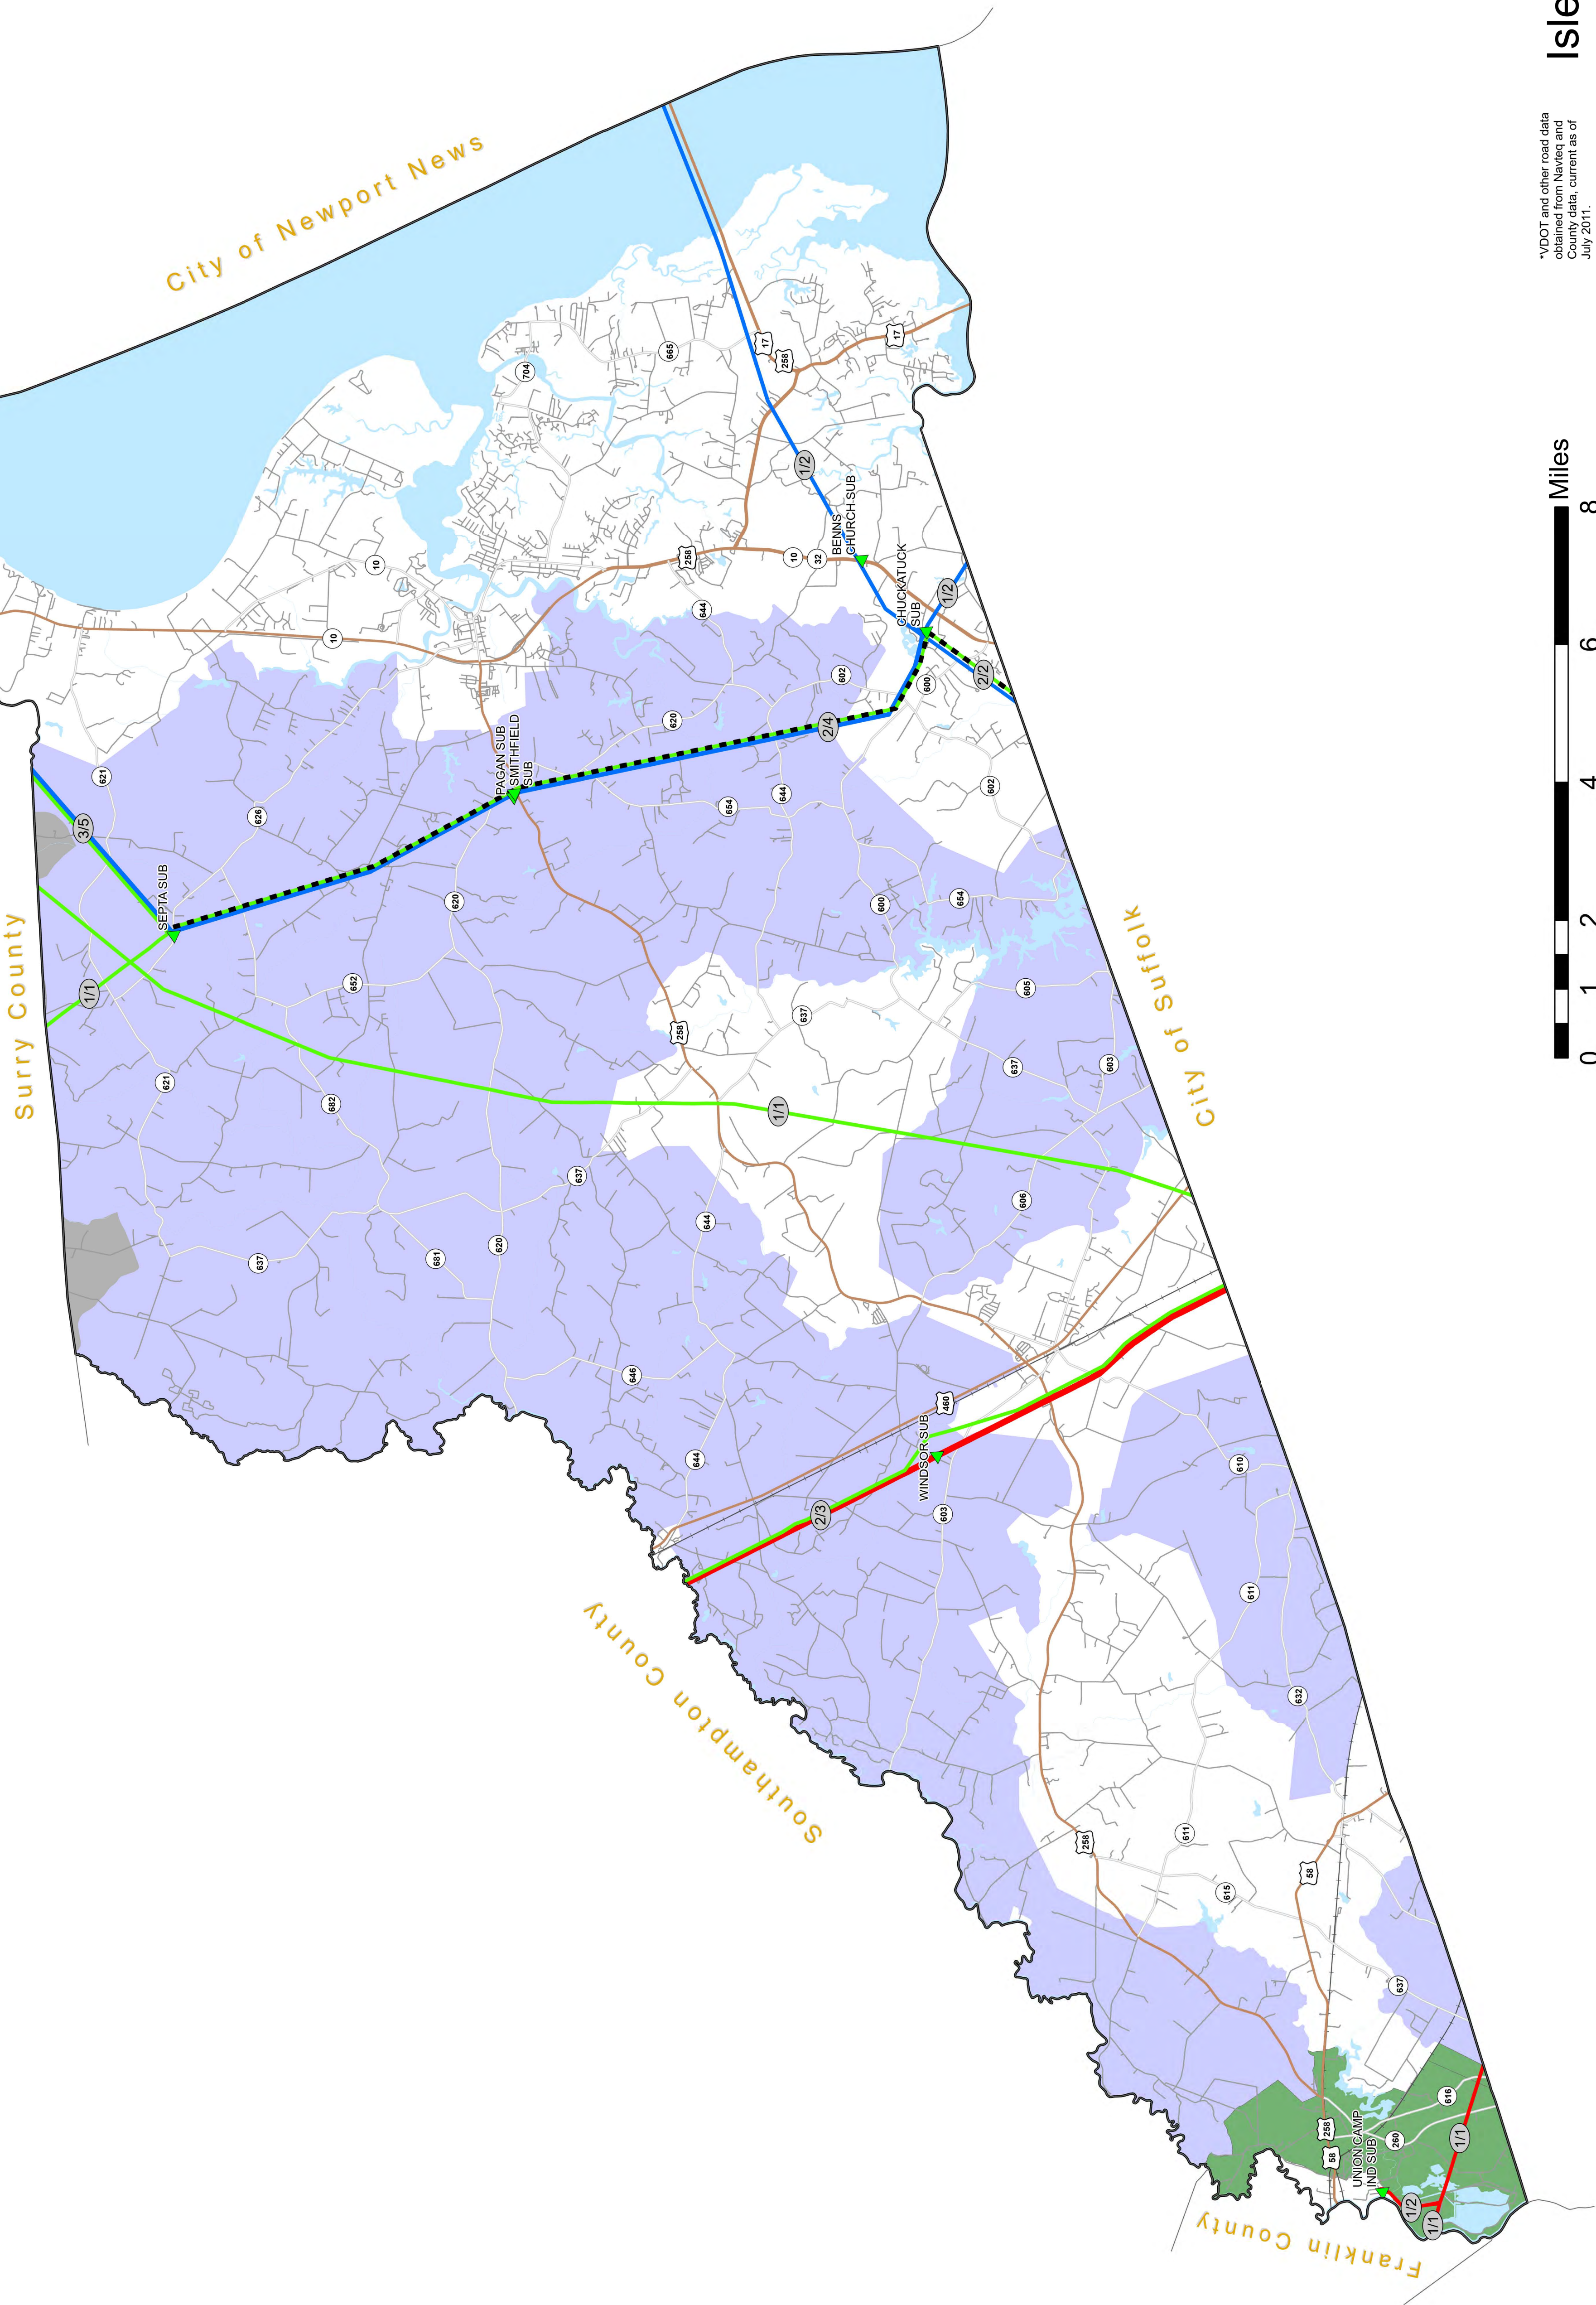
# Isle of Wight County Road Map

This digital map depicts the Virginia Electric and Power Company ("Company") transmission facilities in this county as approved by the Virginia State Corporation Commission ("SCC"), and any proposed transmission facilities in this county, as of 2/13/25. Other company facilities previously authorized by the SCC are shown in black on prior SCC approved county maps.

VIRGINIA ELECTRIC AND POWER COMPANY  
PLANS TO BUILD TRANSMISSION LINES AND  
SUBSTATIONS AS SHOWN IN BLACK DASHES  
ON THIS MAP.

- b. Electronic copies of the VDOT “General Highway Map” for Isle of Wight County and Southeastern Metropolitan Area (which includes the City of Chesapeake and the City of Suffolk) have been marked as required and submitted with the Application. A reduced copy of the Isle of Wight County map is provided as Attachment II.A.12.b.i., and a reduced copy of the Southeastern Metropolitan Area Road Map is provided as Attachment II.A.12.b.ii.

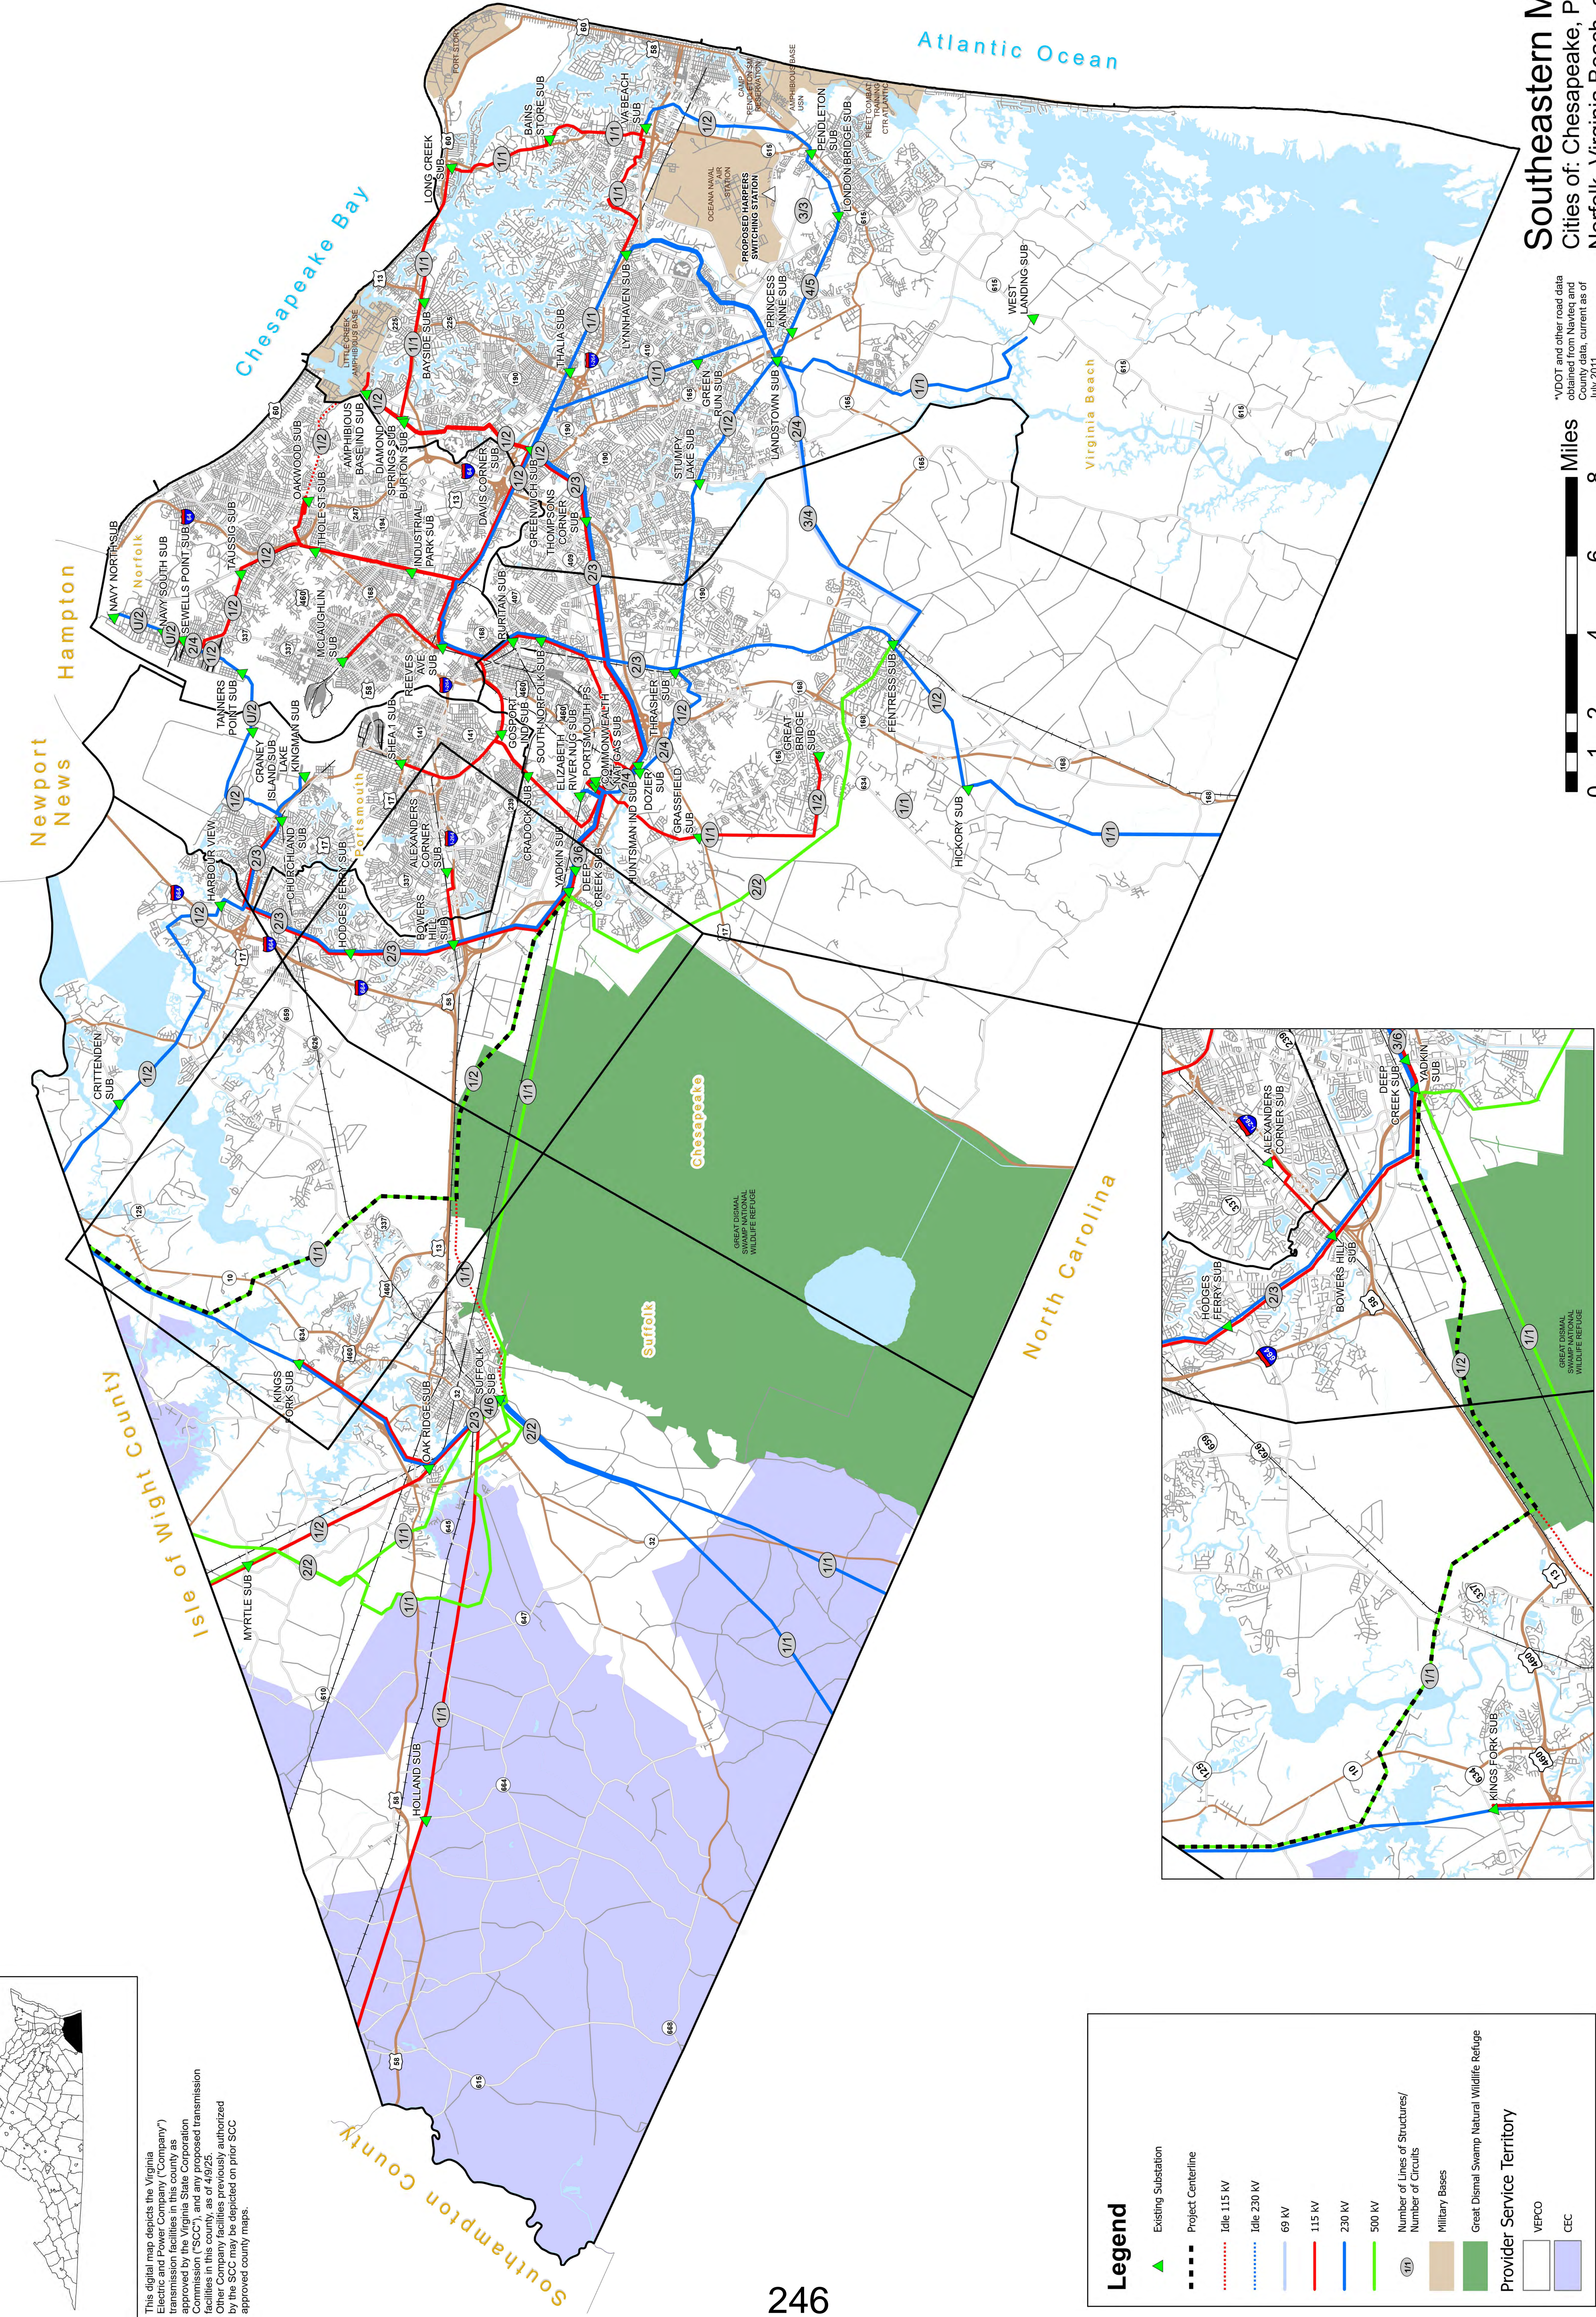
# Southeastern Metropolitan Area Road Map

This digital map depicts the Virginia Electric Power Company's ("VEPCO") transmission facilities in this county as approved by the Virginia State Corporation Commission ("SCC"), and any proposed transmission facilities in this county, as of 4/9/25. Other Company facilities previously authorized by the SCC may be depicted on prior SCC approved county maps.

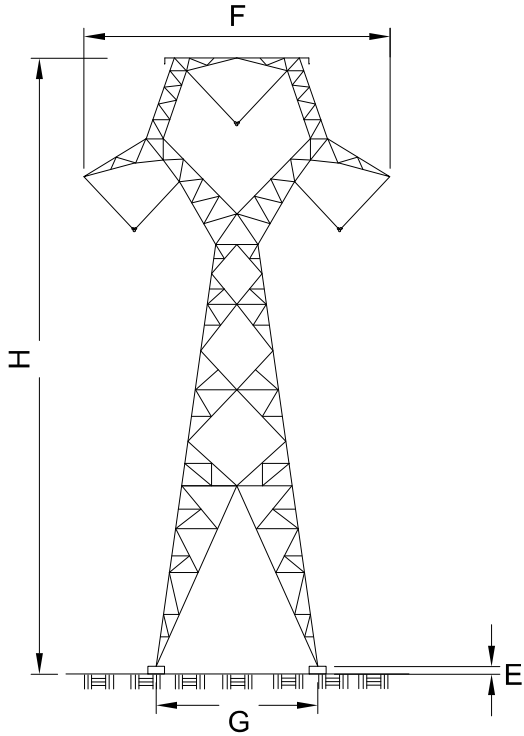
**SINGLE CIRCUIT SUSPENSION TOWER STRUCTURE**

B. RATIONALE FOR STRUCTURE TYPE:		TYPICAL 500KV SUSPENSION TOWER, TIGHTER WIRE SPACING THAN EXISTING
C. LENGTH OF R/W (STRUCTURE QUANTITY):		21.1 MILES (112 STRUCTURES)

D. STRUCTURE MATERIAL:		DULLED GALVANIZED STEEL
RATIONALE FOR STRUCTURE MATERIAL:		TYPICAL TOWER FINISH FOR PROPOSED STRUCTURES
E. FOUNDATION MATERIAL:		STEEL H-PILES
AVERAGE FOUNDATION REVEAL:		SEE NOTE 4

I. AVERAGE SPAN LENGTH:		996'
J. MINIMUM CONDUCTOR-TO-GROUND:		30.9' (AT MAXIMUM OPERATING TEMPERATURE)
<b>NOTES</b> <div><div>1. INFORMATION ON DRAWING IS PRELIMINARY AND SUBJECT TO CHANGE DURING FINAL ENGINEERING</div><div>2. INDIVIDUAL POLE HEIGHTS ABOVE GROUND MAY VARY SUBJECT TO FINAL LOCATION AND TERRAIN</div><div>3. STRUCTURE HEIGHTS ARE MEASURED FROM STRUCTURE CENTERLINE</div><div>4. MINIMUM FOUNDATION REVEAL SHALL BE 1.5', MAX REVEAL SUBJECT TO FINAL LOCATION AND TERRAIN</div></div>		
Electric Transmission		STRUCTURES 579/3-579/16, 579/18-579/29, 579/31-579/59, 579/61-579/63, 579/65, 579/68-579/84, 579/86-579/89, 579/91-579/93, 579/95-579/99, 579/101, 579/103-579/106, 579/111-579/114, 579/116-579/121, 579/123-579/131
<div><div>

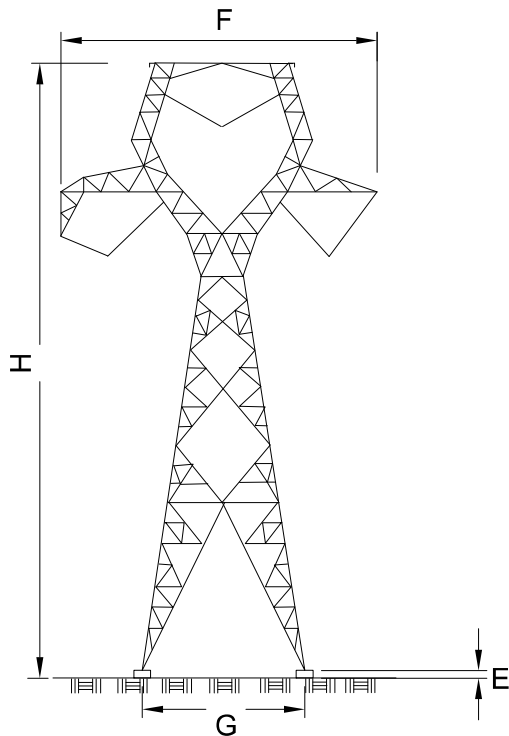
# SINGLE CIRCUIT RUNNING ANGLE TOWER STRUCTURE

B. RATIONALE FOR STRUCTURE TYPE:	TYPICAL 500KV SMALL ANGLE TOWER
C. LENGTH OF R/W (STRUCTURE QUANTITY):	1.5 MILES (9 STRUCTURES)
D. STRUCTURE MATERIAL:	DULLED GALVANIZED STEEL
RATIONALE FOR STRUCTURE MATERIAL:	TYPICAL TOWER FINISH FOR PROPOSED STRUCTURES
E. FOUNDATION MATERIAL:	STEEL H-PILES
AVERAGE FOUNDATION REVEAL:	SEE NOTE 4
F. AVERAGE WIDTH AT CROSSARM:	75'
G. AVERAGE WIDTH AT BASE:	VARIES BASED ON TOWER HEIGHT - 35' ON AVERAGE
H. MINIMUM STRUCTURE HEIGHT:	116'
MAXIMUM STRUCTURE HEIGHT:	176'
AVERAGE STRUCTURE HEIGHT:	136'
I. AVERAGE SPAN LENGTH:	904'
J. MINIMUM CONDUCTOR-TO-GROUND:	30.9' (AT MAXIMUM OPERATING TEMPERATURE)

<div>                     Dominion Energy                      5000 Dominion Blvd                      Glen Allen, VA 23060                 </div> </div>	<div>STRUCTURES</div> <div>579/2, 579/17, 579/30, 579/64, 579/66, 579/85, 579/90, 579/110, 579/115</div>	<div>DRAWING NO.</div> <div>Attachment II.B.3.b</div>
		<div>DRAWN</div> <div>RAJ</div>

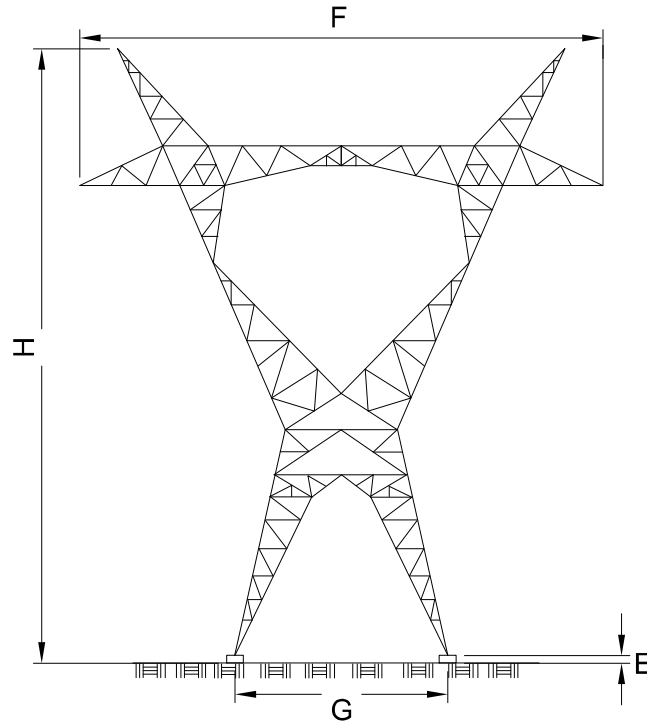
### SINGLE CIRCUIT DEADEND TOWER STRUCTURE

B. RATIONALE FOR STRUCTURE TYPE:	USED FOR MODERATE ANGLES AND WIRE PULLING LOCATIONS
C. LENGTH OF R/W (STRUCTURE QUANTITY):	0.4 MILES (3 STRUCTURES)
D. STRUCTURE MATERIAL:	DULLED GALVANIZED STEEL
RATIONALE FOR STRUCTURE MATERIAL:	TYPICAL TOWER FINISH FOR PROPOSED STRUCTURES
E. FOUNDATION MATERIAL:	STEEL H-PILES
AVERAGE FOUNDATION REVEAL:	SEE NOTE 4
F. AVERAGE WIDTH AT CROSSARM:	91.75'
G. AVERAGE WIDTH AT BASE:	VARIES BASED ON TOWER HEIGHT - 48' ON AVERAGE
H. MINIMUM STRUCTURE HEIGHT:	112'
MAXIMUM STRUCTURE HEIGHT:	162'
AVERAGE STRUCTURE HEIGHT:	132'
I. AVERAGE SPAN LENGTH:	782'
J. MINIMUM CONDUCTOR-TO-GROUND:	30.9' (AT MAXIMUM OPERATING TEMPERATURE)

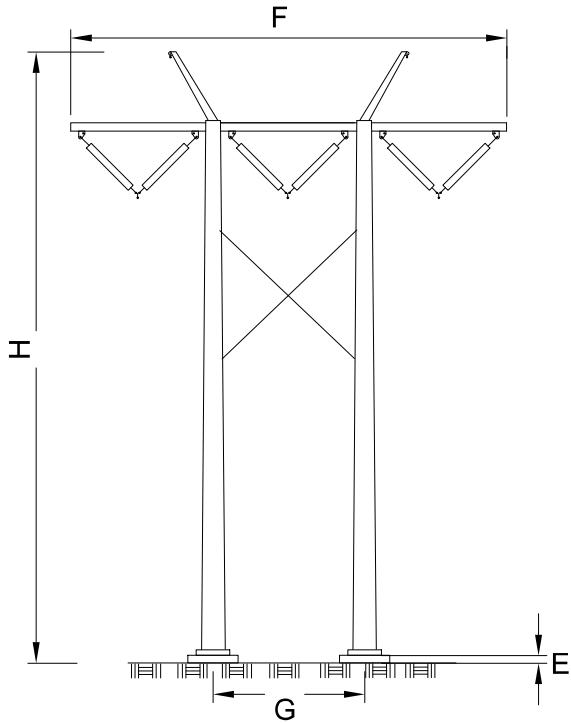
### SINGLE CIRCUIT SUSPENSION H-FRAME STRUCTURE

B. RATIONALE FOR STRUCTURE TYPE:	RIVER CROSSING & AIRPORT SECTION. USED FOR ADDITIONAL CAPACITY AND SHORTER HEIGHT
C. LENGTH OF R/W (STRUCTURE QUANTITY):	1 MILES (5 STRUCTURES)
D. STRUCTURE MATERIAL:	DULLED GALVANIZED STEEL
RATIONALE FOR STRUCTURE MATERIAL:	MATCHING ADJACENT LINES AND TOWER PORTION OF LINE
E. FOUNDATION MATERIAL:	STEEL PIPE PILES
AVERAGE FOUNDATION REVEAL:	SEE NOTE 4
F. AVERAGE WIDTH AT CROSSARM:	92.5'
G. AVERAGE WIDTH AT BASE:	34'-8"
H. MINIMUM STRUCTURE HEIGHT:	127'
MAXIMUM STRUCTURE HEIGHT:	162'
AVERAGE STRUCTURE HEIGHT:	140'
I. AVERAGE SPAN LENGTH:	1022'
J. MINIMUM CONDUCTOR-TO-GROUND:	30.9' (AT MAXIMUM OPERATING TEMPERATURE)

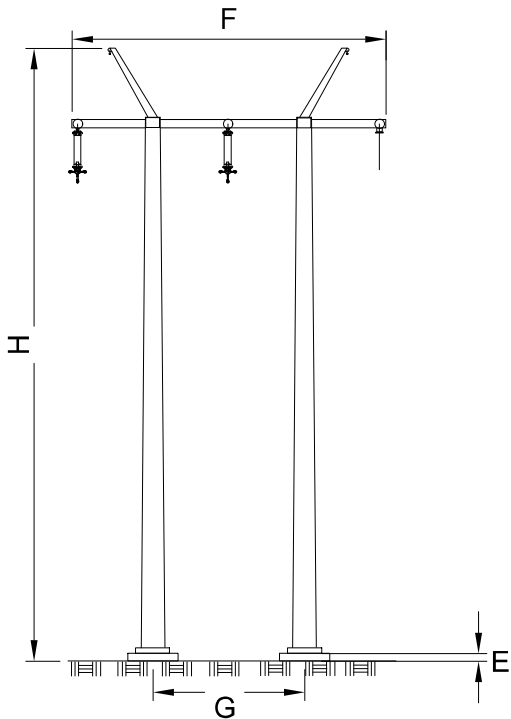
### SINGLE CIRCUIT DEADEND H-FRAME STRUCTURE

B. RATIONALE FOR STRUCTURE TYPE:	AIRPORT SECTION, SHORTEST POSSIBLE STRUCTURE HEIGHT
C. LENGTH OF R/W (STRUCTURE QUANTITY):	0.5 MILES (4 STRUCTURES)
D. STRUCTURE MATERIAL:	DULLED GALVANIZED STEEL
RATIONALE FOR STRUCTURE MATERIAL:	MATCHING ADJACENT LINES AND TOWER PORTION OF LINE
E. FOUNDATION MATERIAL:	STEEL PIPE PILES
AVERAGE FOUNDATION REVEAL:	SEE NOTE 4
F. AVERAGE WIDTH AT CROSSARM:	66.5'
G. AVERAGE WIDTH AT BASE:	33'
H. MINIMUM STRUCTURE HEIGHT:	91'
MAXIMUM STRUCTURE HEIGHT:	96'
AVERAGE STRUCTURE HEIGHT:	94'
I. AVERAGE SPAN LENGTH:	658'
J. MINIMUM CONDUCTOR-TO-GROUND:	30.9' (AT MAXIMUM OPERATING TEMPERATURE)

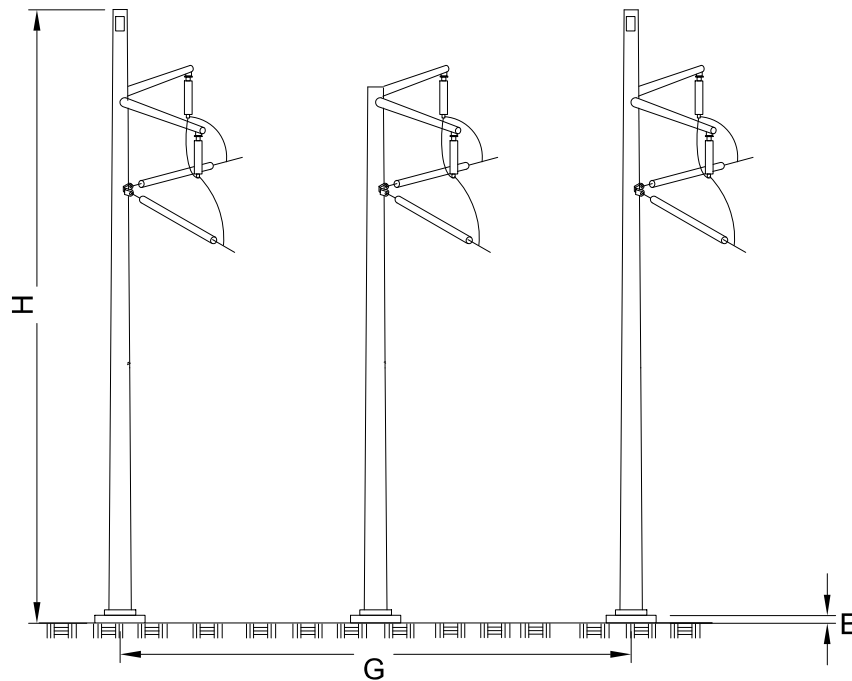
### SINGLE CIRCUIT DEADEND 3-POLE STRUCTURE

B. RATIONALE FOR STRUCTURE TYPE: HEAVY ANGLES

E. FOUNDATION MATERIAL: STEEL H-PILES  
AVERAGE FOUNDATION REVEAL: SEE NOTE 4

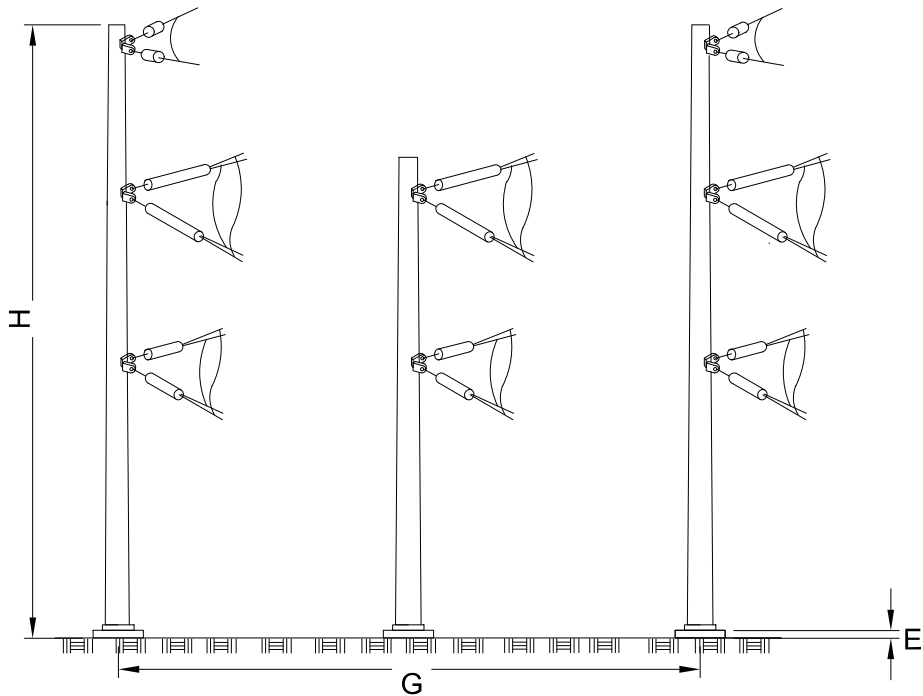
**DOUBLE CIRCUIT DEADEND 3-POLE STRUCTURE**

B. RATIONALE FOR STRUCTURE TYPE: USED TO TRANSITION 230KV CIRCUIT ONTO STRUCTURES

E. FOUNDATION MATERIAL: STEEL H-PILES  
AVERAGE FOUNDATION REVEAL: SEE NOTE 4

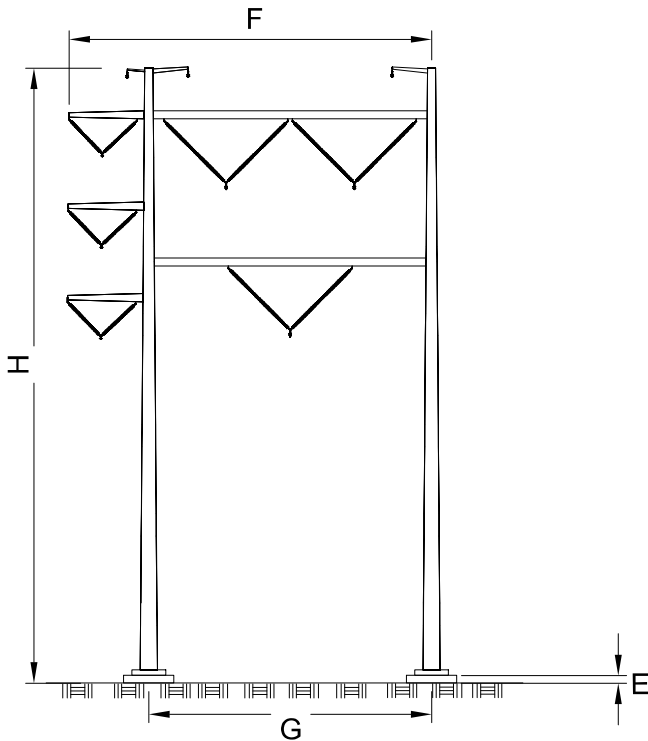
# **DOUBLE CIRCUIT SUSPENSION H-FRAME STRUCTURE**

B. RATIONALE FOR STRUCTURE TYPE:	DOUBLE CIRCUIT TANGENT SECTIONS, TIGHTER SPACING THAN TYPICAL TOWERS
C. LENGTH OF R/W (STRUCTURE QUANTITY):	6.9 MILES (40 STRUCTURES)
D. STRUCTURE MATERIAL:	DULLED GALVANIZED STEEL
RATIONALE FOR STRUCTURE MATERIAL:	MATCHING ADJACENT LINES AND TOWER PORTION OF LINE
E. FOUNDATION MATERIAL:	STEEL PIPE PILES
AVERAGE FOUNDATION REVEAL:	SEE NOTE 4
F. AVERAGE WIDTH AT CROSSARM:	81.5'
G. AVERAGE WIDTH AT BASE:	63.5'
H. MINIMUM STRUCTURE HEIGHT:	137'
MAXIMUM STRUCTURE HEIGHT:	162'
AVERAGE STRUCTURE HEIGHT:	144'
I. AVERAGE SPAN LENGTH:	910'
J. MINIMUM CONDUCTOR-TO-GROUND:	30.9' (500KV AT MAXIMUM OPERATING TEMPERATURE) 25.5' (230KV AT MAXIMUM OPERATING TEMPERATURE)

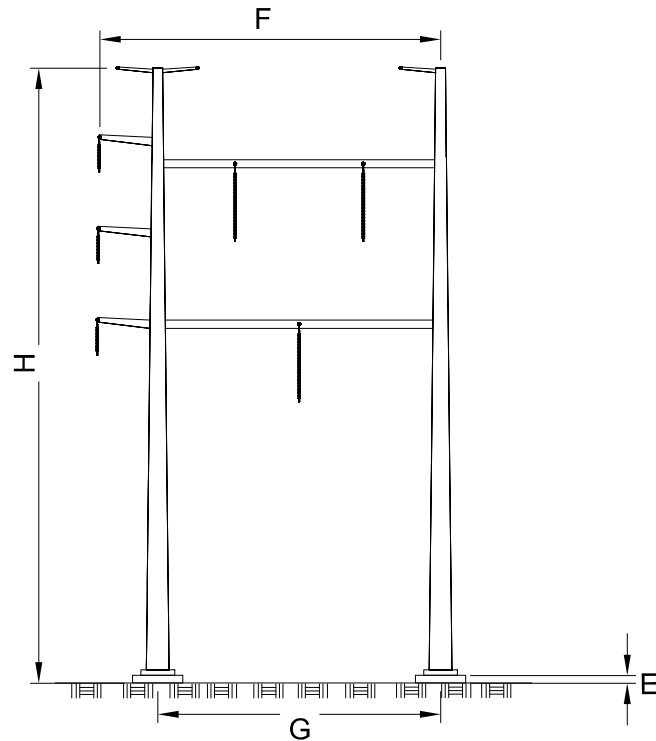
## DOUBLE CIRCUIT DEADEND H-FRAME STRUCTURE

B. RATIONALE FOR STRUCTURE TYPE: DOUBLE CIRCUIT ANGLES, TIGHTER SPACING THAN TYPICAL TOWERS

E. FOUNDATION MATERIAL: STEEL H-PILES  
AVERAGE FOUNDATION REVEAL: SEE NOTE 4

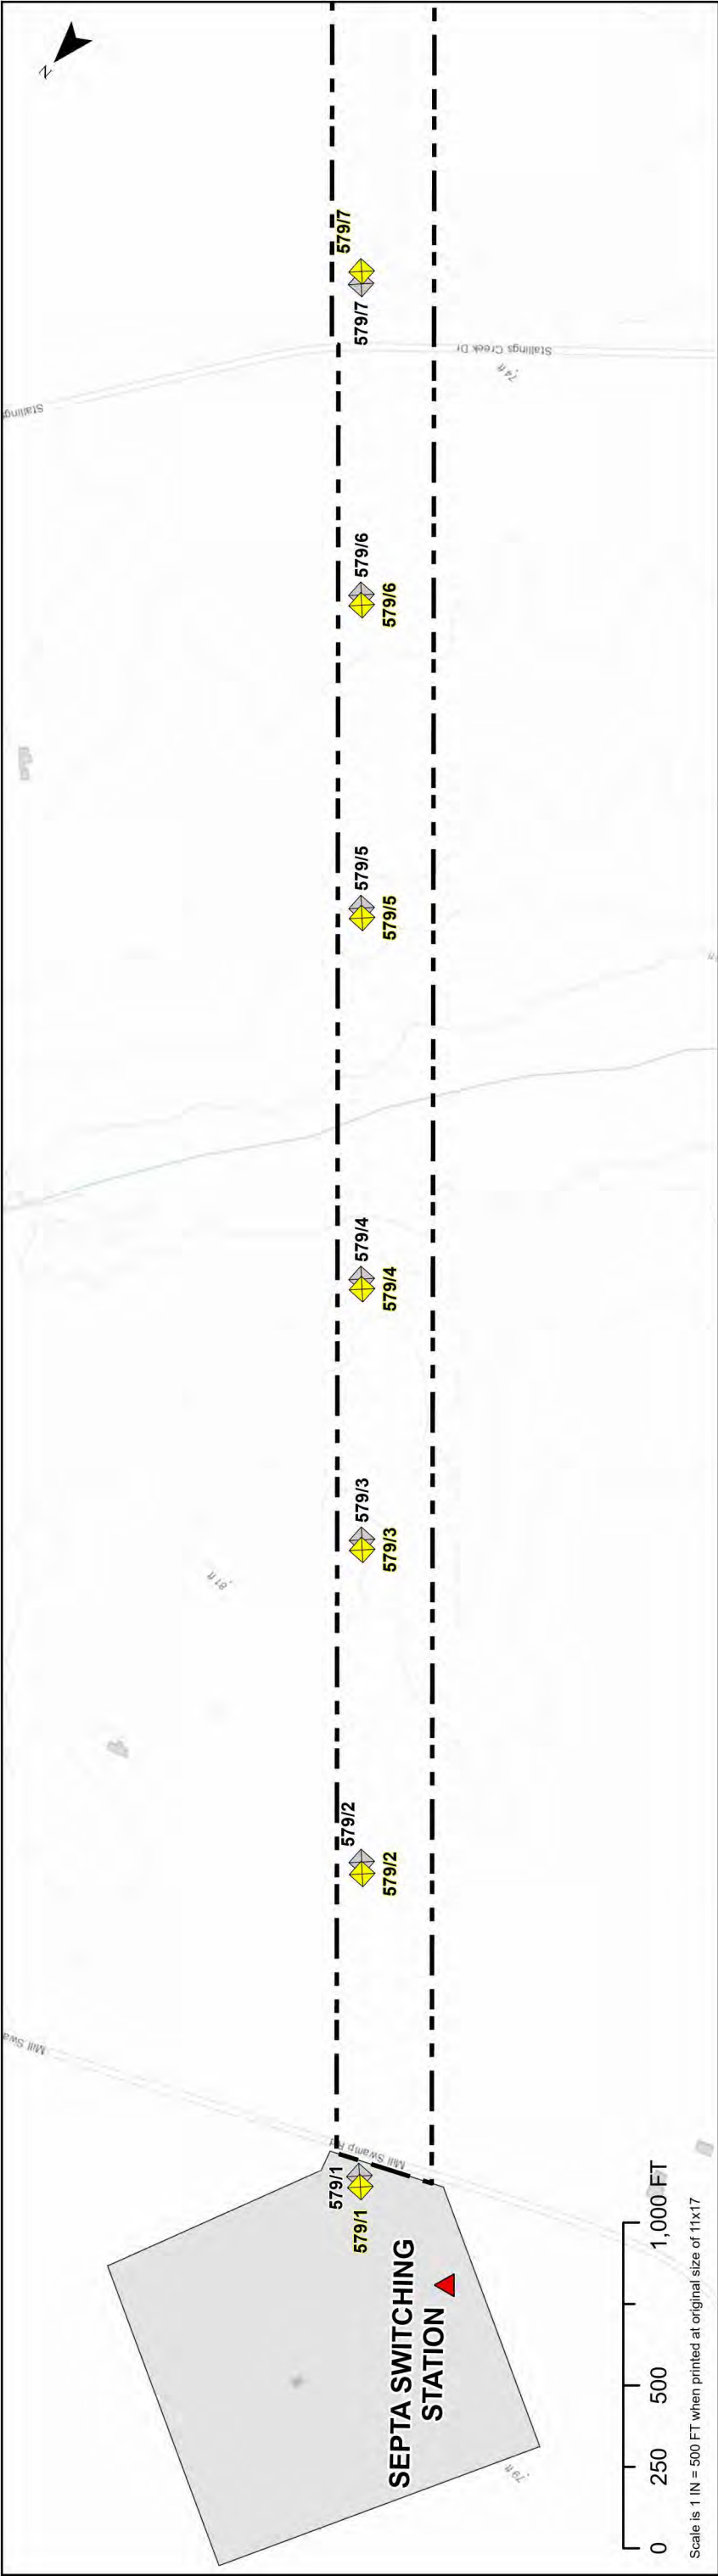
TABLE II.B.3

Proposed Line #579 Structure Number	579/1	579/2	579/3	579/4	579/5	579/6	579/7
Proposed Height (FT)	117	135	140	125	140	135	140
Existing Height (FT)	87	123	113	103	117	98	118

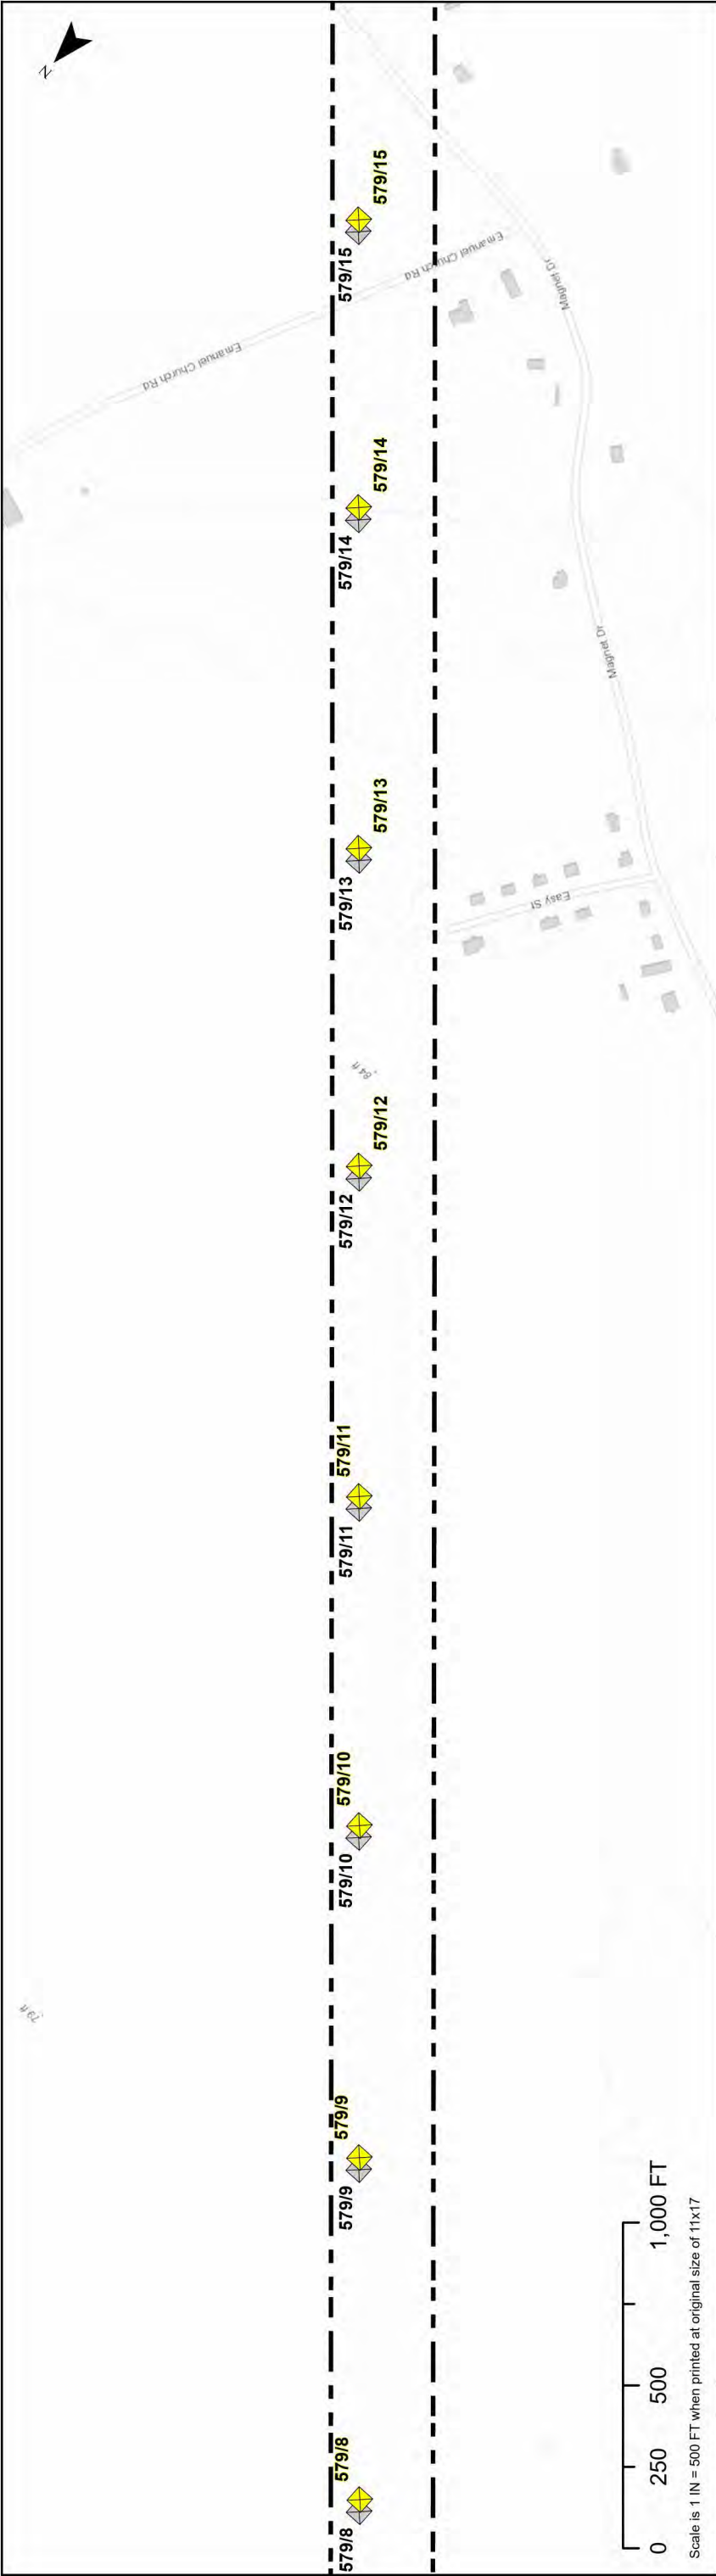
TABLE II.B.3

Proposed Line #579 Structure Number	579/8	579/9	579/10	579/10	579/11	579/11	579/12	579/13	579/14	579/15
Proposed Height (FT)				140	135	135	135	140	135	125
Existing Height (FT)				118	113	113	113	108	118	108

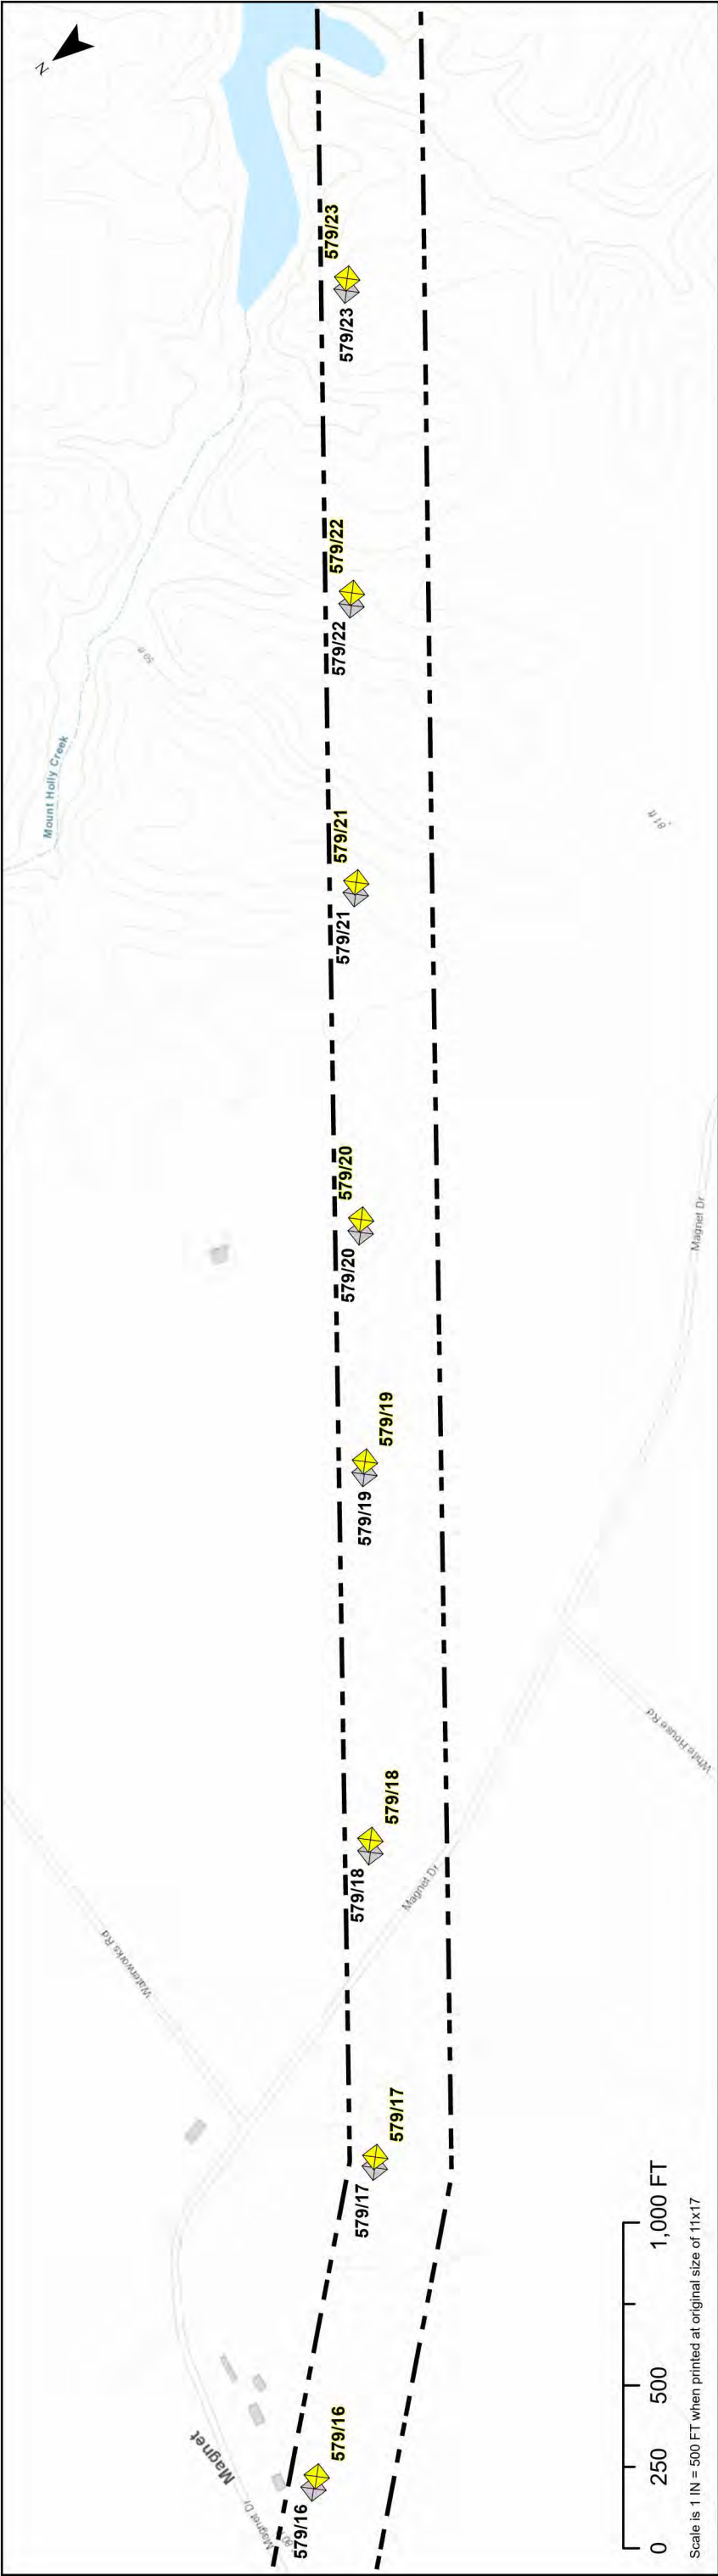
TABLE II.B.3

Proposed Line #579 Structure Number	579/16	579/17	579/18	579/19	579/20	579/21	579/22	579/23
Proposed Height (FT)	145	136	160	140	135	140	130	125
Existing Height (FT)	123	107	121	127	117	113	122	108
