> Application of Virginia Electric and Power Company for approval and certification of electric transmission facilities: 230 kV Lines #2113 and #2154 Transmission Line Rebuilds and Related Projects <u>Case No. PUR-2021-00010</u>

Please find enclosed for electronic filing in the above-captioned proceeding the application for approval of electric transmission facilities on behalf of Virginia Electric and Power Company (the "Company"). This filing contains the Application, Appendix, Direct Testimony, and DEQ Supplement, including attachments.

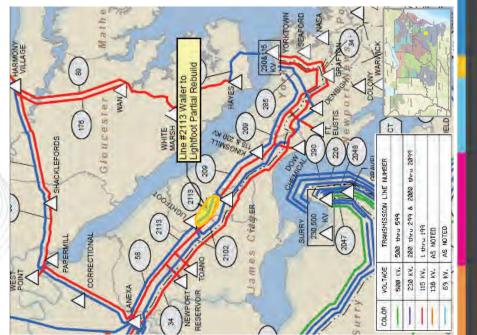
→ End-of-Life reliability assessment, with Waller to Lightfoot section removed from service, creates a radial line from ^{CO} Skiffes Creek to Waller with 118 MW. This is a violation of Dominion's 100 MW planning criteria. N-1-1 study also indicates multiple thermal overload conditions.

Estimated Project Cost: \$4 M Required In-service Date: Immediate Need Projected In-service Date: 12/30/2024 Project Status: Conceptual

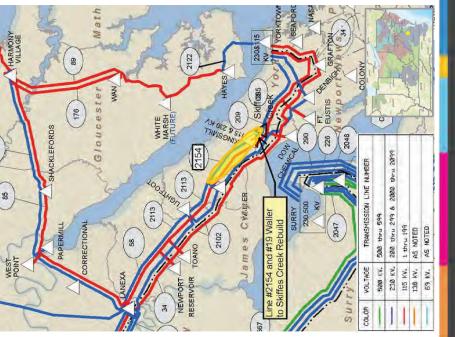
from Lenexa to Waller with 113.5 MW. This is a violation of Dominion's 100 MW planning criteria. N-End-of-Life reliability assessment, with the line #2154 removed from service, creates a radial line 1-1 study also indicates multiple thermal overload conditions.

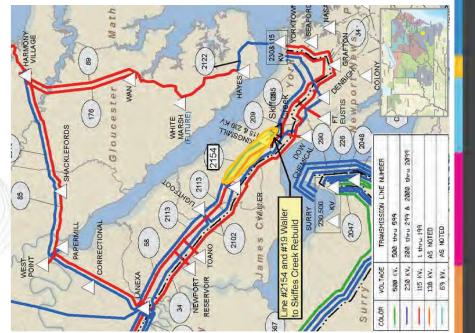
summer emergency rating of 1047 MVA utilizing single circuit steel structures. Remove this 6.1 mile section of Line #58 between Waller and Kings Mill. Rebuild the 1.6 miles of Line #2154 and #19 Rebuild 6.1 miles of Line #2154 between Waller and Kings Mill to current standards with a minimum between Kings Mill and Skiffes Creek to current standards with a minimum summer emergency rating of 1047 MVA at 230 kV for Line #2154 and 261 MVA at 115kV for Line #19, utilizing double circuit steel structures. 21

Alternative: No feasible alternatives. Estimated Project Cost: \$10 M Required In-service Date: Immediate Need Projected In-service Date: 12/30/2024 Project Status: Conceptual

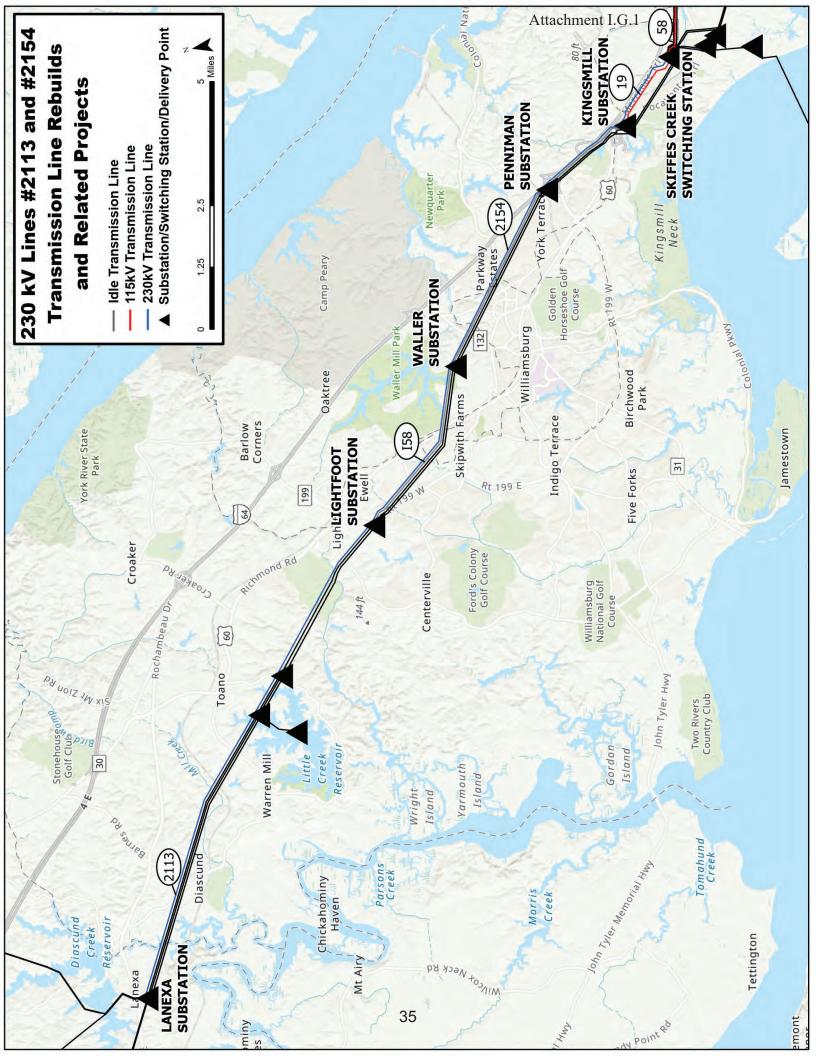
G. Provide a system map, in color and of suitable scale, showing the location and voltage of the Applicant's transmission lines, substations, generating facilities, etc., that would affect or be affected by the new transmission line and are relevant to the necessity for the proposed line. Clearly label on this map all points referenced in the necessity statement.

Response: See <u>Attachment I.G.1</u>.

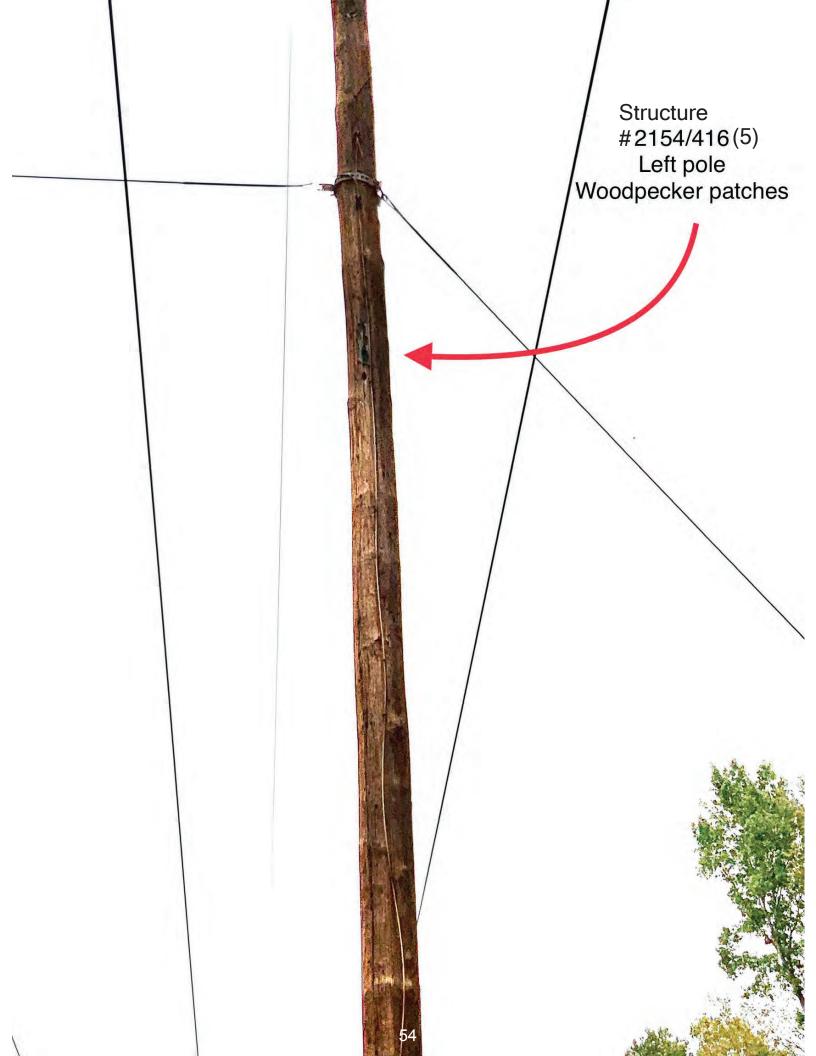
Structure #2154/416 (6) Left pole Woodpecker holes

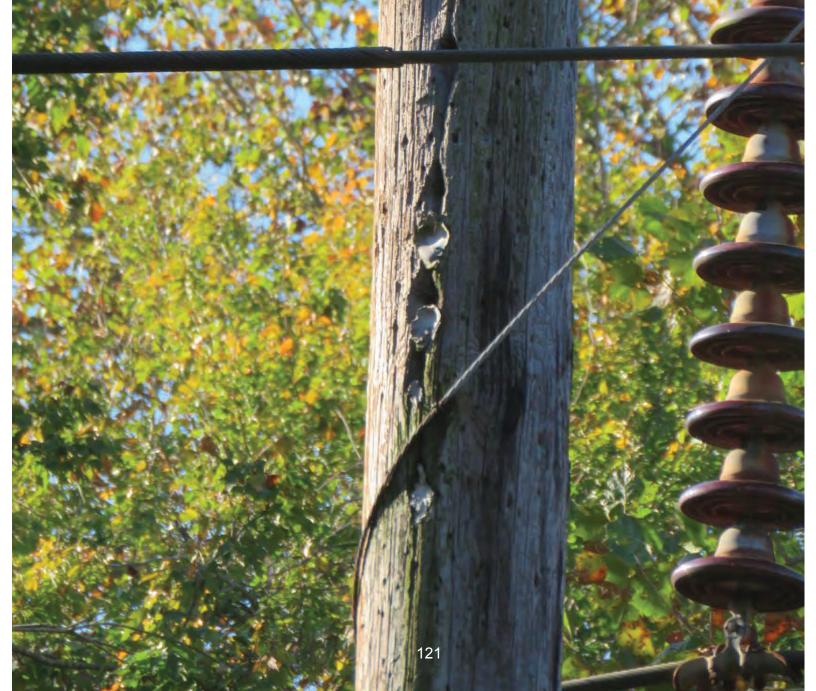
Structure #2154/477(1) Middle pole is splitting

Structure # 2154/477(2) Middle pole is splitting

19/202, 2154/477 Pending Removal Pole Position	I Pole Position	2nd Pole From Left		2/12/2004	
19/204, 2154/479	Guys	Guy Buried		2/12/2004	
19/204, 2154/479	Anchors	Anchors Broken		3/11/1999	
2154/363A	Steel Pole	Needs Painting		5/8/2017	
2154/412	Switch	Switch Other=	Install Anti-Climb Device	10/19/2015	
2154/413	Hardware	Hardware - Corroded		3/8/1999	
2154/413	Guys	Guys - Other	BROKEN DOWN GUY	6/16/2011	WIL0152
2154/413	Guy	Guy Other=	Broken	6/3/2016	
2154/413	Wood Pole	Pole Position=	Left	6/3/2016	
2154/414	Wood Pole	Pole Position=	Left	6/3/2016	
2154/414	Wood Pole	WP Damage-MI=Minor, MA=Major		6/3/2016	
2154/416	Static Wire	Cotter Key-BO=Backed Out, M=Mi	BO- middle pole	3/30/2018	HAZON
2154/420	Hardware	Hardware - Damaged		3/8/1999	
2154/420	Guys	Guys - Other	BROKEN	6/16/2011	WIL0152
2154/420	Wood Pole	Pole Position=	Left	6/3/2016	
2154/420	Wood Pole	WP Damage-MI=Minor, MA=Major		6/3/2016	
2154/421	Structure - Wood or Concrete	Structure - Minor Woodpecker Hole / Hole		2/12/2004
